POA-2004-1127-M5, Isabella Creek. Pictures from Sept, 2016 site visit.

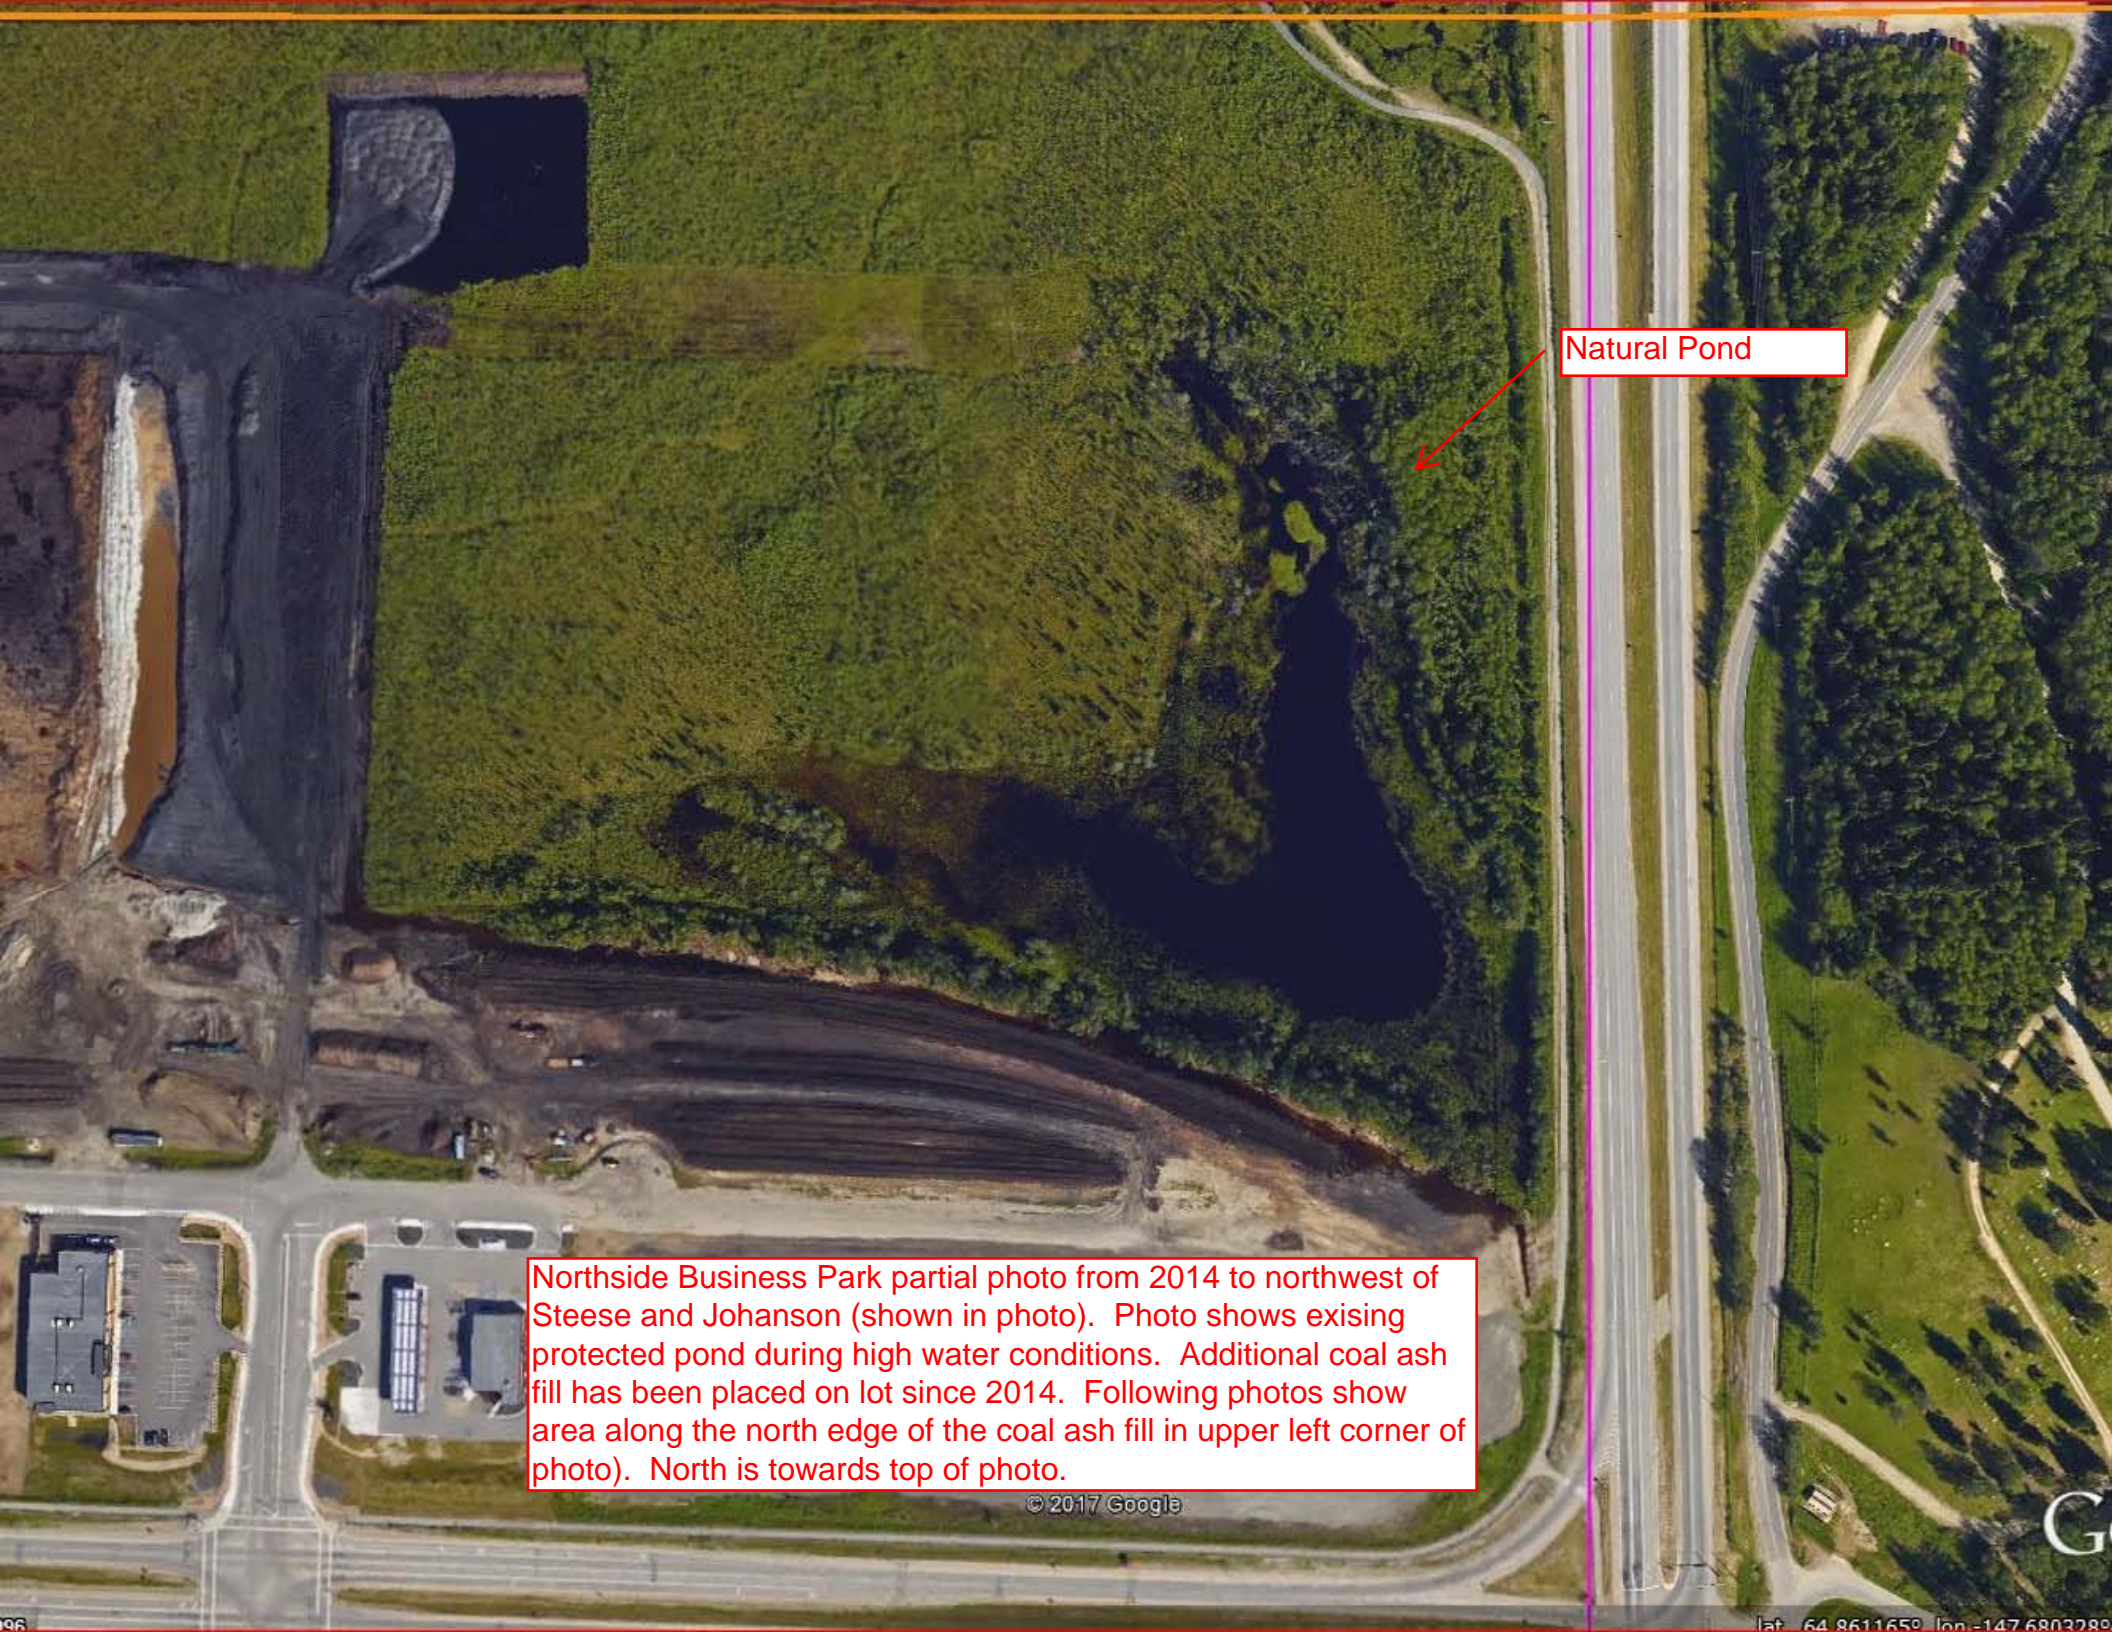
Natural Pond

Northside Business Park partial photo from 2014 to northwest of Steese and Johanson (shown in photo). Photo shows existing protected pond during high water conditions. Additional coal ash fill has been placed on lot since 2014. Following photos show area along the north edge of the coal ash fill in upper left corner of photo). North is towards top of photo.

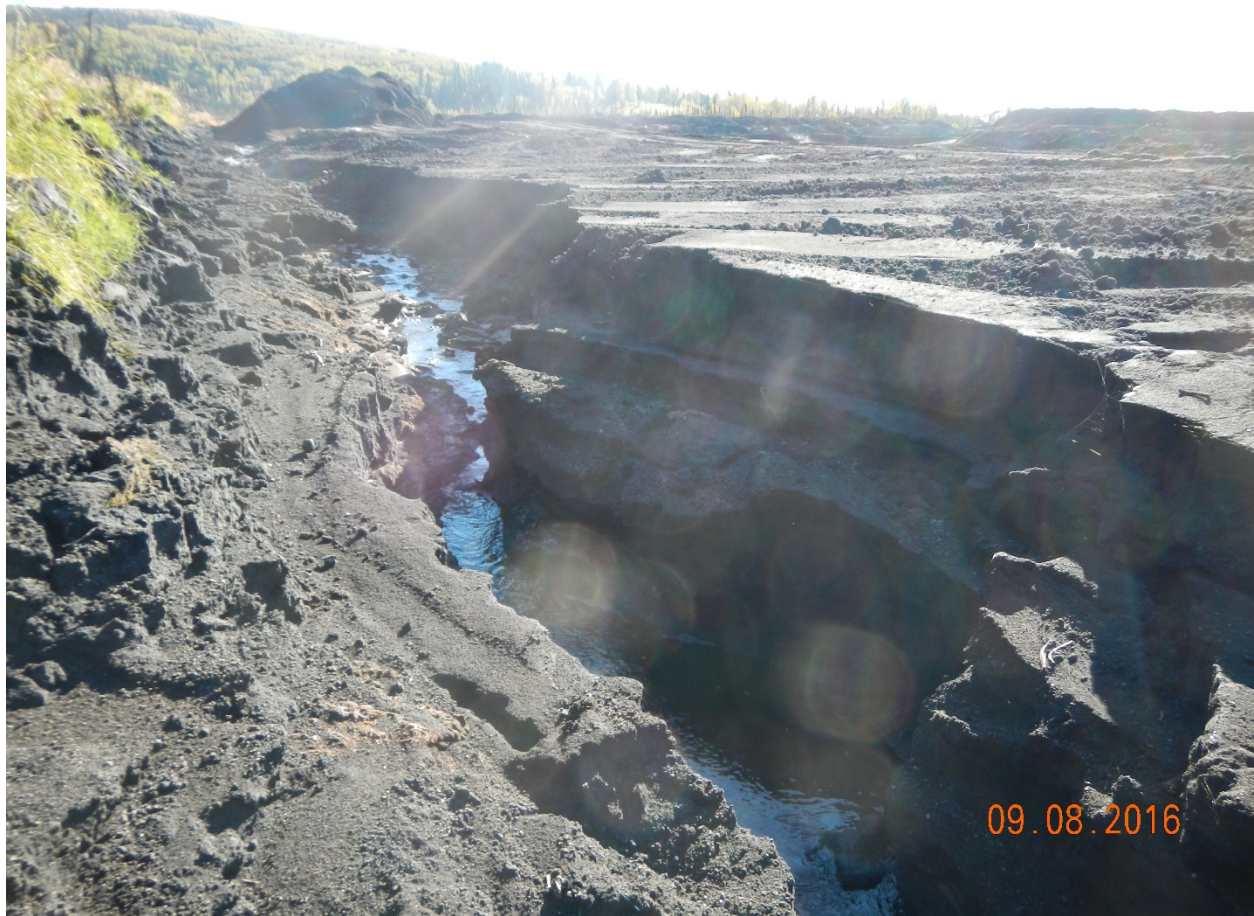
Northside of property. Water eroding coal ash, flowing from top to bottom of picture (east to west) towards and into storm water pond. Depth of eroded area is approximately 3+ feet.

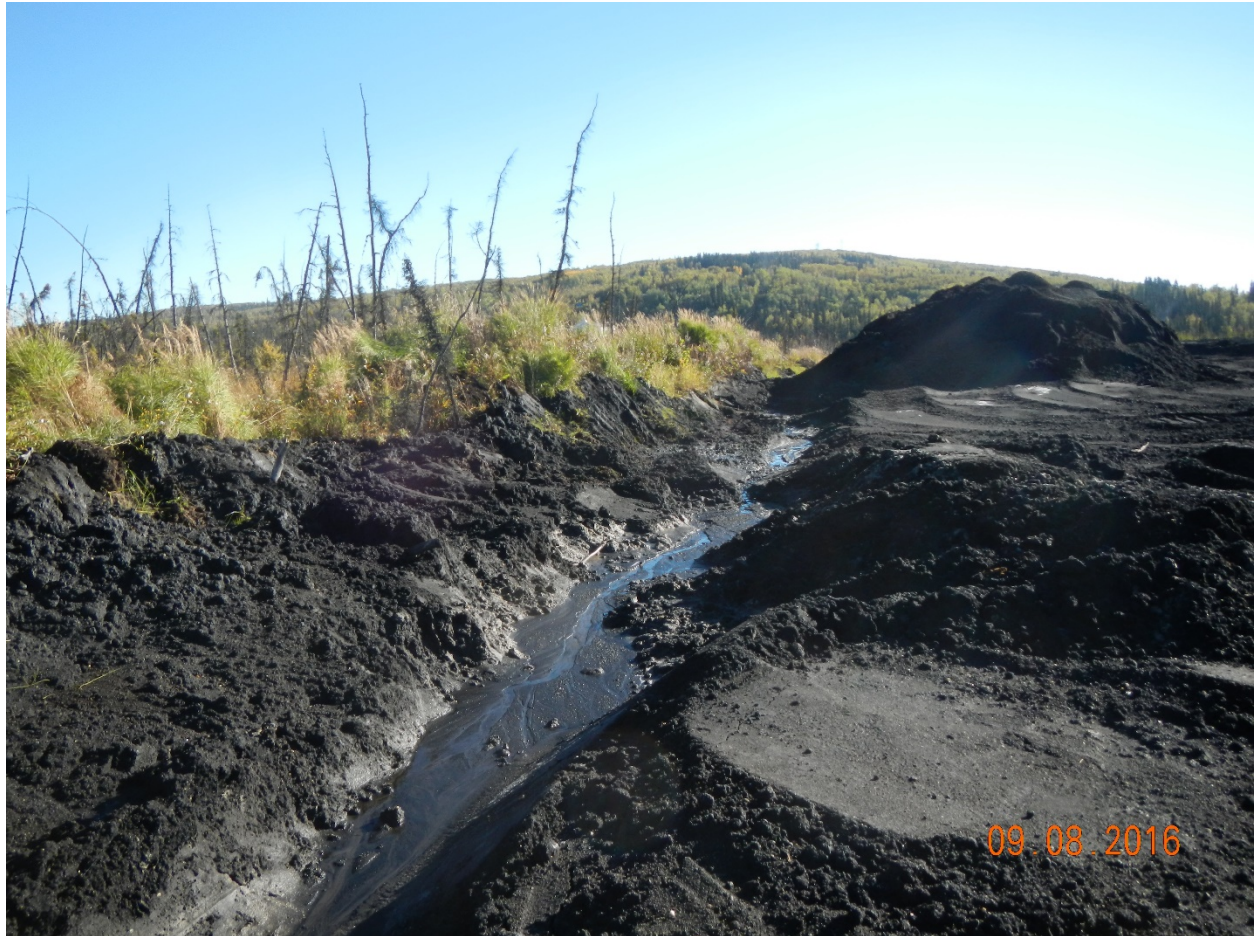
Northside of property. Water eroding coal ash, flowing from top to bottom of picture (east to west) towards and into storm water pond. Pile of ash in this picture is same as one in the background of picture above. As water flows across coal ash, eroded area becomes deeper.

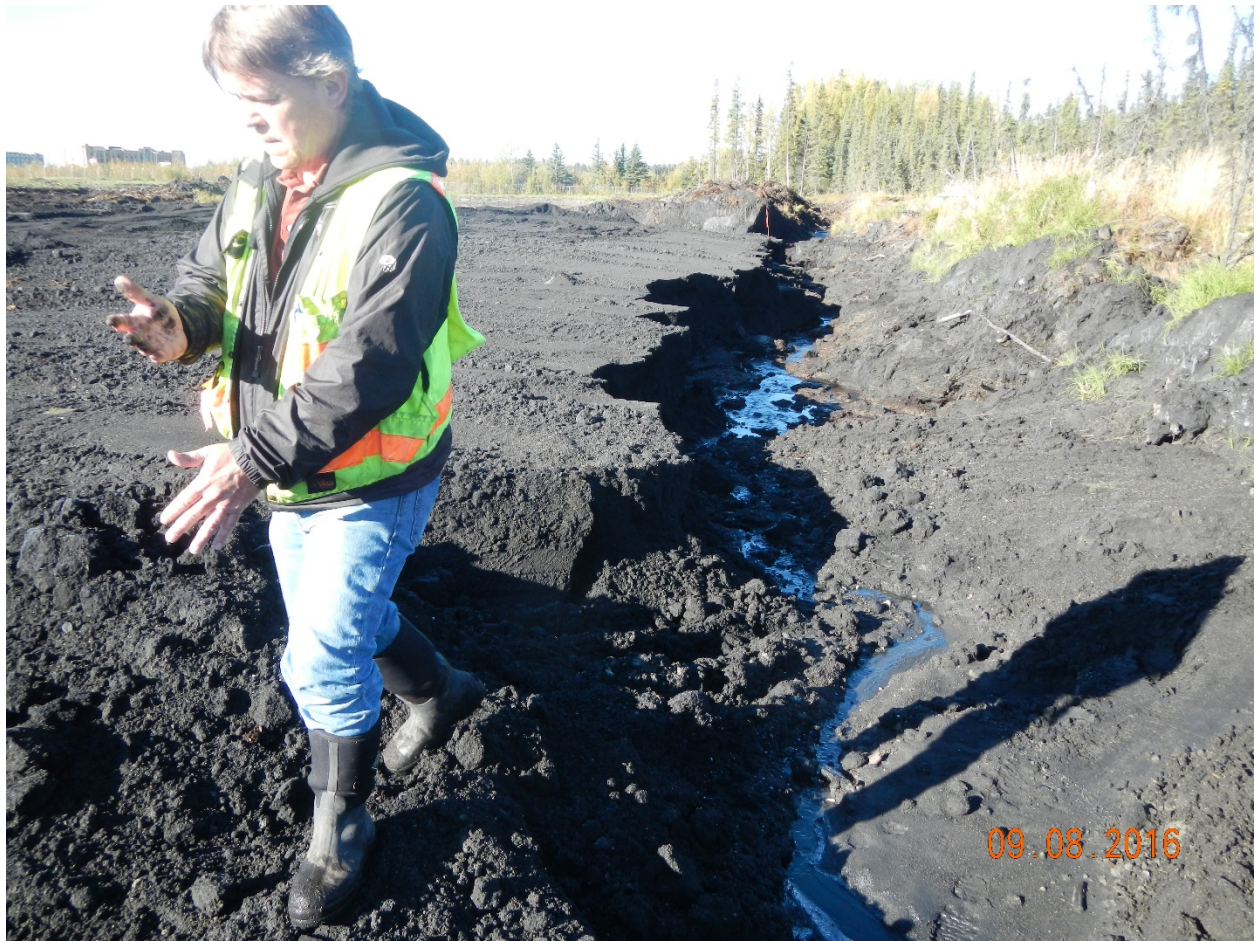
Northside of property. Picture taken of north side of property from east to west. Same area of eroded coal ash. Storm water pond is not visible at top of picture.

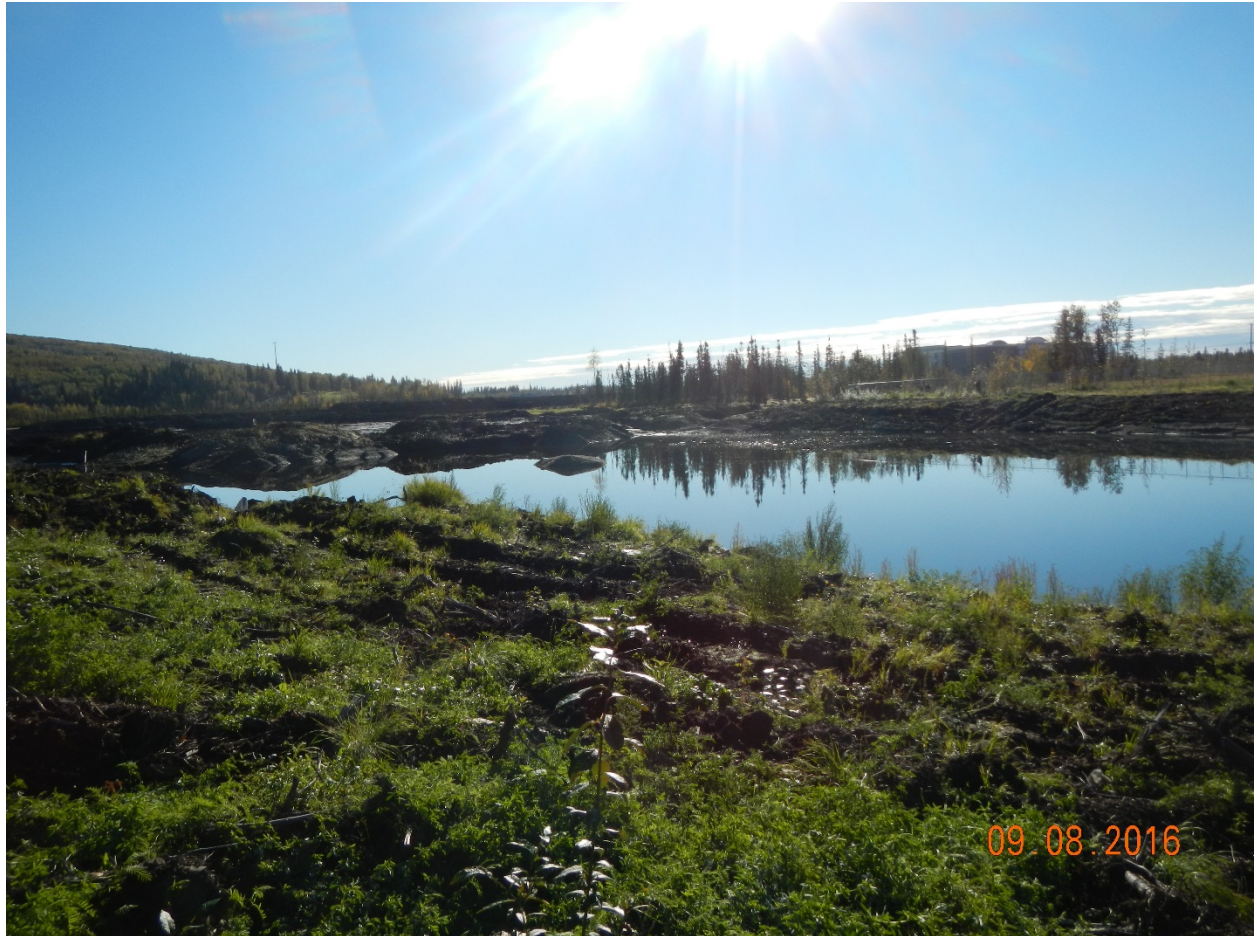
Created stormwater retention pond. The channel in the previous three pictures discharges into the upper left hand corner of the pond.

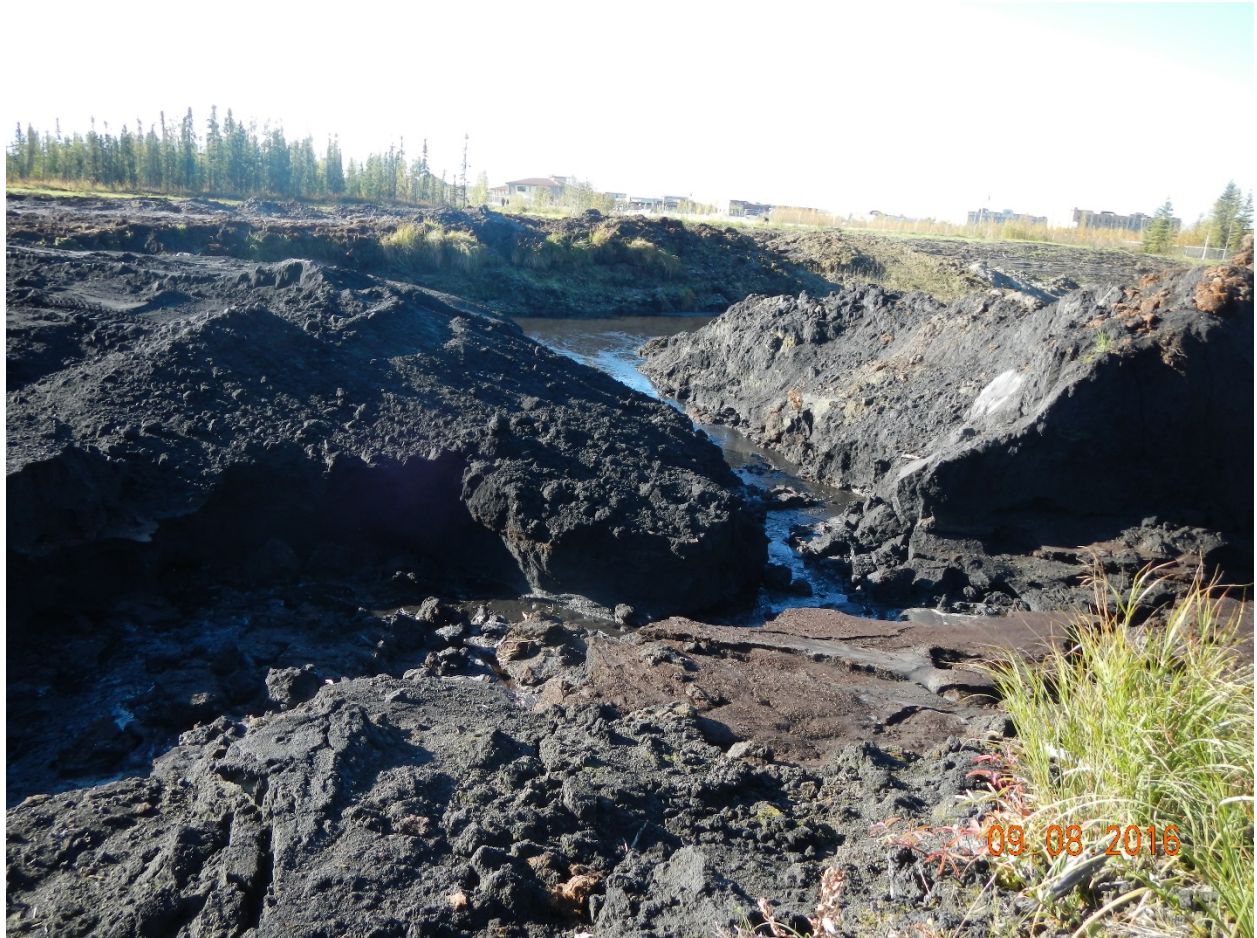
Point at which channel flows into stormwater pond. Entire pond not visible in this photo.

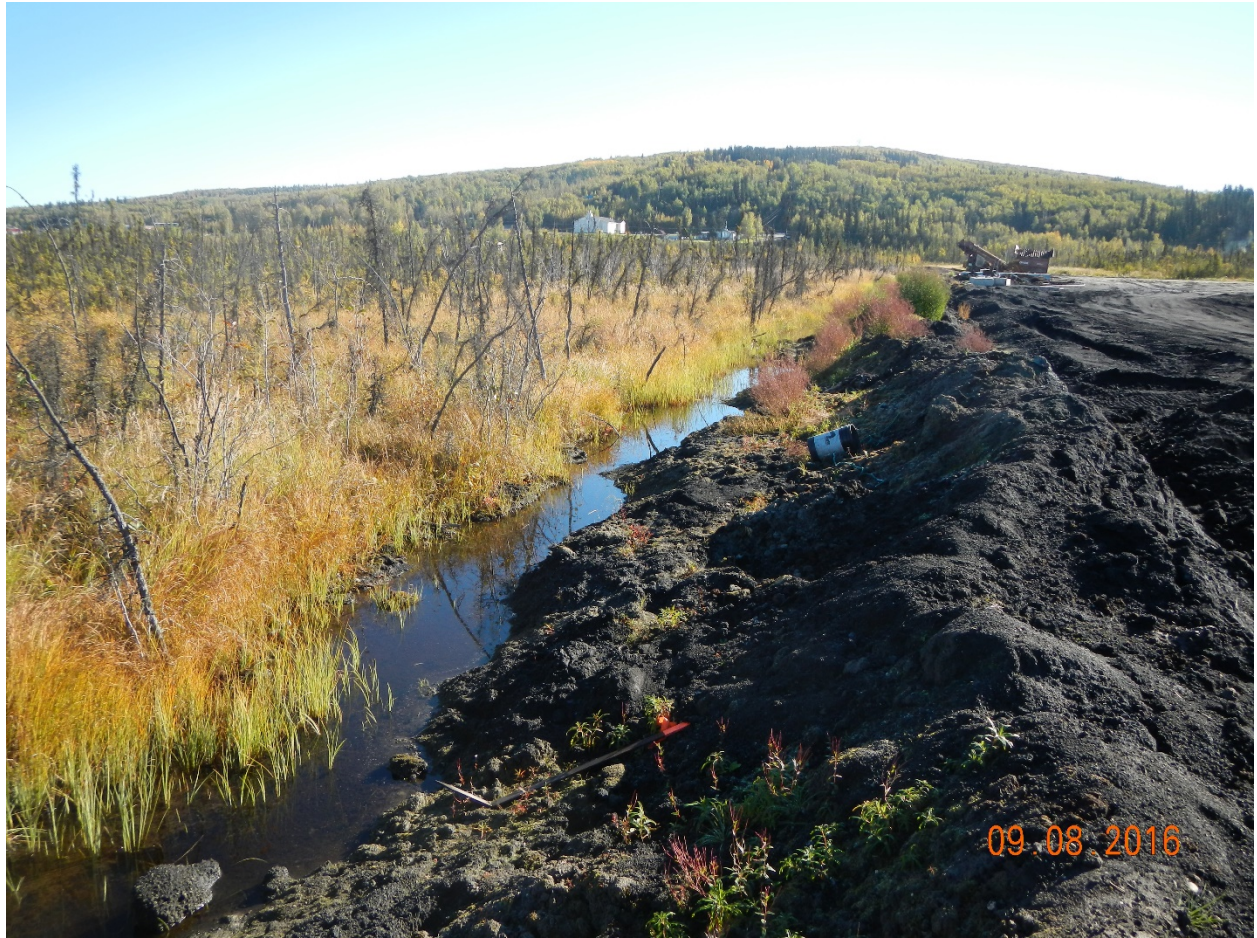
Picture illustrates amount of water flowing into coal ash area out of wetlands to north of parcel.
