U.S. Army Corps
of Engineers
Alaska District

ALASKA BASELINE EROSION ASSESSMENT

Erosion Information Paper – Circle View and Stampede Estates, Alaska

Current as of October 31, 2007

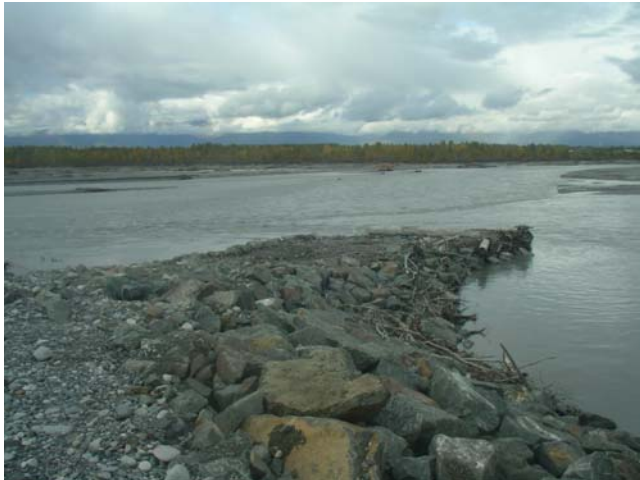
Photo 1: Finger dike #5 added in 2006 to protect lower end of Circle View Subdivision, Sept. 2007.

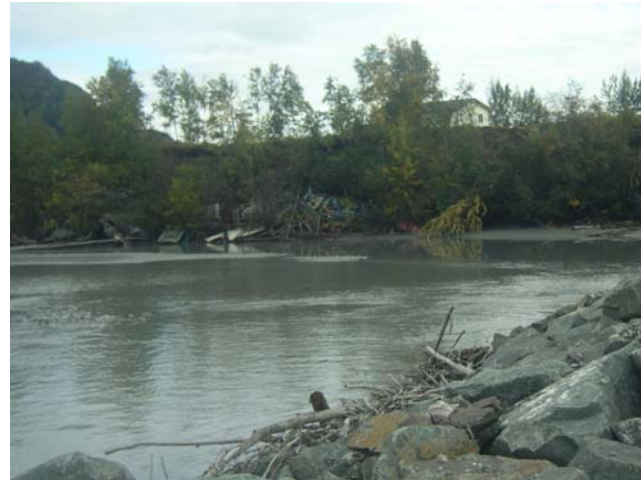
Photo 2: View from river end of Dike #5 Circle View Subdivision looking back at junk cars placed illegally to slow erosion, Sept. 2007.

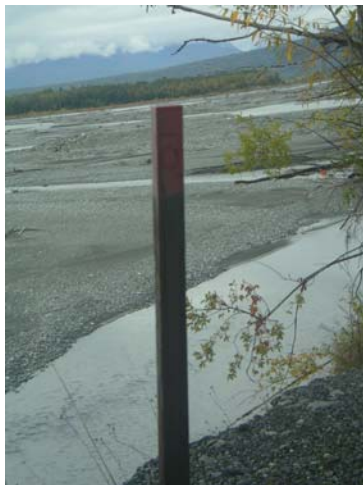
Photo 3: Stake marking 10 ft to the Matanuska river's edge at less than 2 ft, Sept. 2007.

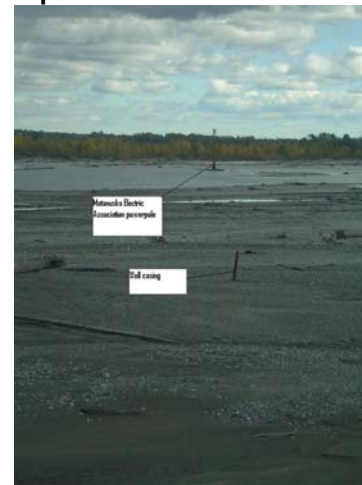
Photo 4: Well casing all that remains of former home site lost to Matanuska river erosion during early 1990's, Sept. 2007.

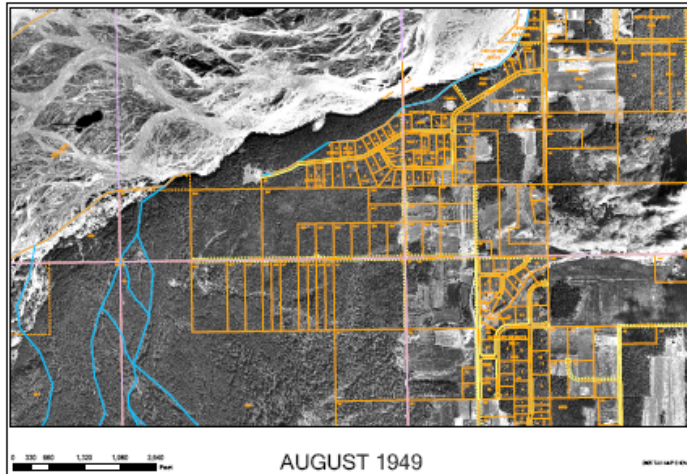
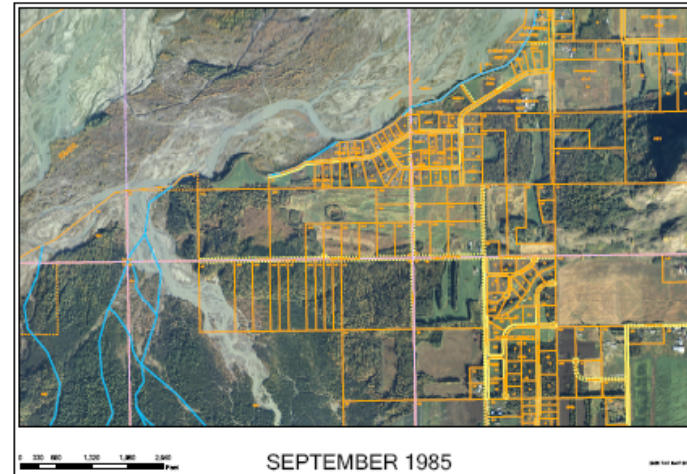
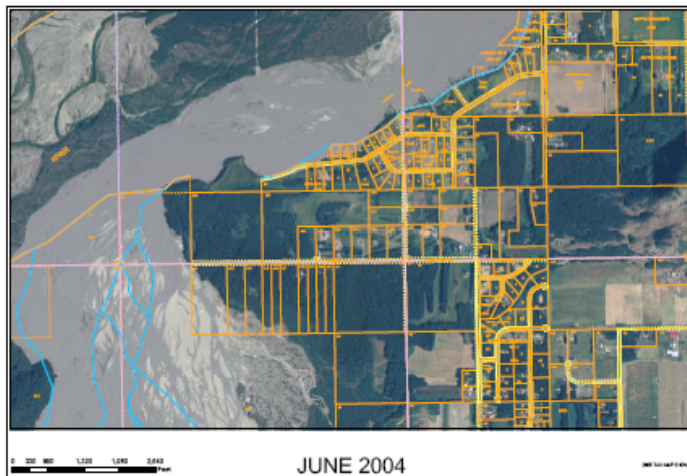
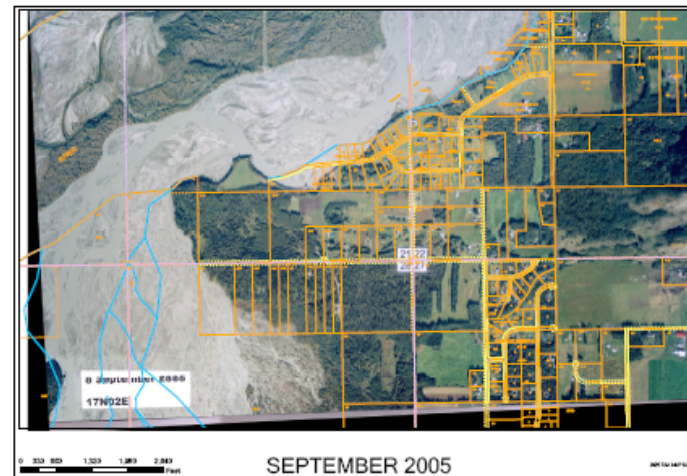
MATANUSKA RIVER EROSION AT CIRCLE VIEW SUBDIVISION

Matanuska River Erosion at Circle View Subdivision from 1949 through 2005 provided by Matanuska-Susitna Borough

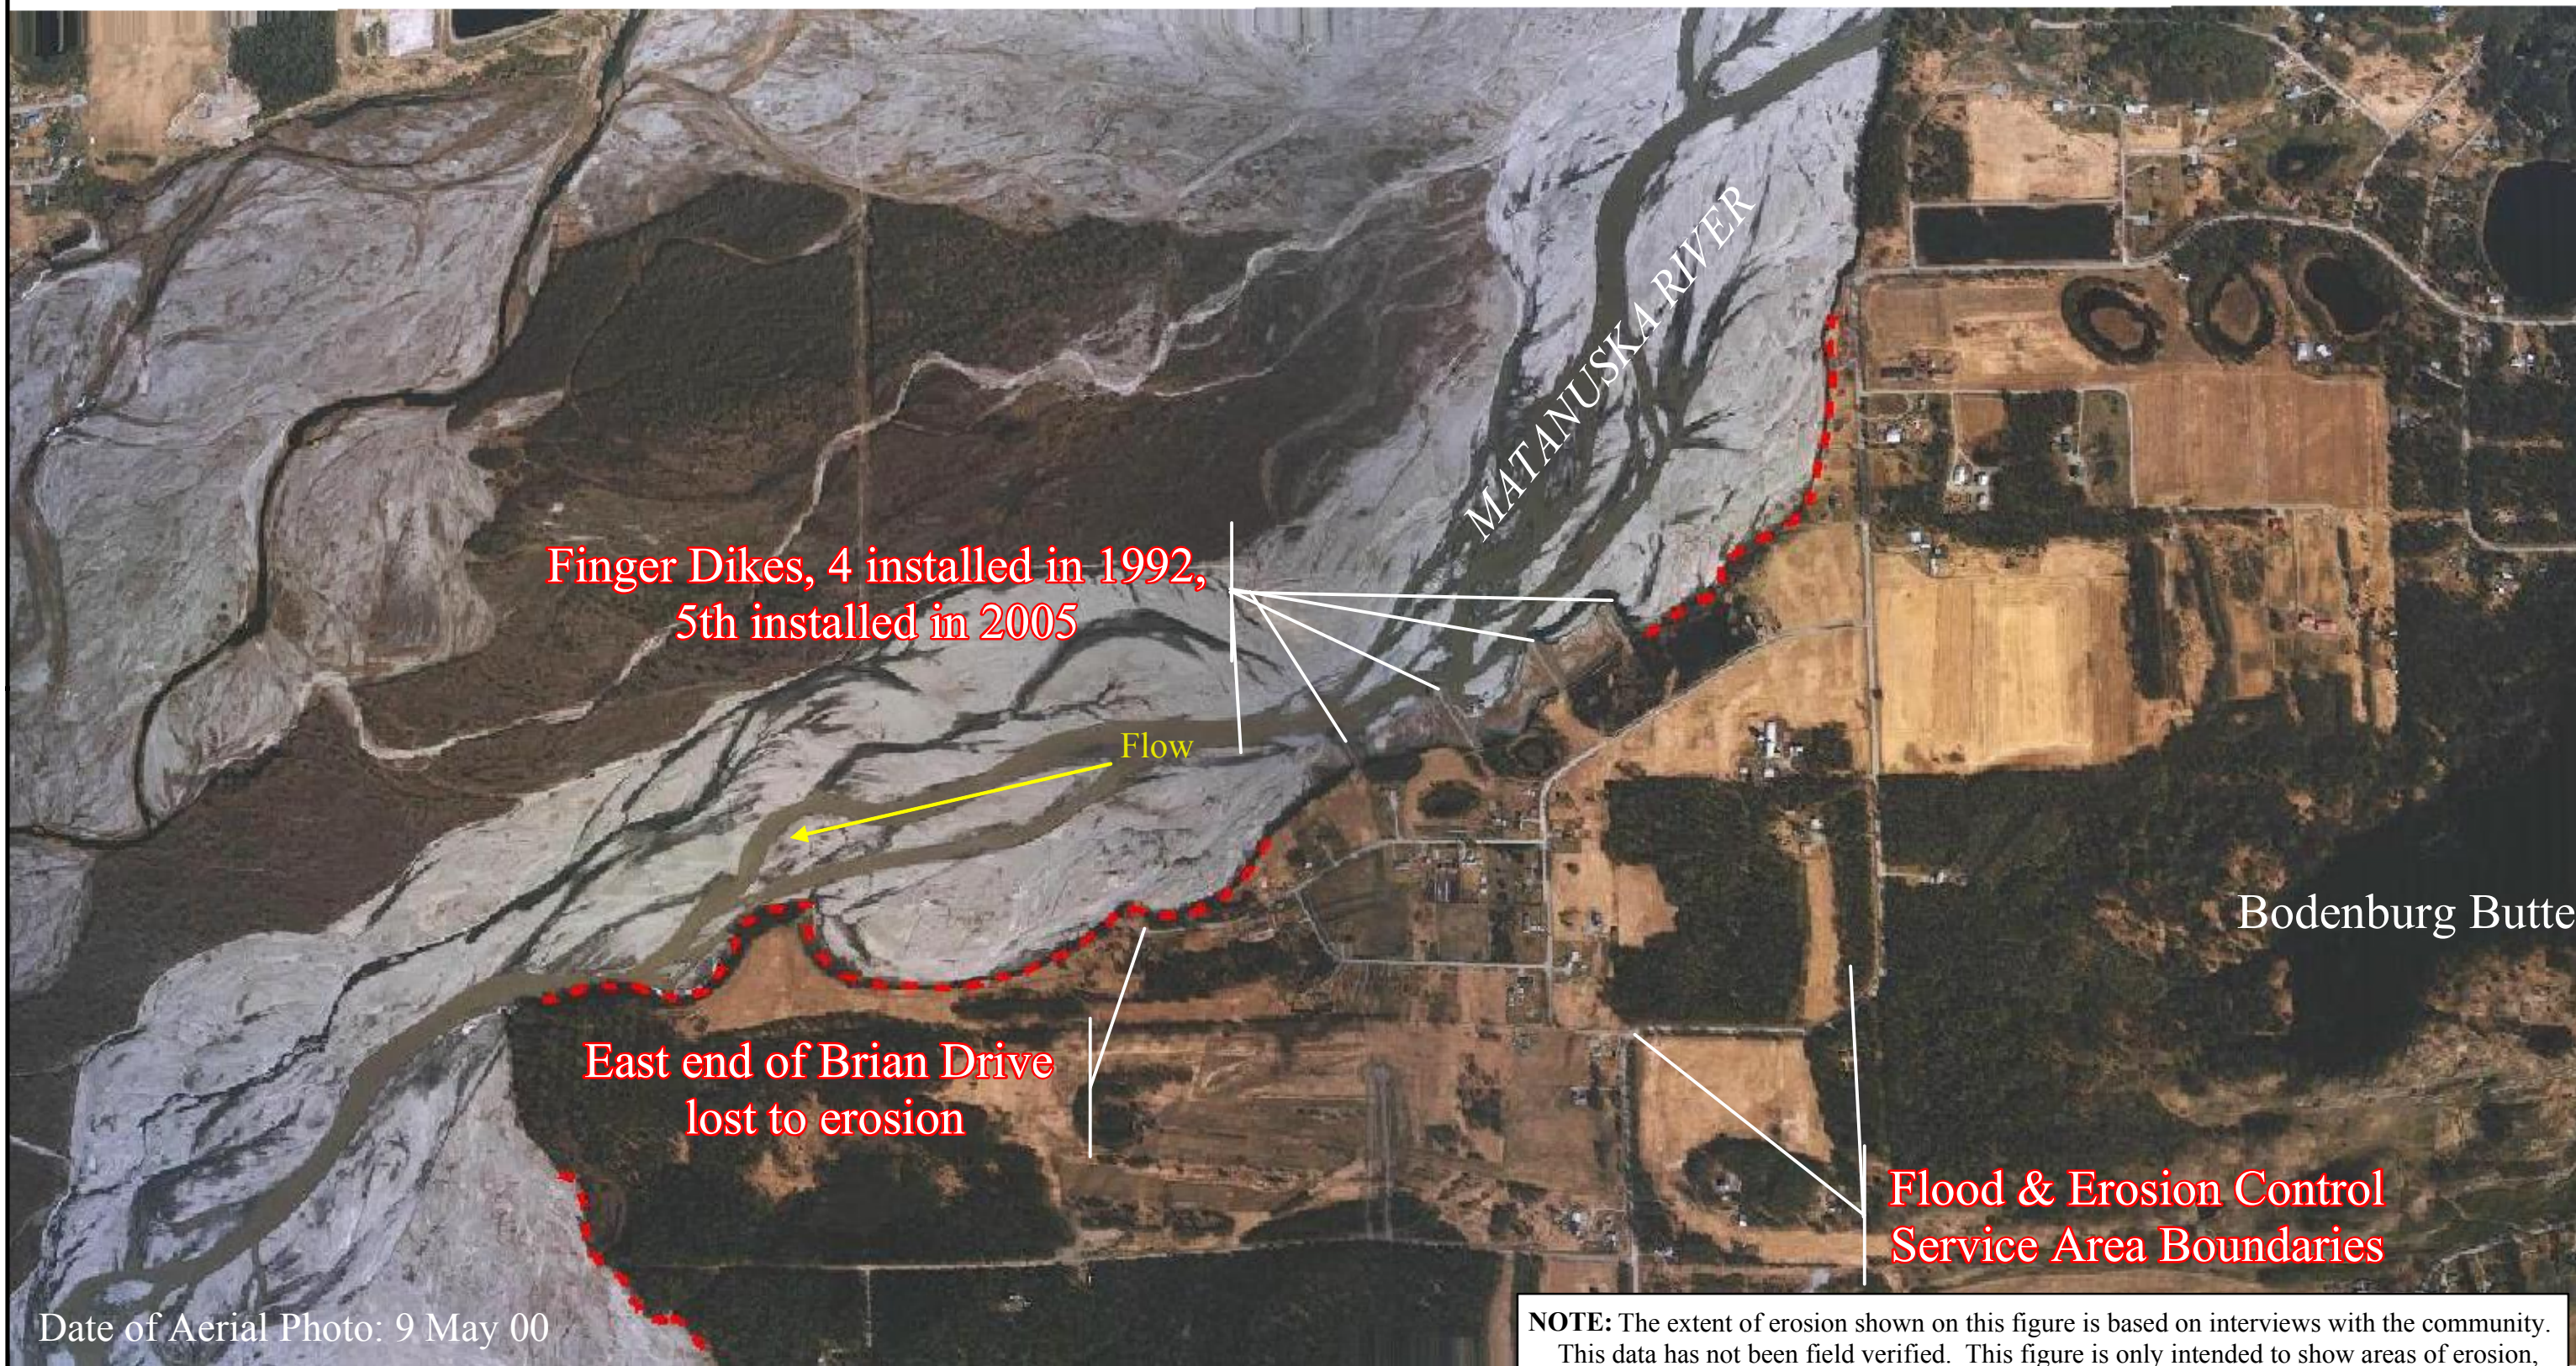
Alaska Baseline Erosion
Circle View & Stampede
Estates SD, Butte, Alaska

----- Linear Extent of Erosion
