ALASKA BASELINE EROSION ASSESSMENT

Erosion Information Paper – Clark’s Point, Alaska

Current as of October 12, 2007

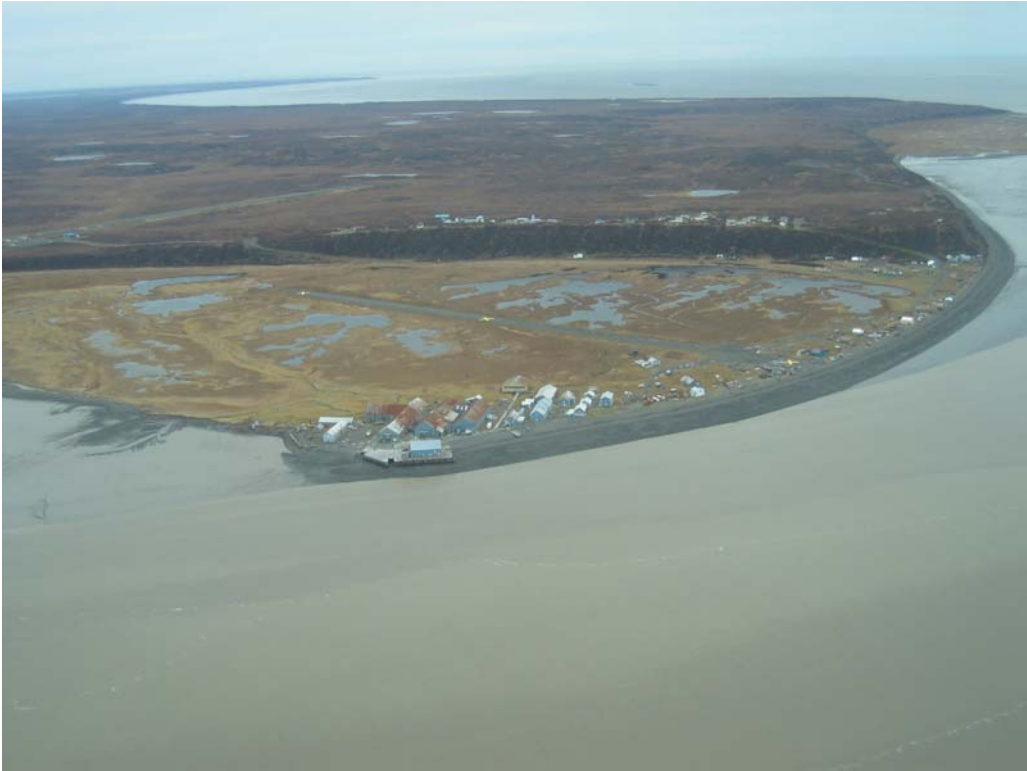
Photo 1: Clark's Point from the North, October 2005.

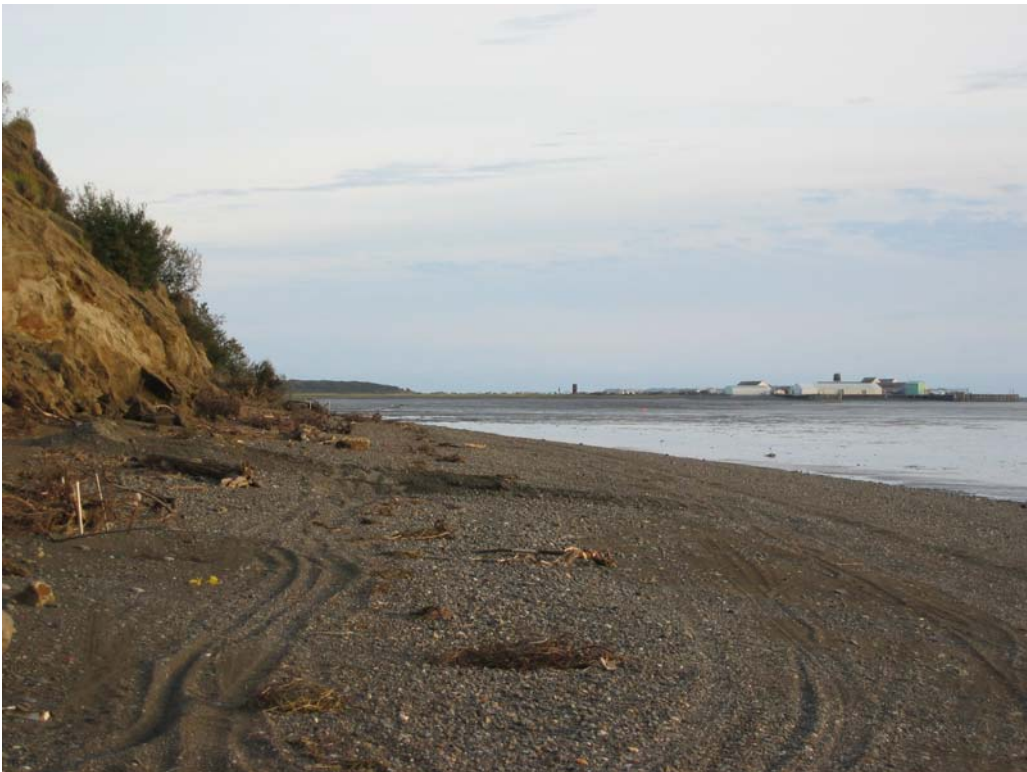
Photo 2: Looking towards fish plant, September 2005.
