U.S. Army Corps  
of Engineers  
Alaska District

## **ALASKA BASELINE EROSION ASSESSMENT**

### **Erosion Information Paper - Ekwok, Alaska**

Current as of March 11, 2008

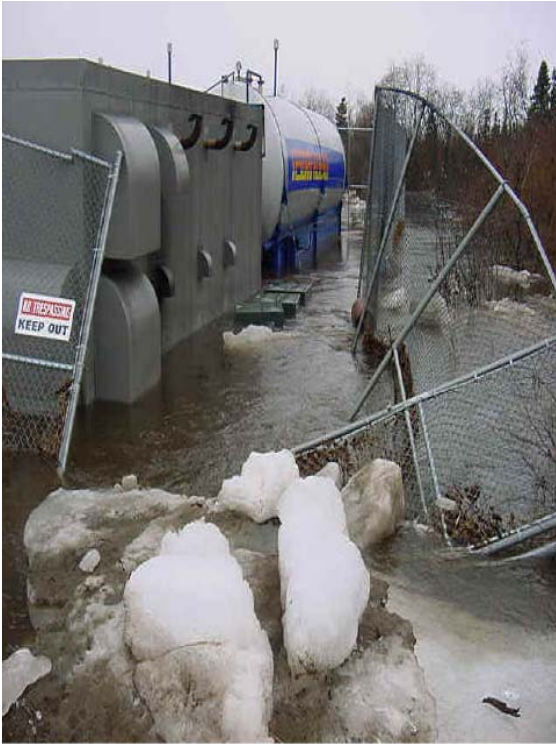
**Photo 1: Ice jam flooding around the Ekwok power plant, May 2002.**

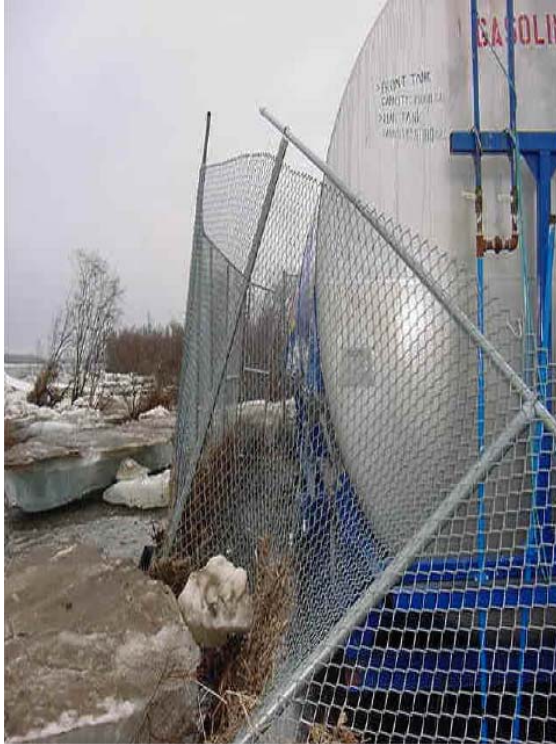
**Photo 2: Fence around the power plant and fuel tanks damaged by ice jam in May 2002.**

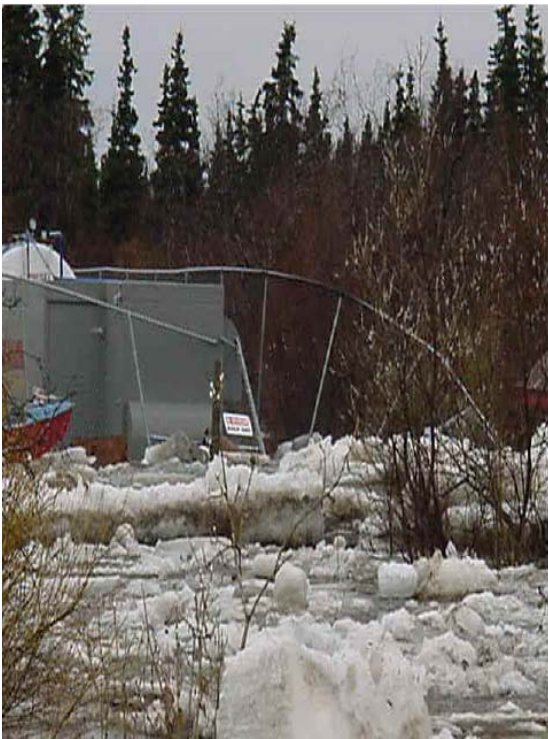
**Photo 3: Ice jam pushed up around power plant, May 2002.**

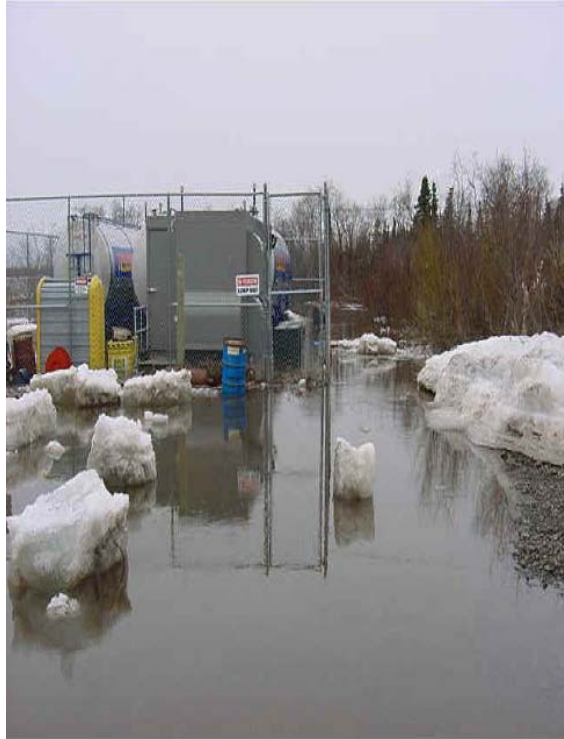
**Photo 4: Ice jam flooding at the power plant, May 2002.**

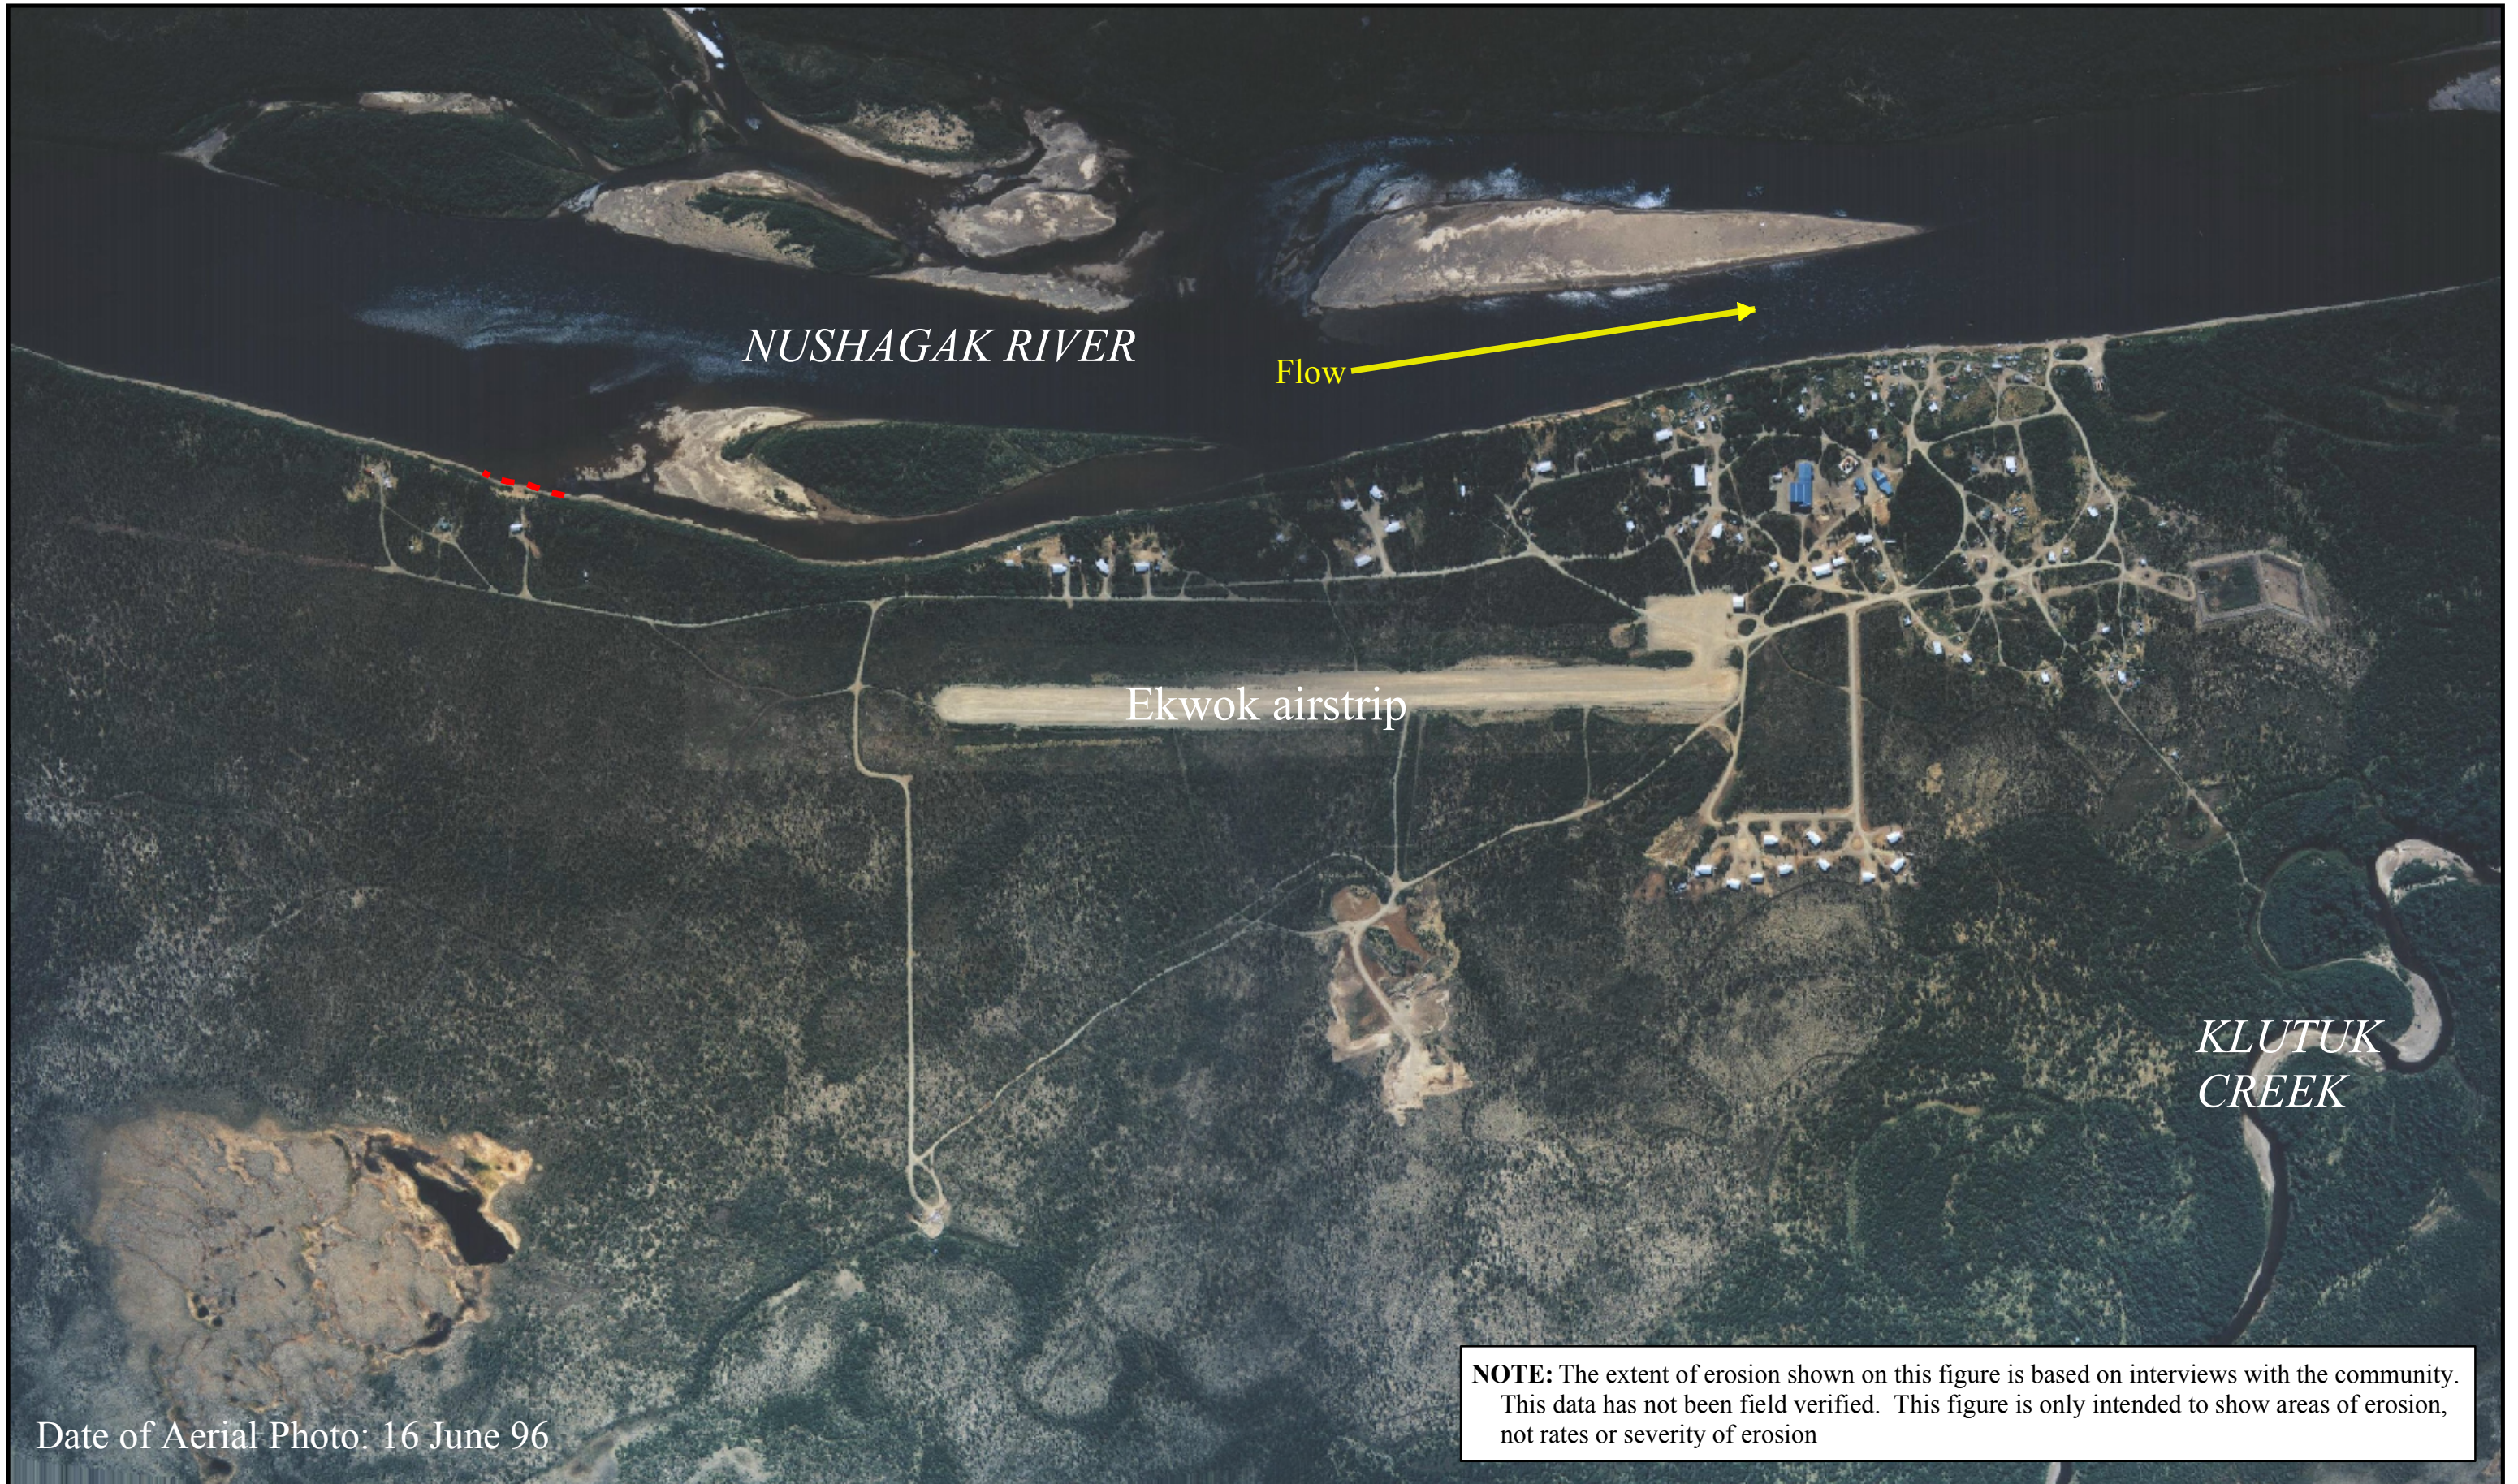
Alaska Baseline Erosion  
Ekwok, Alaska

Photos are attached of the community following an ice jam flood. Also, attached is a diagram depicting the linear extent of erosion in the community, based on information provided in the community survey by the city administrator and not from other sources (the community profile maps from 1981 and 2003 showed more extensive erosion areas).

**NOTE:** The extent of erosion shown on this figure is based on interviews with the community. This data has not been field verified. This figure is only intended to show areas of erosion, not rates or severity of erosion
