U.S. Army Corps
of Engineers
Alaska District

ALASKA BASELINE EROSION ASSESSMENT

Erosion Information Paper - Homer, Alaska

Current as of August 24, 2007

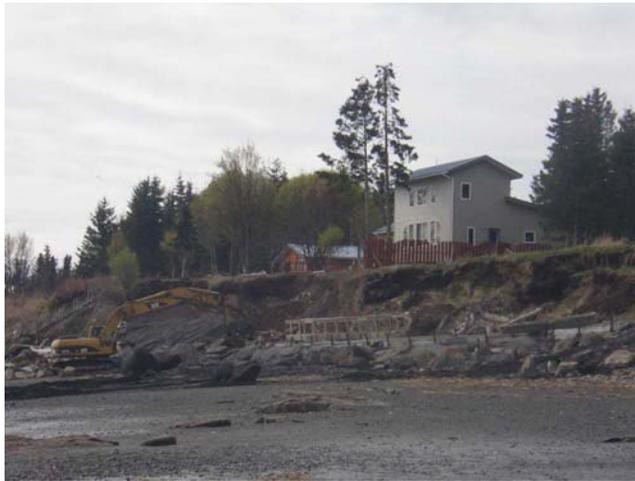
Photo 1: Homer Bluff Kachemak Drive home site May 2006

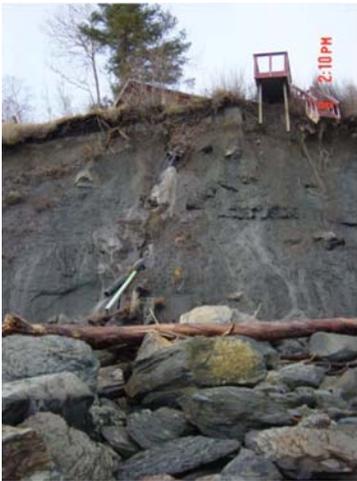
Photo 2: Homer Bluff erosion December 2006

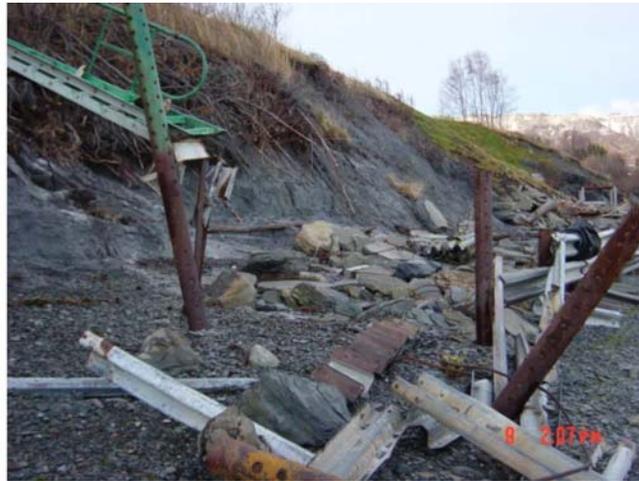
Photo 3: Kachemak Drive December 2006

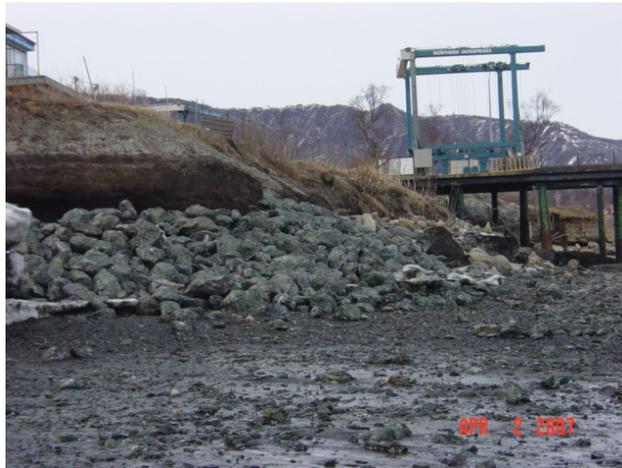
Photo 4: Homer bluff private property riprap project April 2007

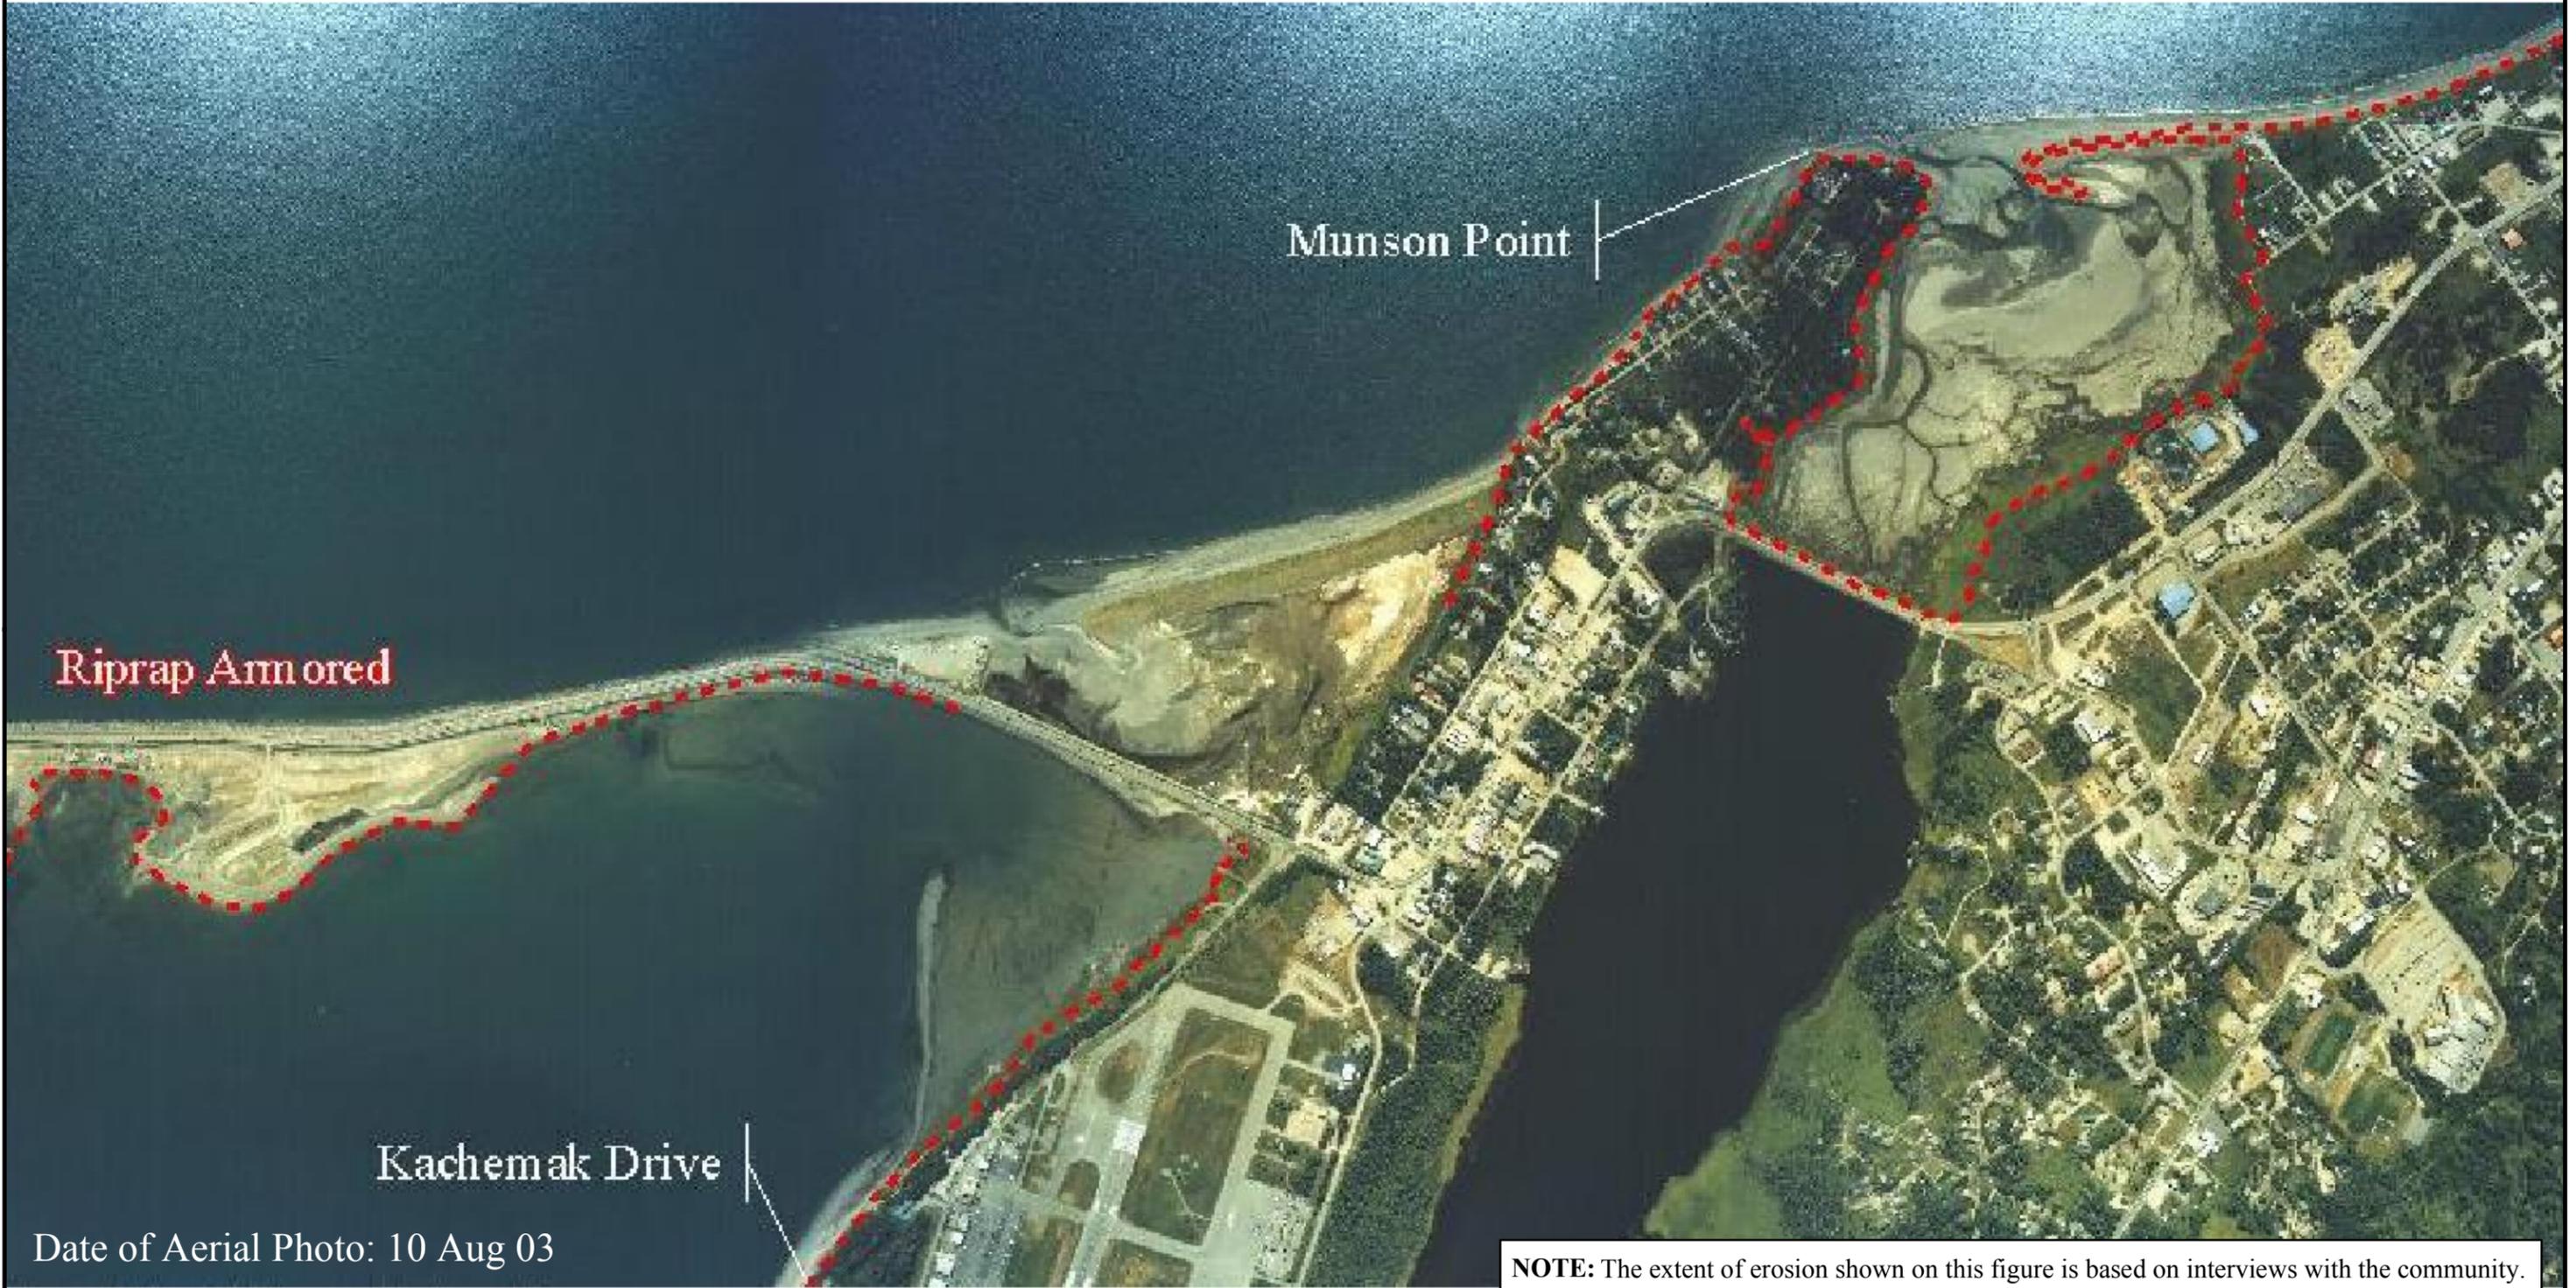
Linear Extent of Erosion
Part 1

Seasonal Accretion & Erosion

Rip Rap Armored
