U.S. Army Corps
of Engineers
Alaska District

ALASKA BASELINE EROSION ASSESSMENT

Erosion Information Paper - Kaltag, Alaska

Current as of March 5, 2008

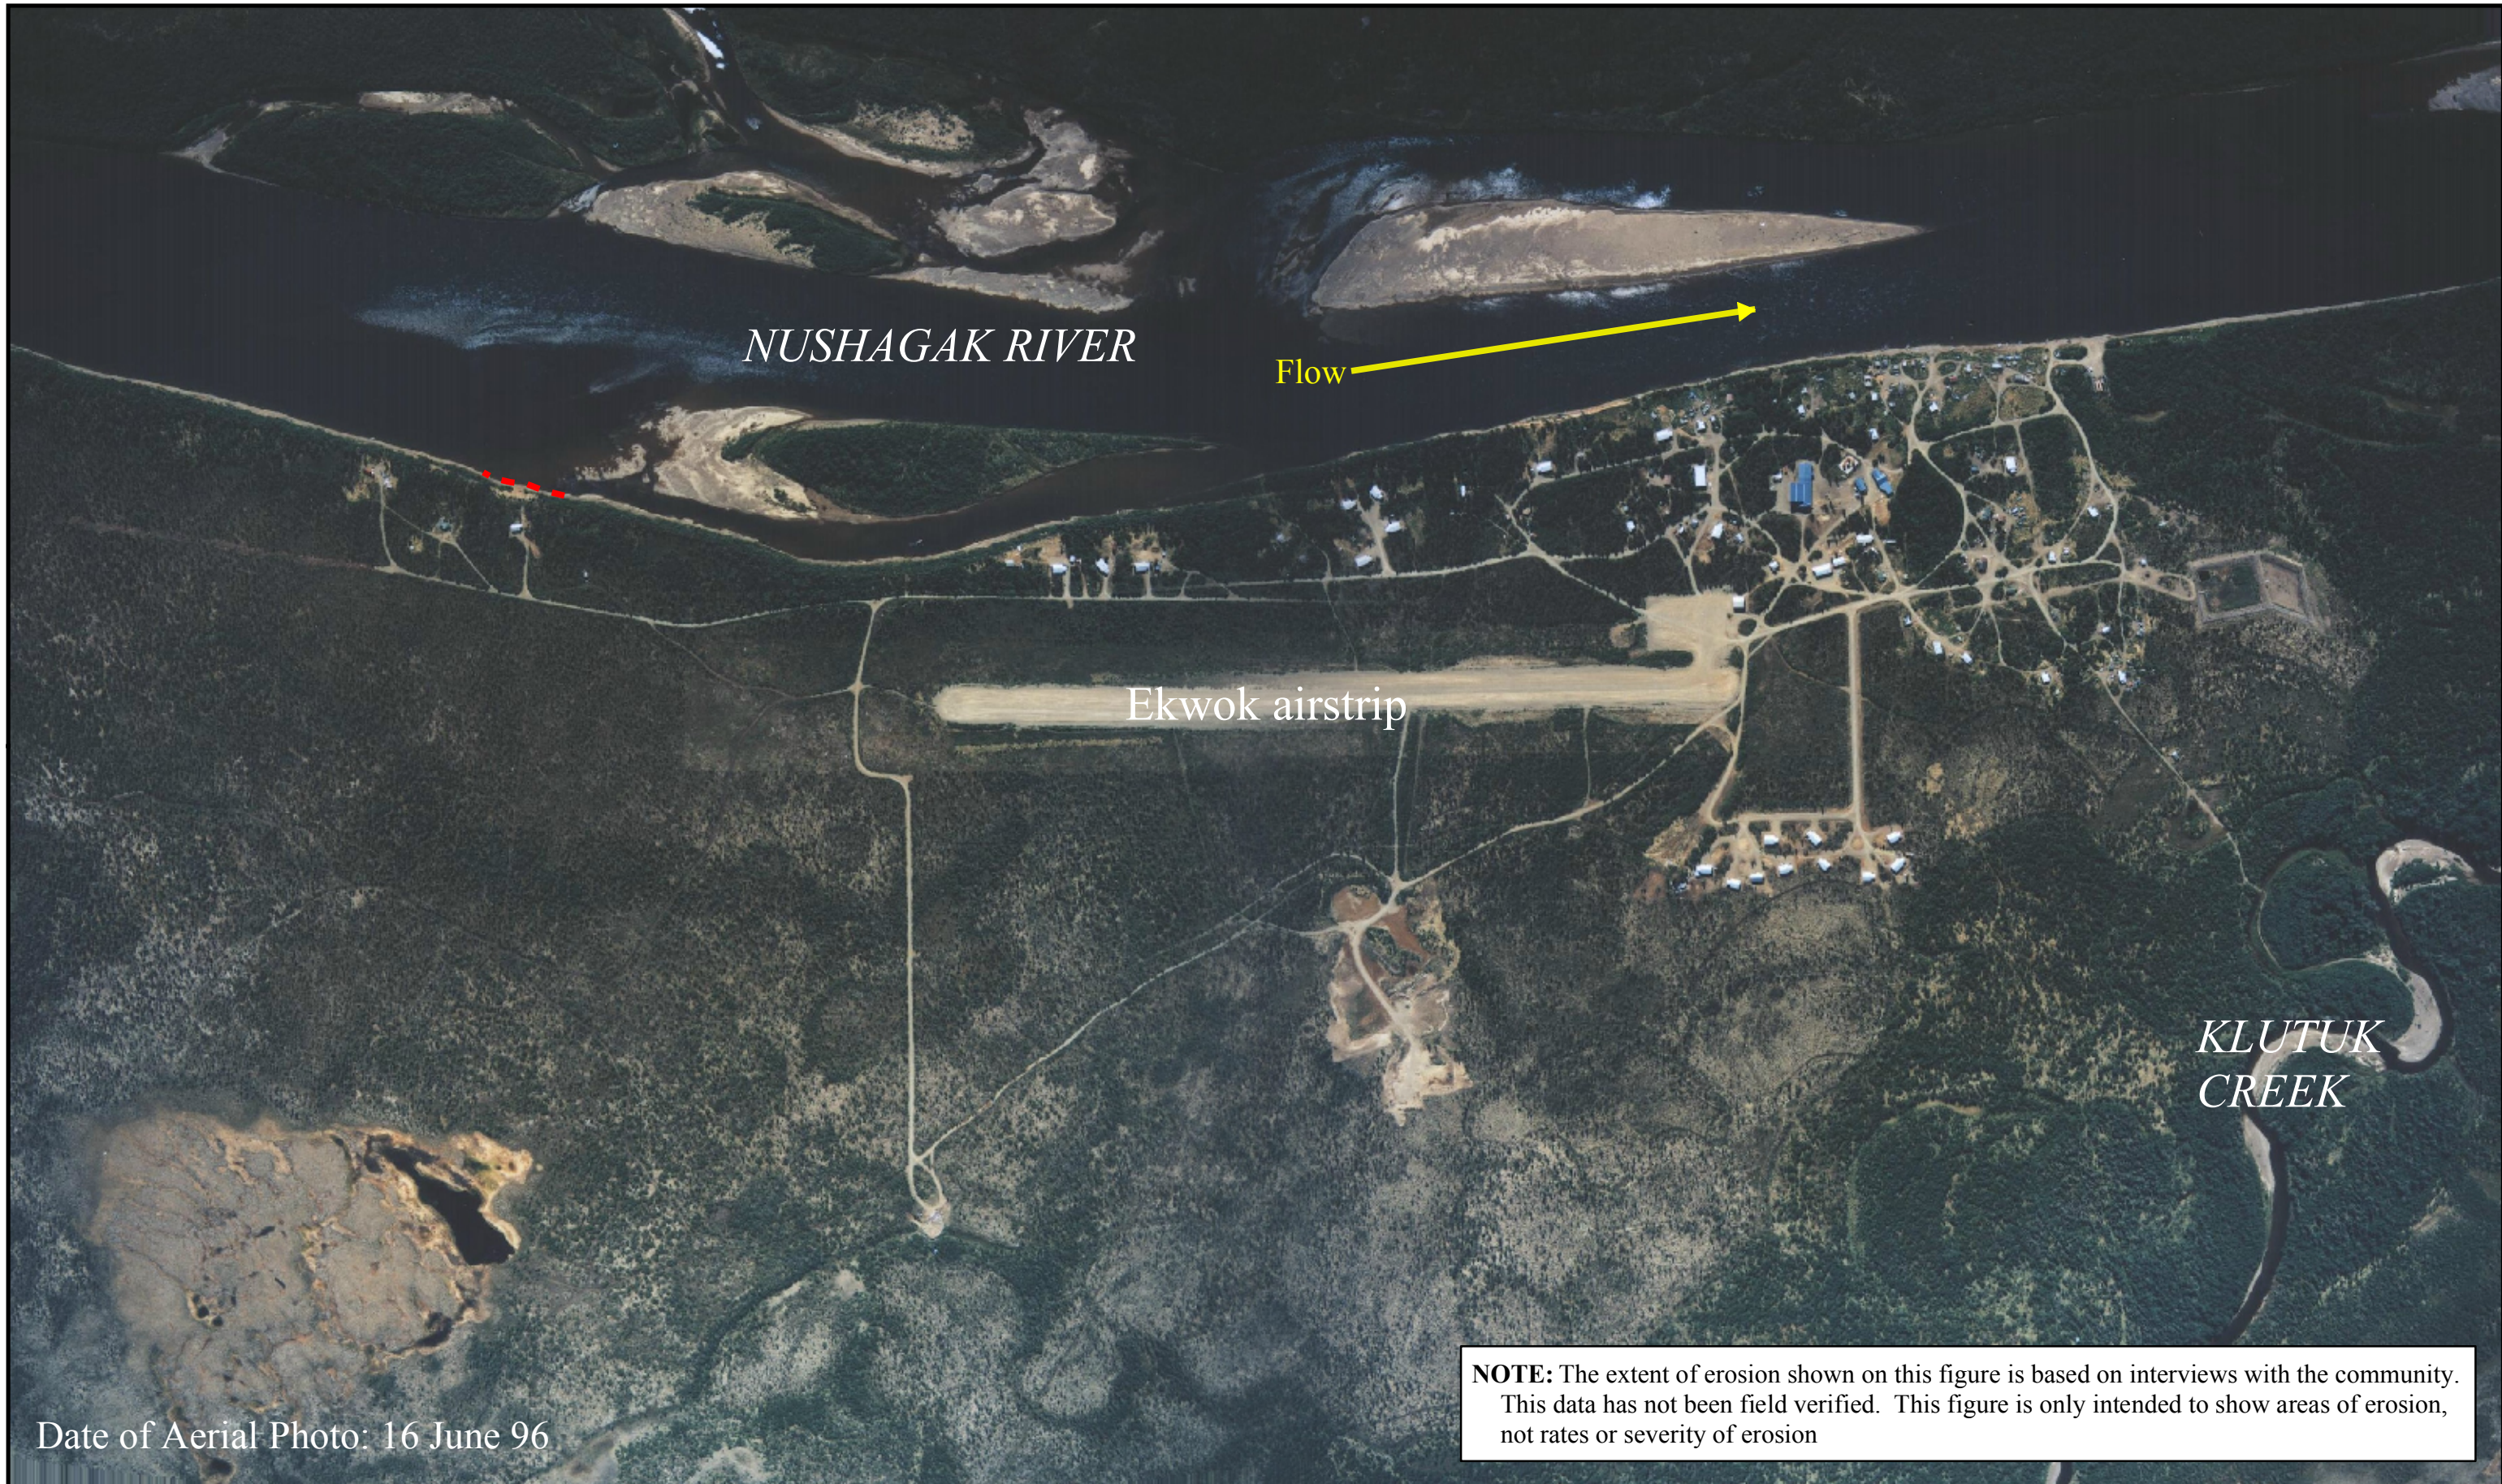
No photos of erosion have been provided by the community or other sources. The attached diagram depicts the linear extent of erosion.
