ALASKA BASELINE EROSION ASSESSMENT

Erosion Information Paper - Karluk, Alaska

Current as of December 11, 2007

Alaska Baseline Erosion
Karluk, Alaska

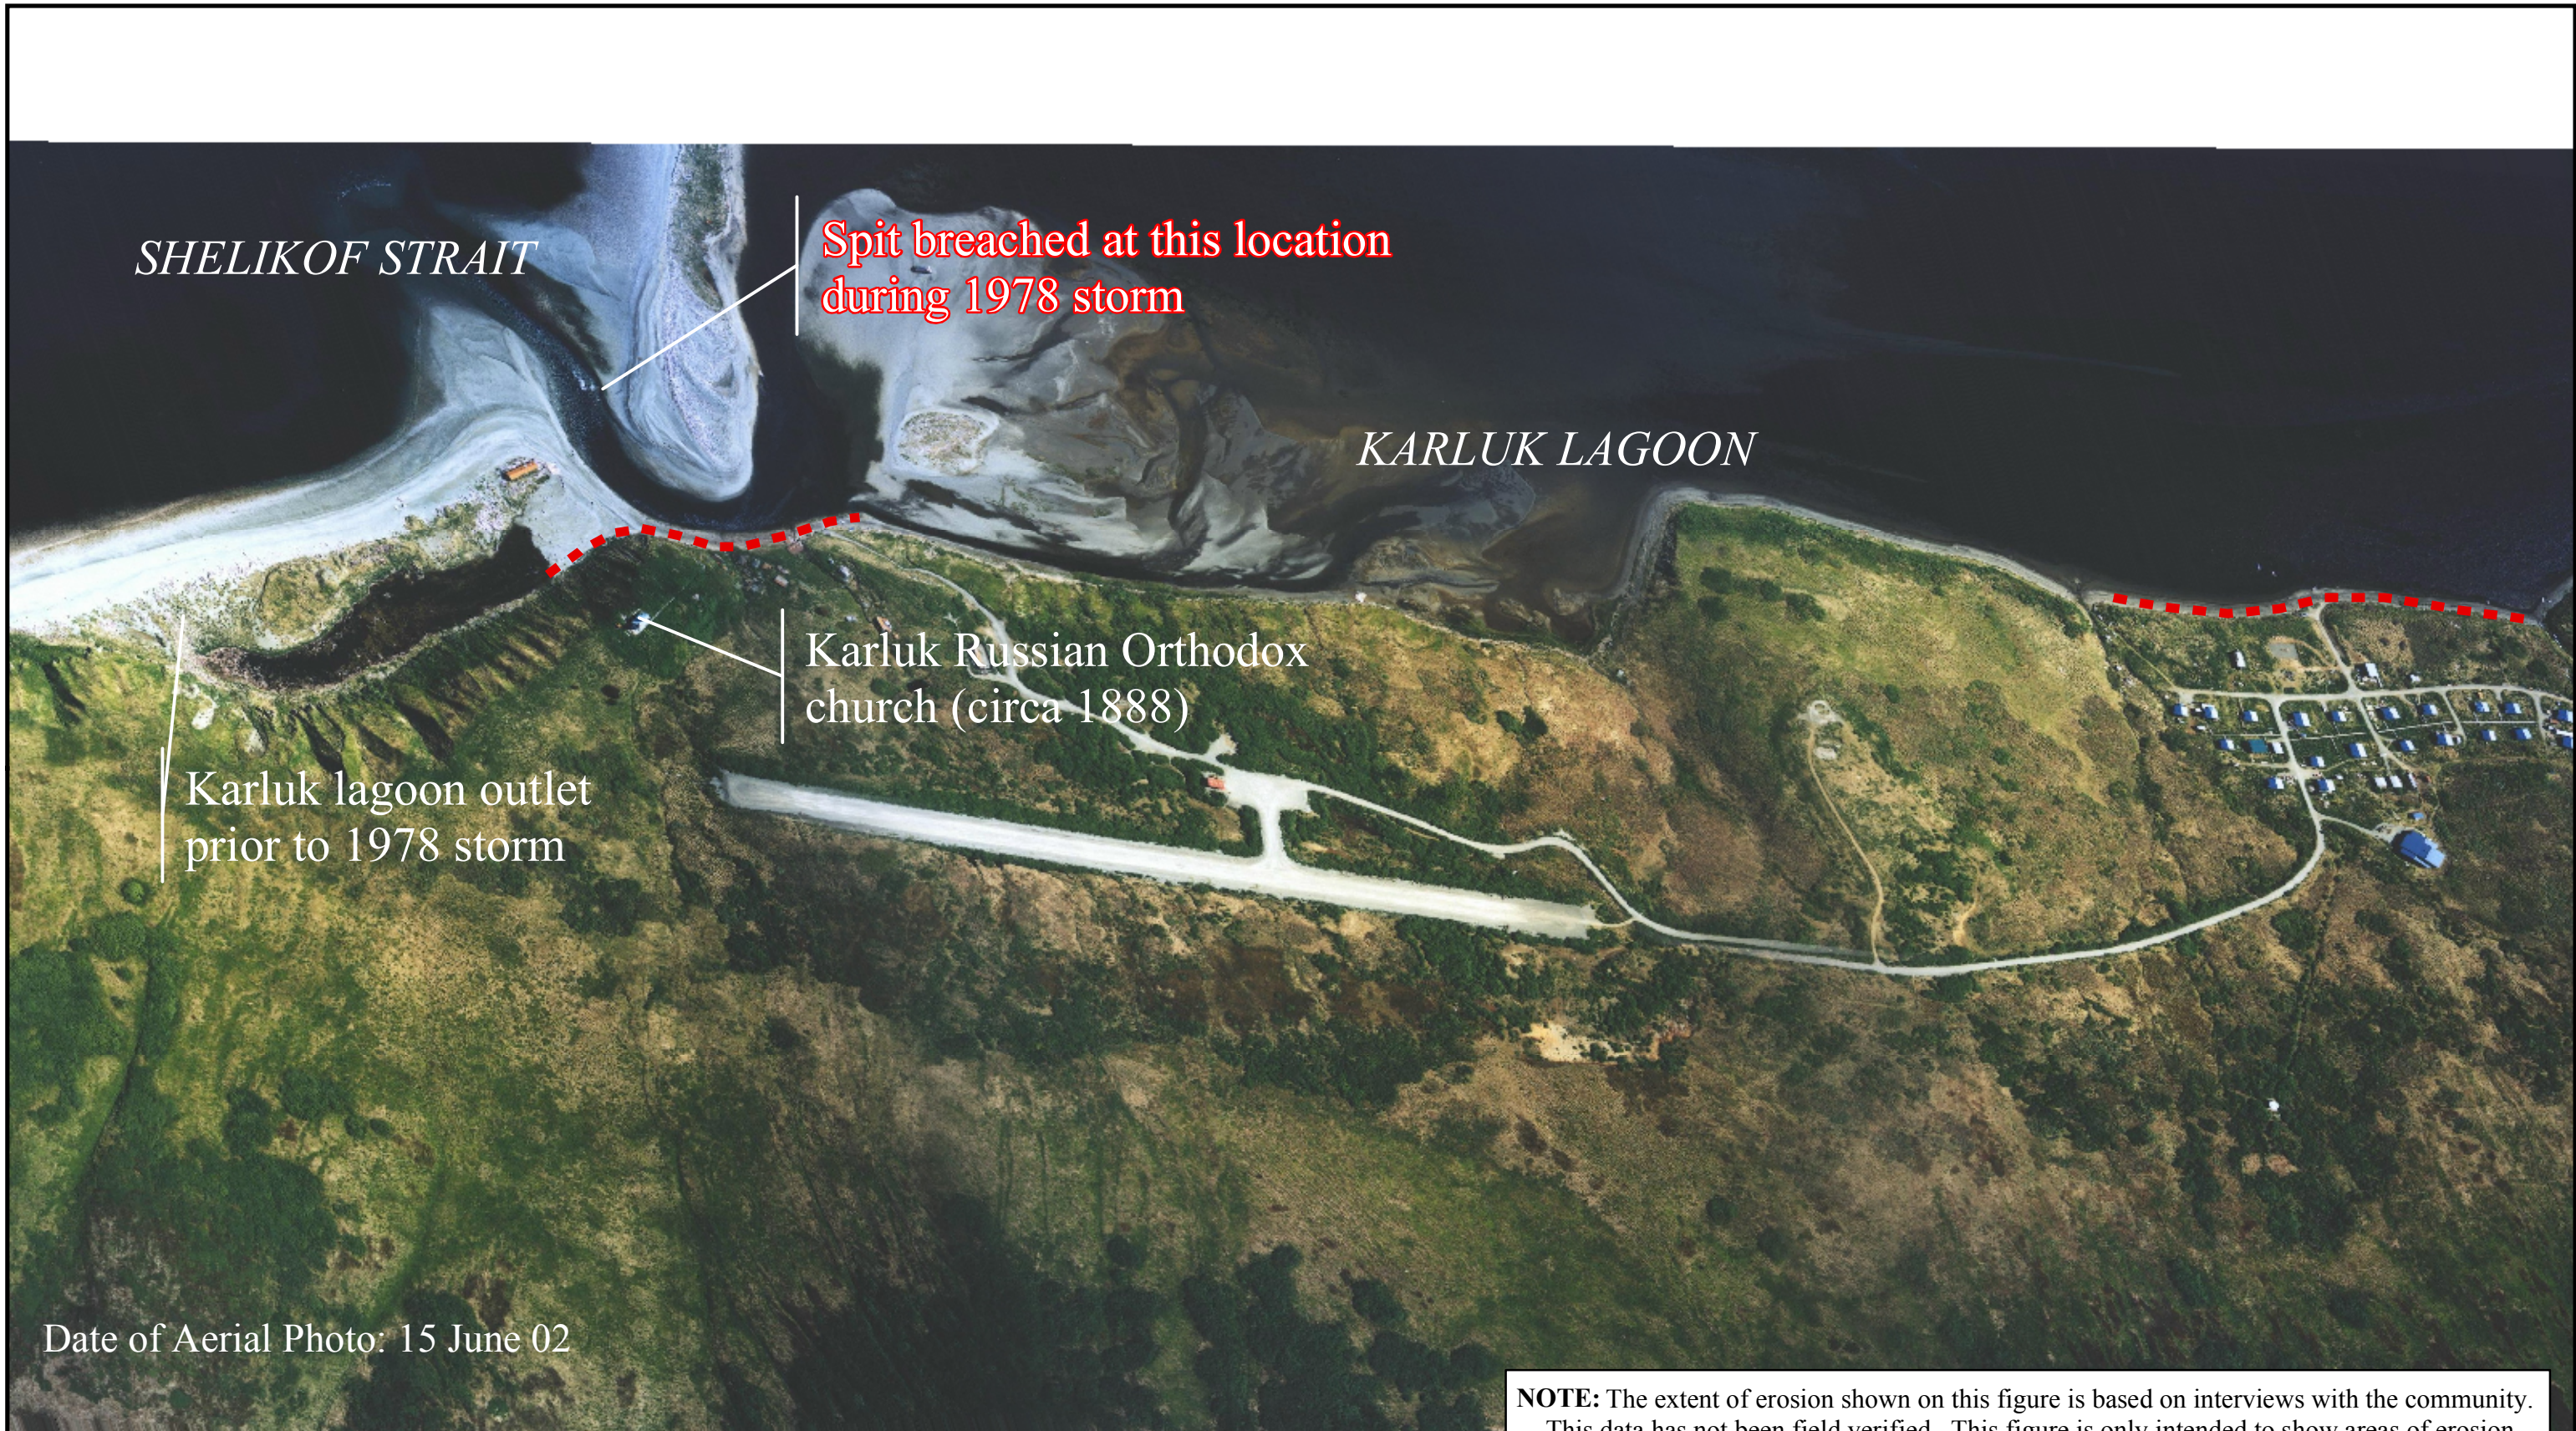
The old portion of the community was built on a high bluff protected by a spit until 1978 when a storm breaches the spit and a new outflow was created from Karluk Lagoon. The new outflow and channel changes exposed the bluff to erosion during high tides and the community was relocated farther inland. Erosion of the bluff is estimated at an annual rate of 3 to 5 feet. The area impacted by erosion is approximately 400 linear feet along the 150-foot high bluff. The banks of the Karluk Lagoon and Karluk River are periodically undercut, with chunks of the bank breaking off and falling into the water, water level changes, flooding, boat traffic, and storm events. The rate of erosion along the lagoon and river is 1 foot per year.

The 100+ year old Russian Orthodox Church, the cemetery, and the Karluk Spit Lodge are less than 100 feet from the eroding bluff. No protective measures have been attempted since the relocation after the 1978 storm.
