**Community Erosion Assessment
Kipnuk, Alaska
26 January 2009**

1. Community: Kipnuk, Alaska

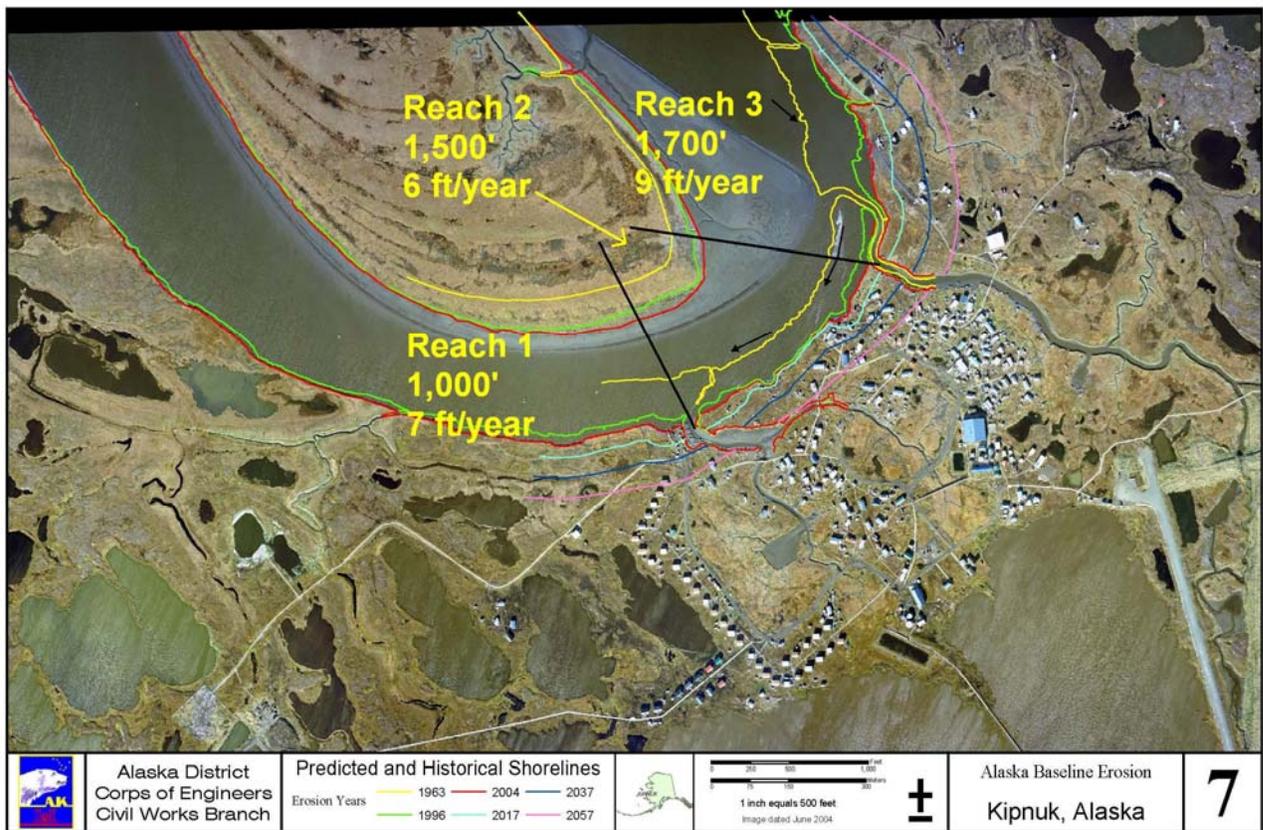
Figure 2. Kipnuk Erosion Map

Erosion is affecting three different areas in Kipnuk. Reach 1 is a 1,000 foot reach that starts at the barge landing and stretches downstream. This region is eroding at an average rate of 7.0 feet per year. Reach 2 is 1,500 feet long and stretches from the barge landing to the slough near the tribal offices. It is eroding at an average rate of 6.0 feet per year. Reach 3 is 1,700 feet long and eroding at an average annual rate of 9.0 feet.

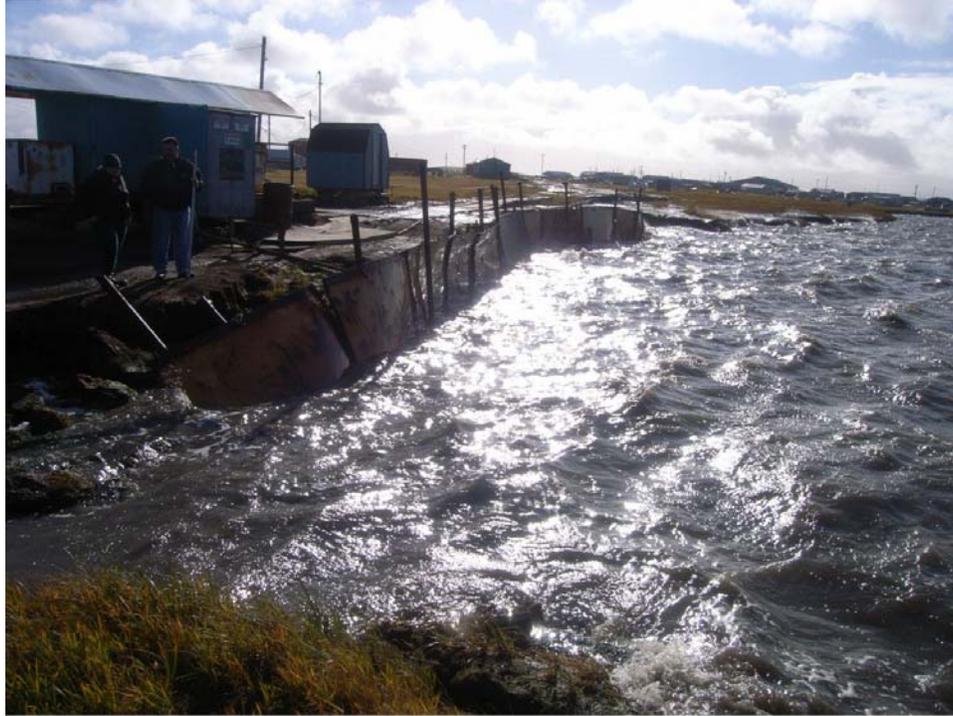
RIMG0095

Photo 1: Looking downstream from sheet metal barrier north of town. Sheet metal barrier is attached to a 2 inch pipe driven into the ground.

Sheet Pile Bulkhead for Reach 1

This option would replace the sheet metal barrier with a sheet pile bulkhead to protect the bank from wave and mooring forces. The bulkhead would have a 200-foot face for mooring with 50-foot wing walls to protect the structure from flanking. The toe of the structure would be protected from scour by riprap. Upstream protection of this structure is to be provided by revetments. This will allow for a repairable feature that can be adjusted to meet the changing conditions of the river. Approximate cost of the bulkhead is \$7.4 million at approximately \$24,000 per foot.

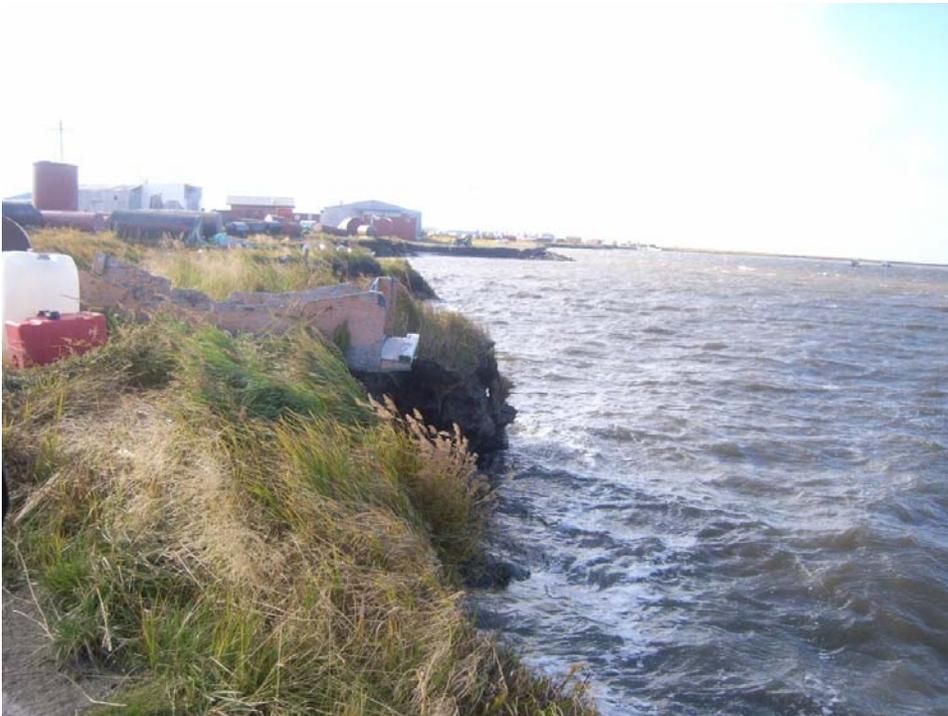
RIMG0124

Photo 2: Looking downstream at bank just north of town.

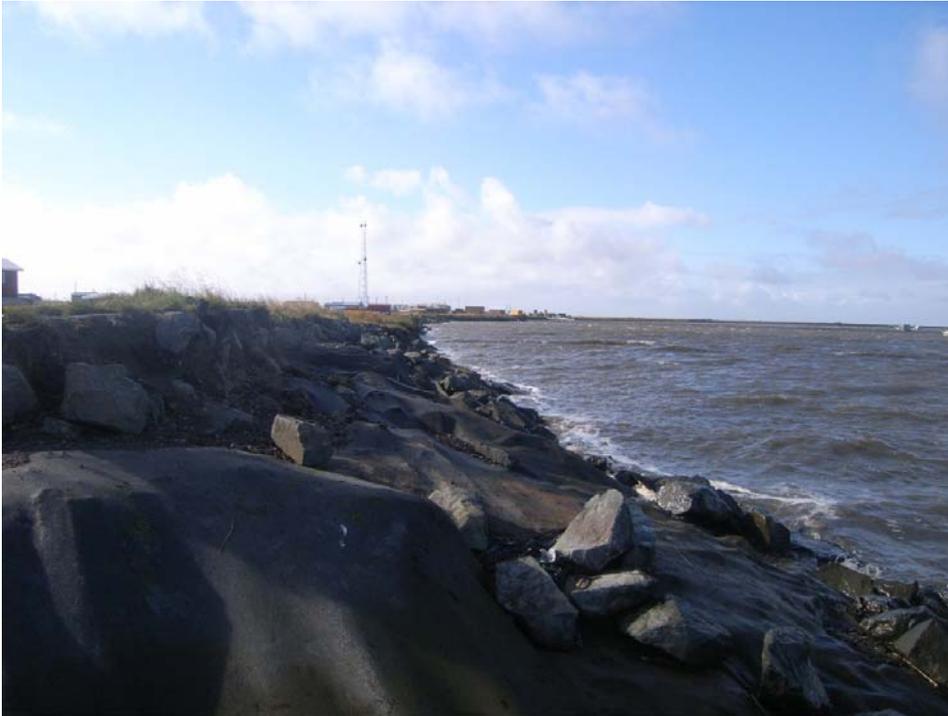
RIMG0132

Photo 1: Looking downstream at the riprap. This project has failed with most of the protection being provided by the fabric at this point.

Rock Revetment Repair for Reach 2

An existing 850-foot rock revetment protects a portion of Kipnuk. The revetment is divided into two sections with a break to allow for boat mooring. This revetment has lost some rock over its life and could be repaired with the addition of material. Some areas of the revetment will need less material and some will need more. Since this revetment is already in place, the quantity of rock can be adjusted to meet budget constraints while targeting the most severely damaged areas. It is assumed that the slope of the revetment will not need to be laid back and that the existing fabric will not need to be replaced. Approximate cost of the repairs is \$2.8 million at approximately \$3,295 per foot.
