ALASKA BASELINE EROSION ASSESSMENT

AVETA Report Summary – Kivalina, Alaska

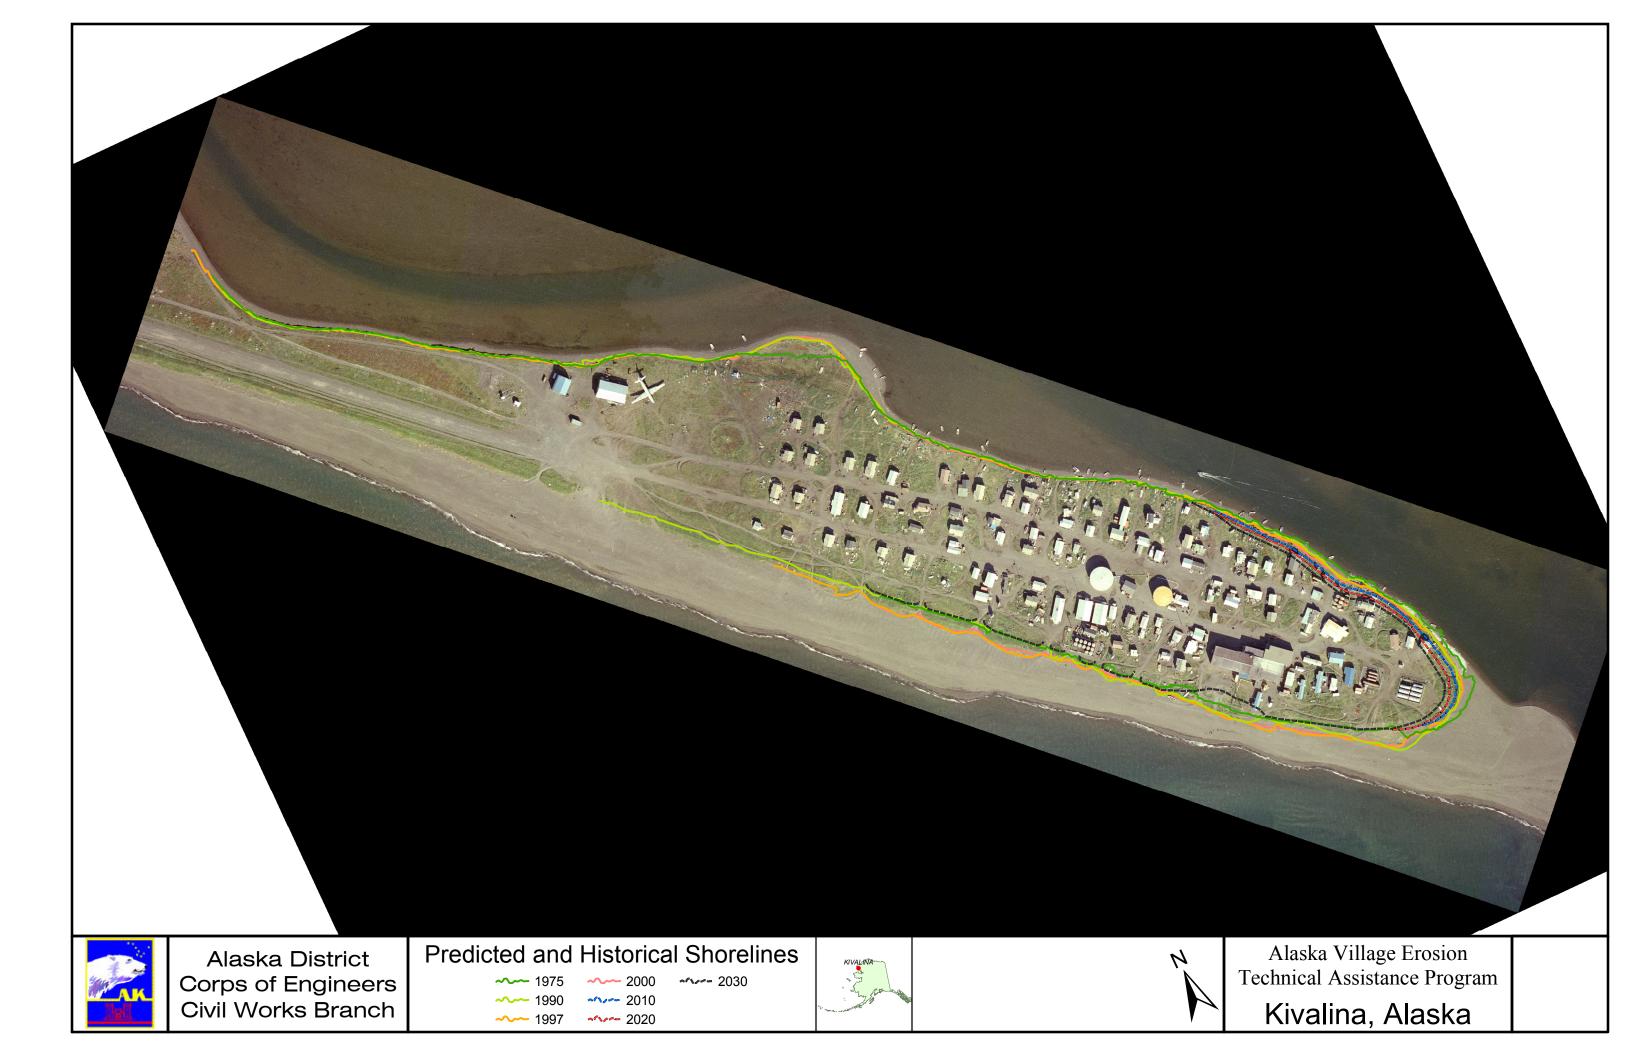
Emergency shoreline protection - 2005
