**Community Erosion Assessment
Kwigillingok, Alaska
27 January 2009**

1. Community: Kwigillingok, Alaska

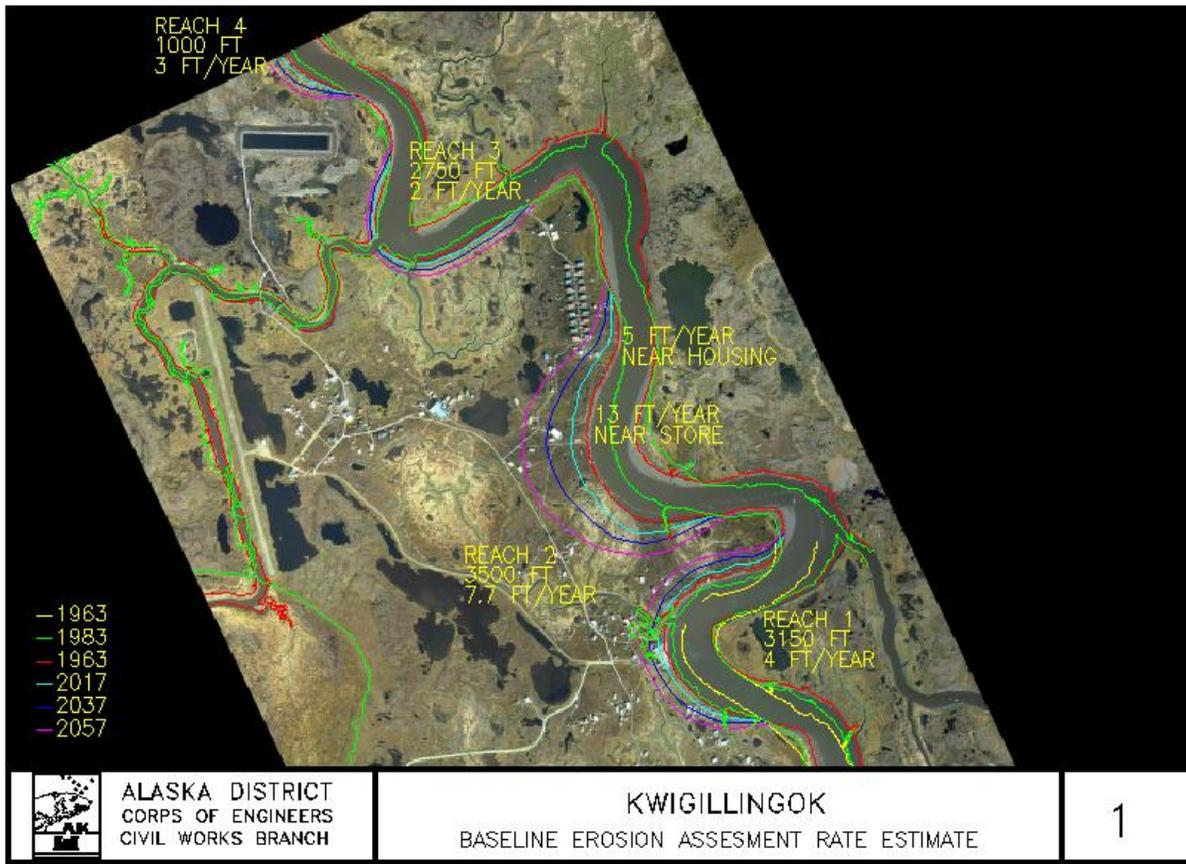
Figure 2. Kwigillingok Erosion Map

For this study the area was divided into four reaches. Reach 1 is a 3,150-foot portion of riverbank that fronts the community and is eroding at a rate of 4.0 feet per year. Reach 2 is a 3,500-foot portion of riverbank directly upstream (and north) of Reach 1 and is eroding at a rate of 7.7 feet per year. Reach 3 is a 2,750-foot portion of riverbank upstream of Reach 2 and is eroding at a rate of 2.0 feet per year. Reach 4 is a 1,000-foot portion of riverbank upstream of Reach 3 and is eroding at a rate of 3.0 feet per year. There is an area near the store that is eroding at a rate of 13 feet per year.

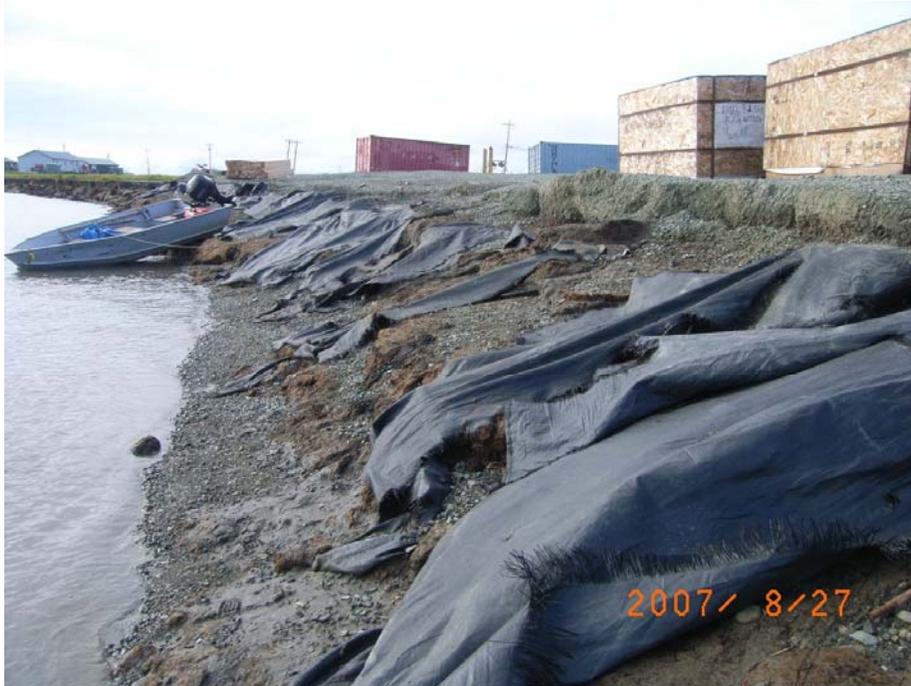
RIMG0193

Kwigillingok
Photo 1: Reach 1.

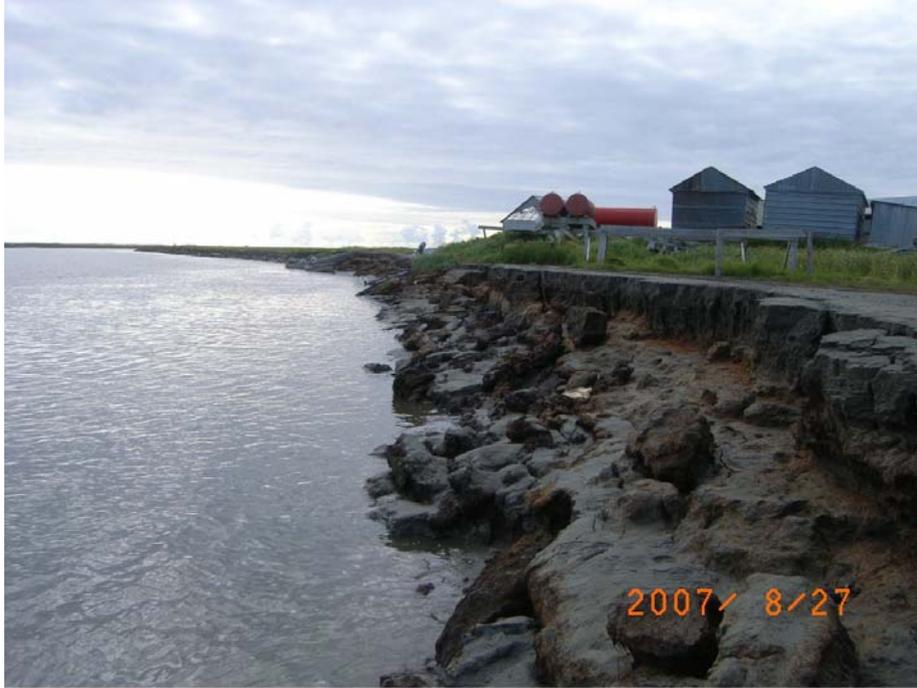
RIMG0184

Photo 2: Looking downstream at structures.
