## ***ALASKA BASELINE EROSION ASSESSMENT***

# **Erosion Information Paper – Northway Village, Alaska**

Current as of March 3, 2008

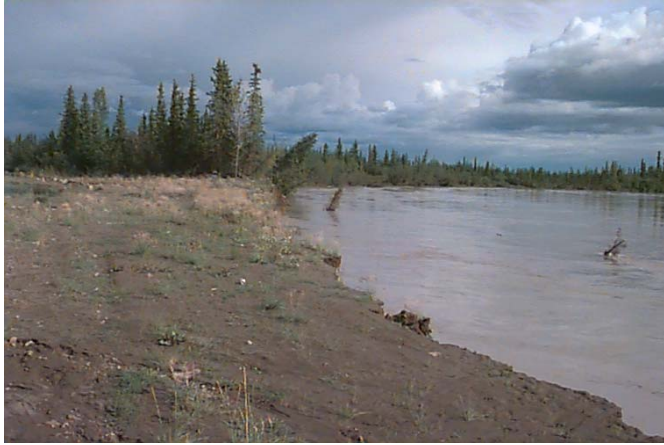
**Photo 1: Nabesna River at Northway Village close to the road, photo courtesy of Michael L. Bird, November 2, 1998.**

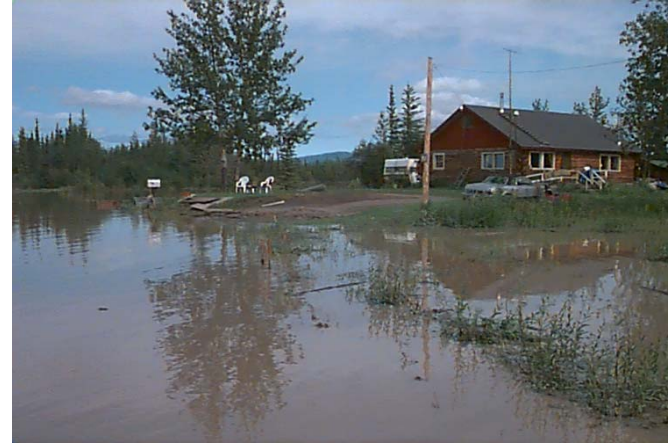
**Photo 2: High water near Northway Village, photo courtesy of Michael L. Bird, November 2, 1998.**

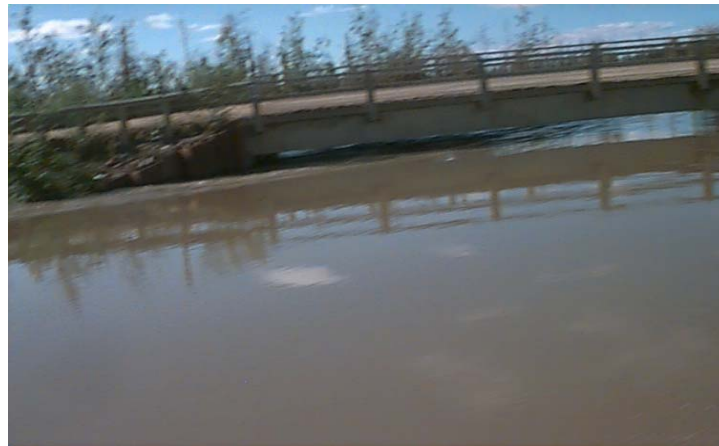
**Photo 3: Bridge near Northway Village, November 2, 1998 flooding, photo courtesy of Michael L. Bird.**

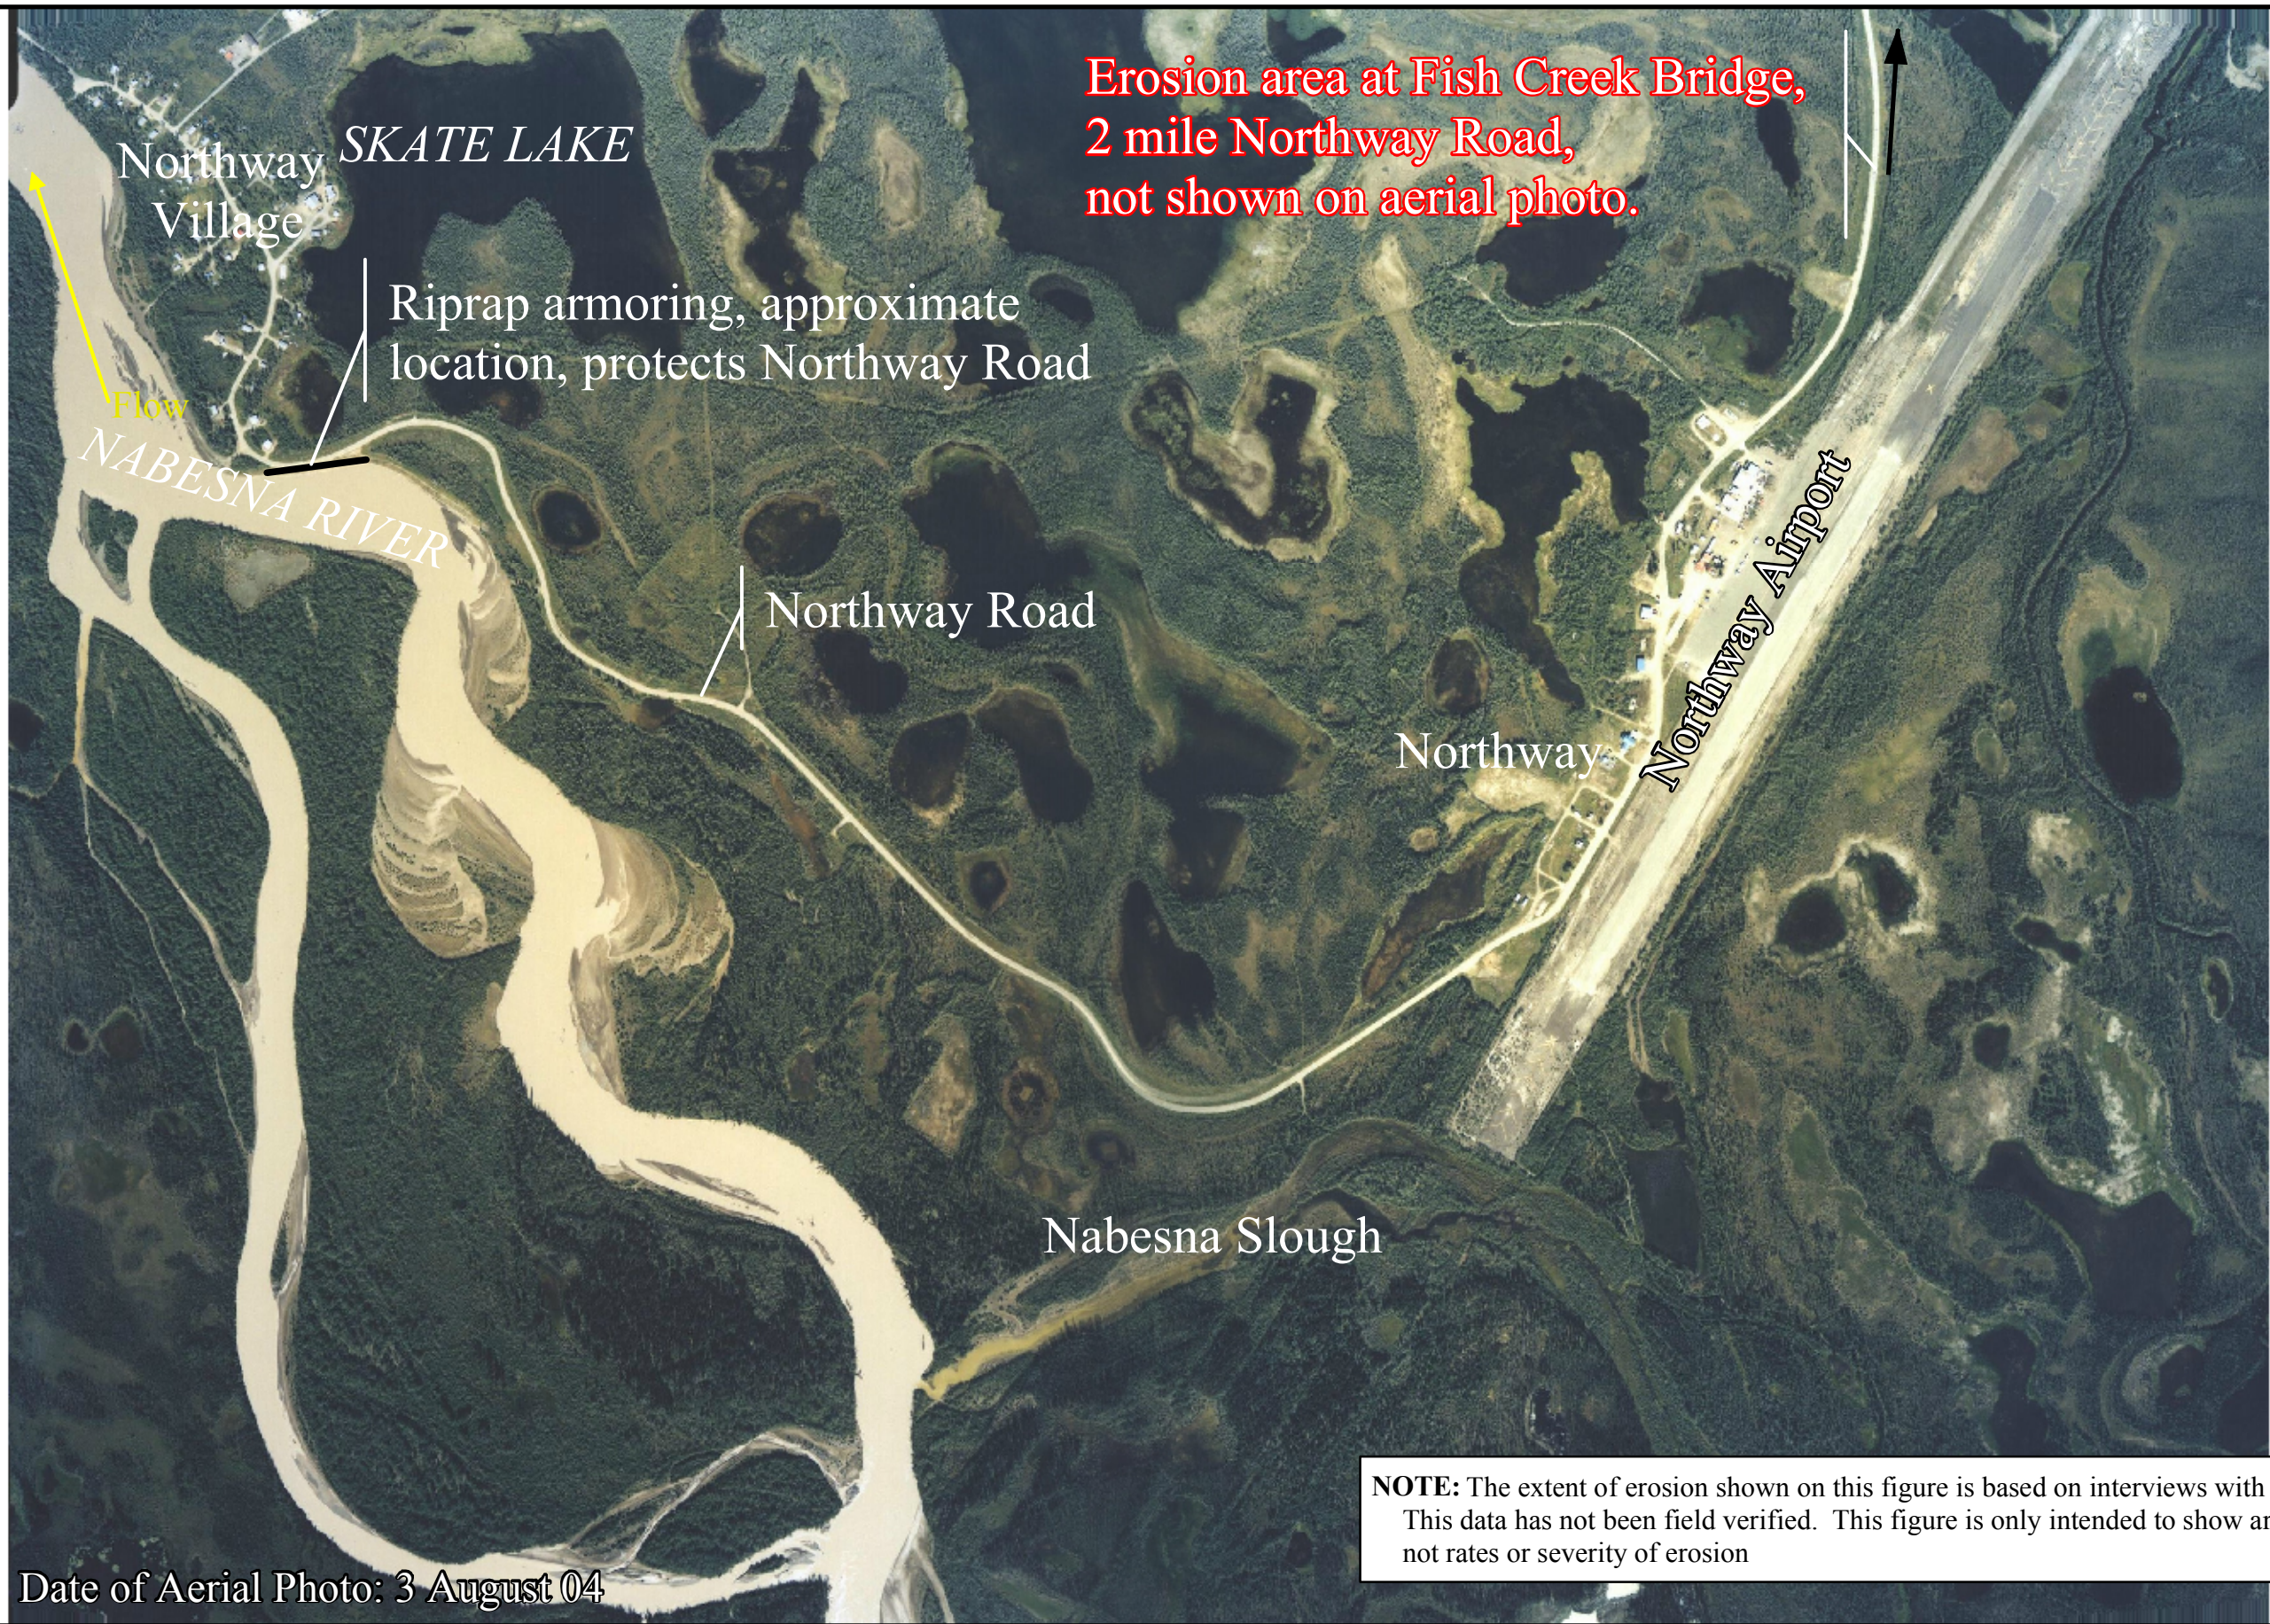
Alaska Baseline Erosion  
Northway, Alaska

The Nabesna River is a moderately flowing, shallow, braided glacial river that increases in volume when heavy spring and summer rains combine with snow melt. The Northway Airport runway and land surrounding the Northway Village was flooded in the late 1940's and one end of the runway has been flooded occasionally in more recent years. The Nabesna River is eroding at approximately Mile 2.5 to 2.6 of Northway Road where the road crosses Fish Creek.
