ALASKA BASELINE EROSION ASSESSMENT

Erosion Information Paper - Palmer, Alaska

Current as of September 7, 2007

Alaska Baseline Erosion
Palmer, Alaska

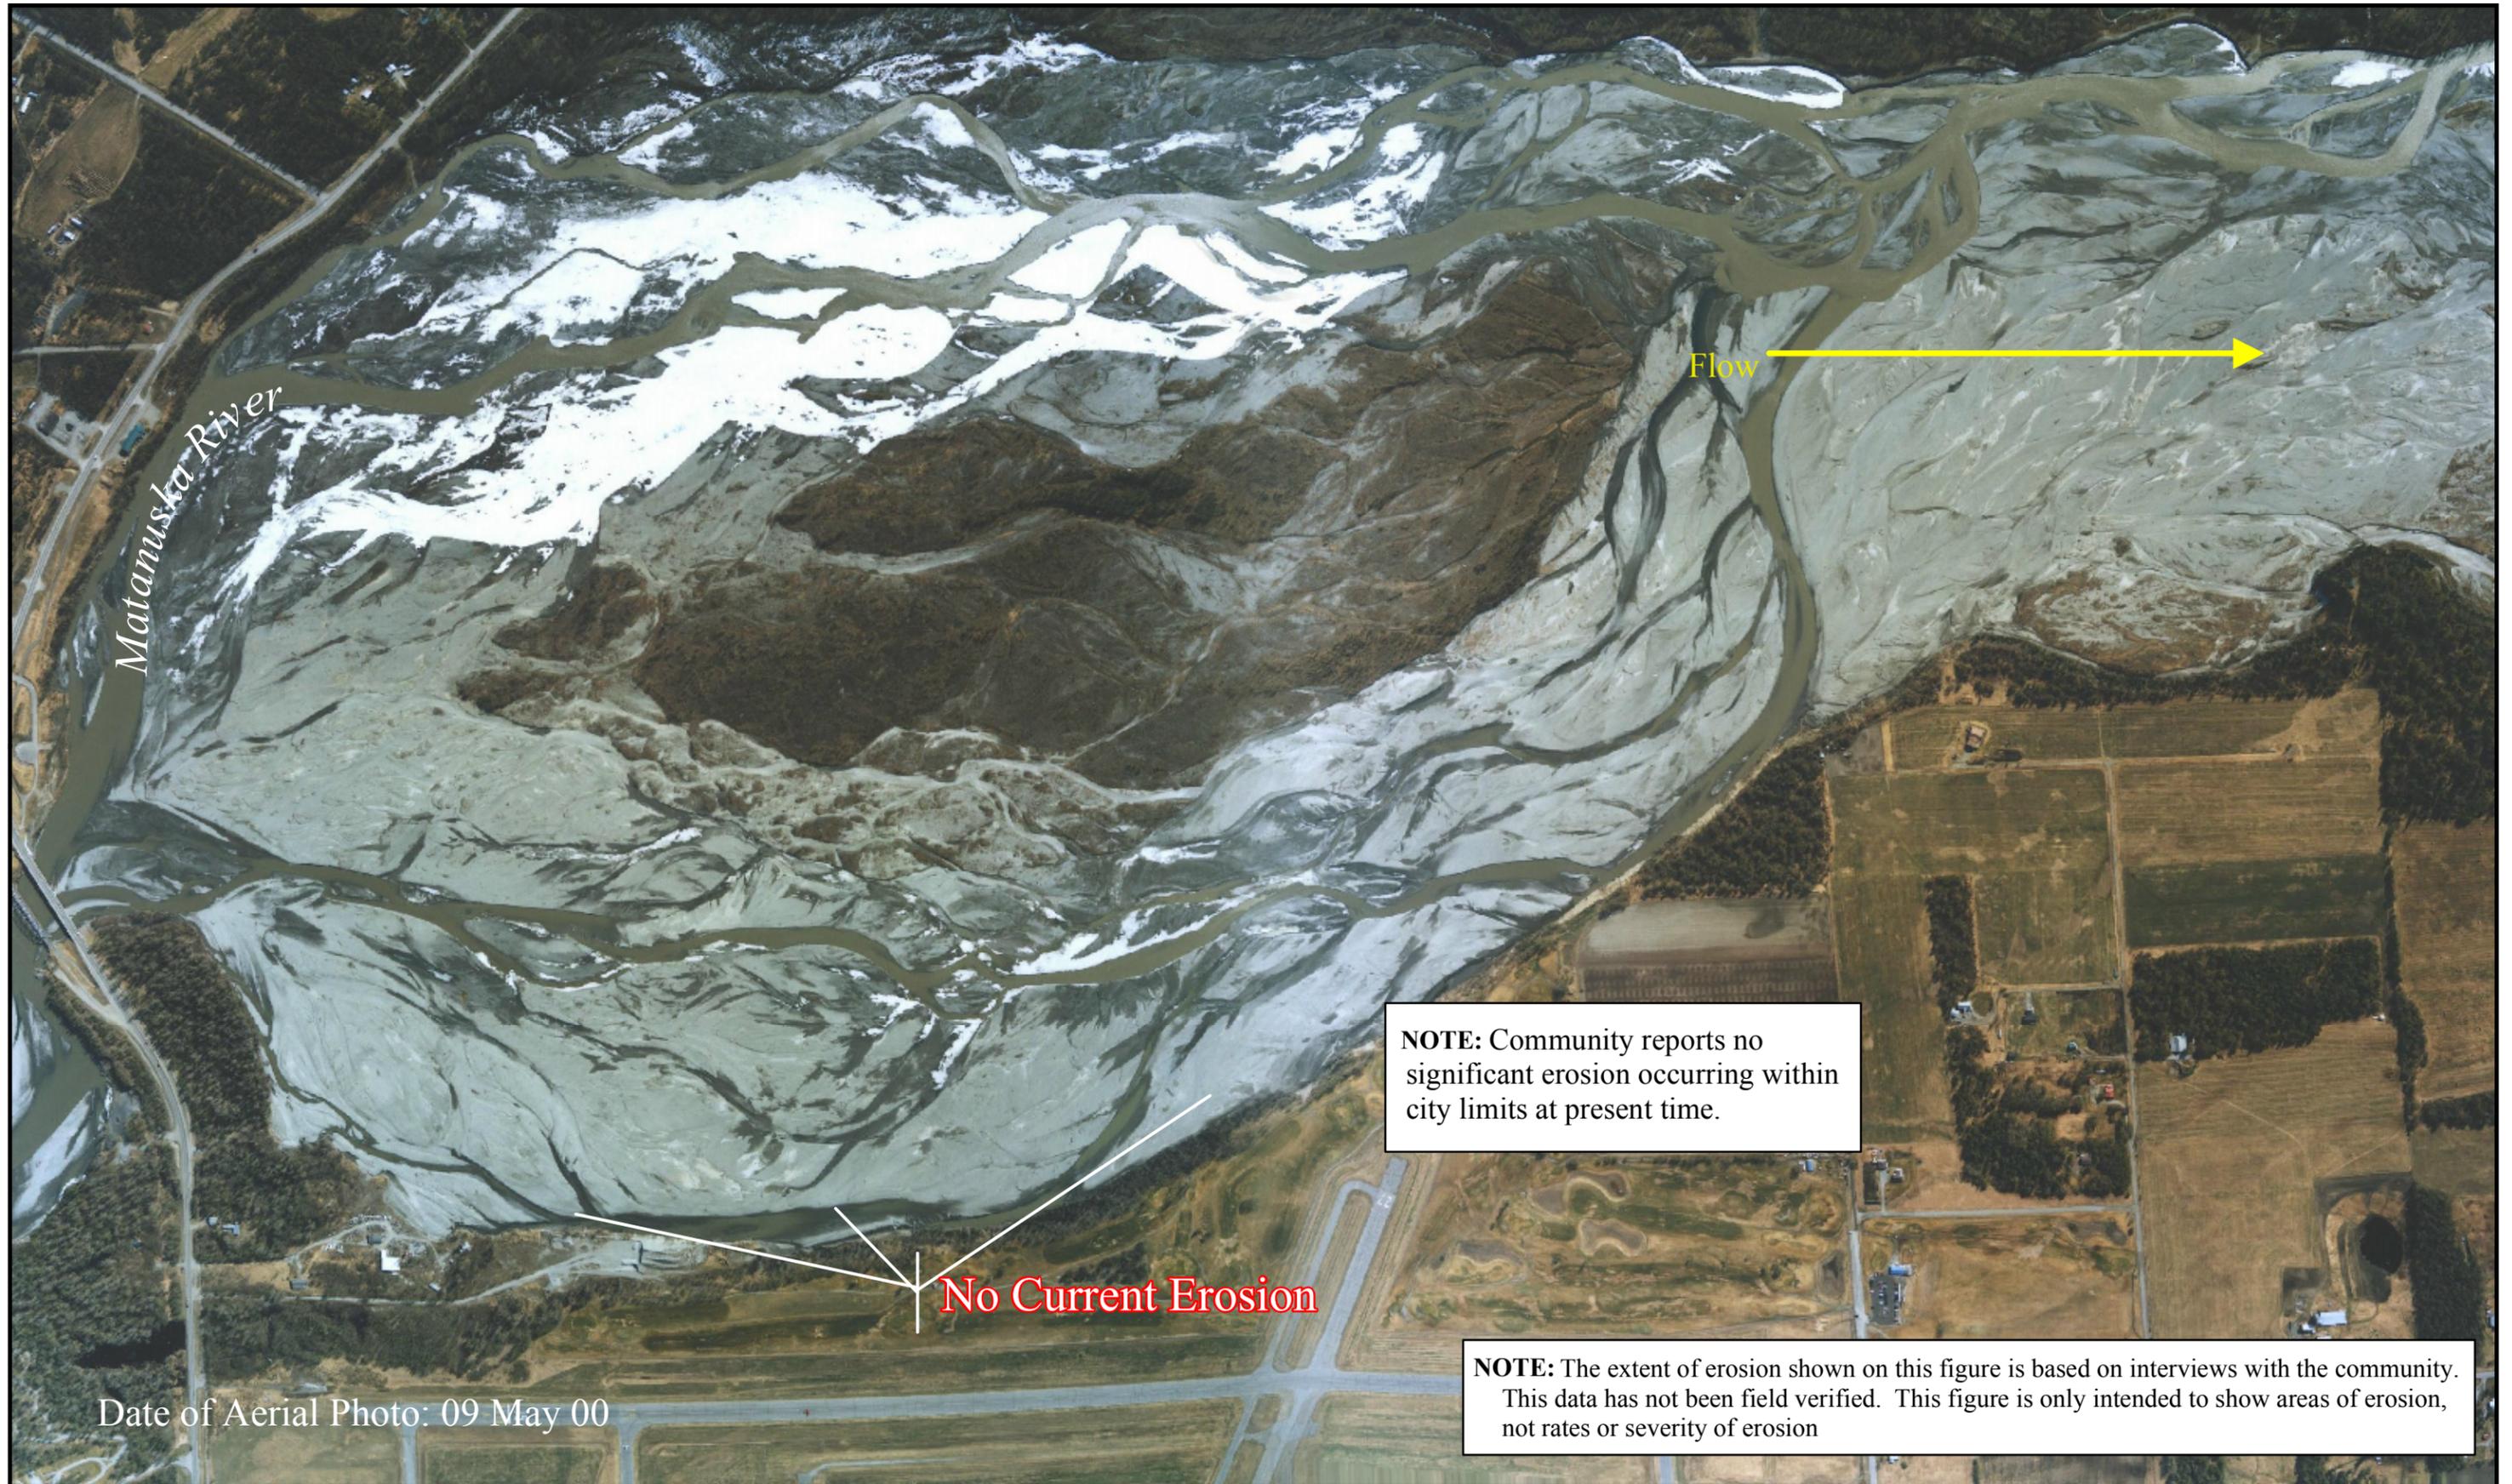
According to information from the assistant to the city/airport manager, erosion has been a problem in the past for Palmer; but currently there is no significant erosion because the active channel of the river has been moving along the opposite bank. No discrete major events have been noted in the last 20 years within the Palmer city limits. The city does not have any active erosion control projects at this time.

NOTE: Community reports no significant erosion occurring within city limits at present time.

No Current Erosion
