U.S. Army Corps
of Engineers
Alaska District

ALASKA BASELINE EROSION ASSESSMENT

Erosion Information Paper - Ugashik, Alaska

Current as of January 2, 2008

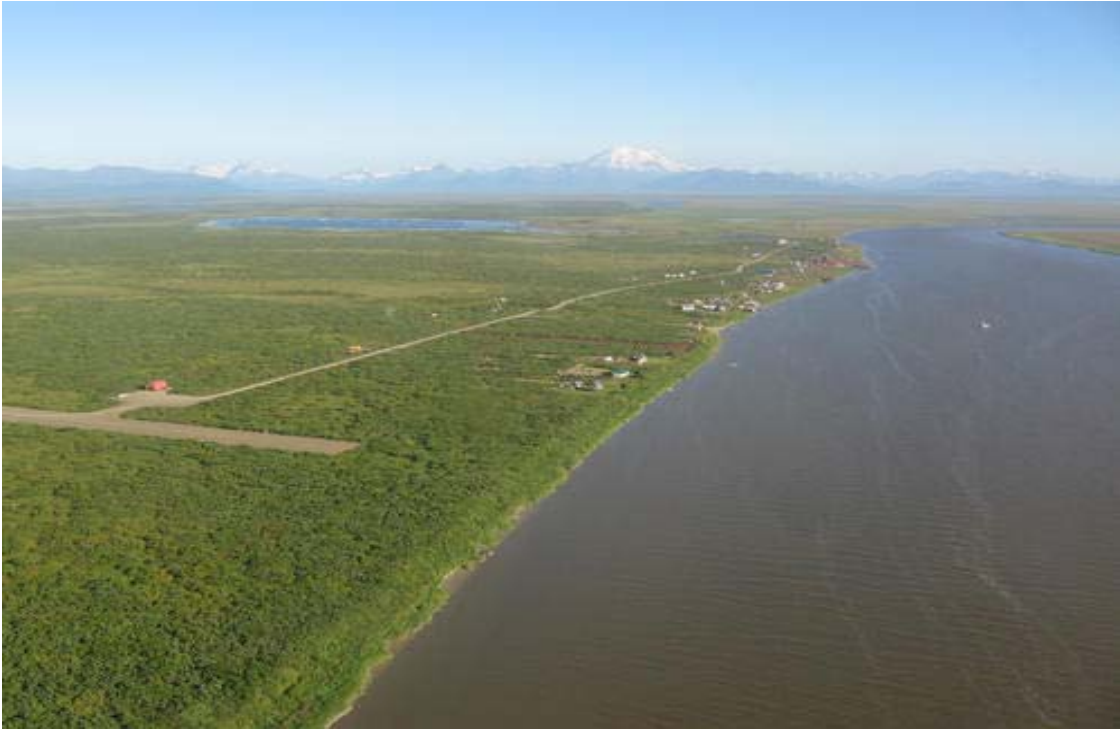
Photo 1: Ugashik River and Community of Ugashik, No photo date.

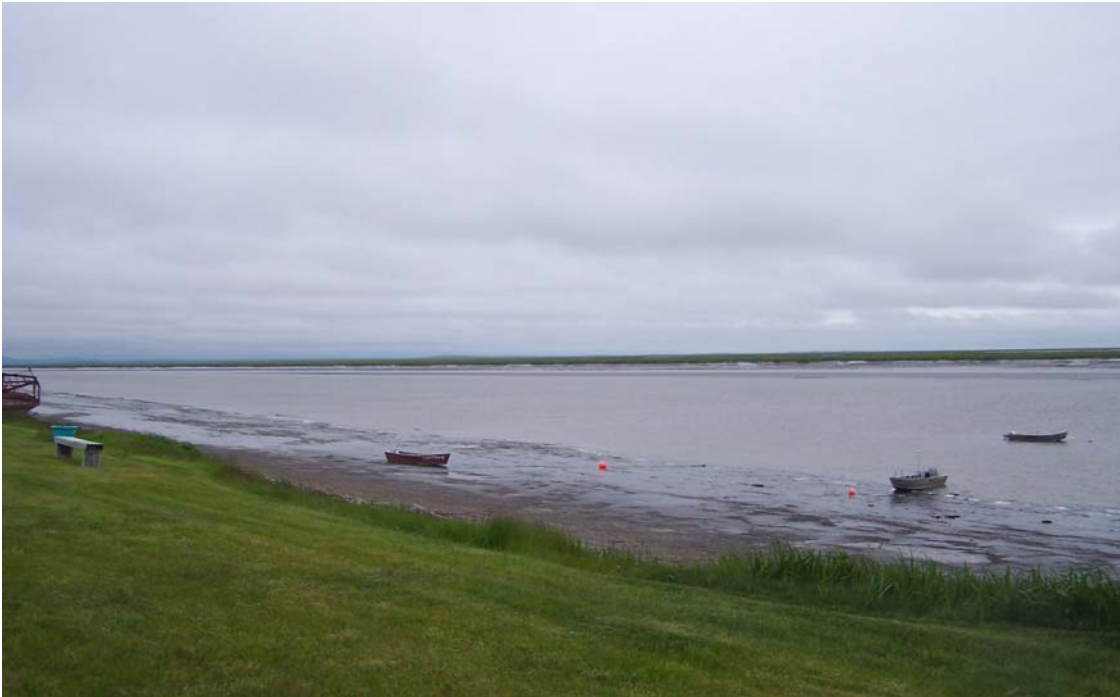
Photo 2: Ugashik River Shoreline, No photo date.

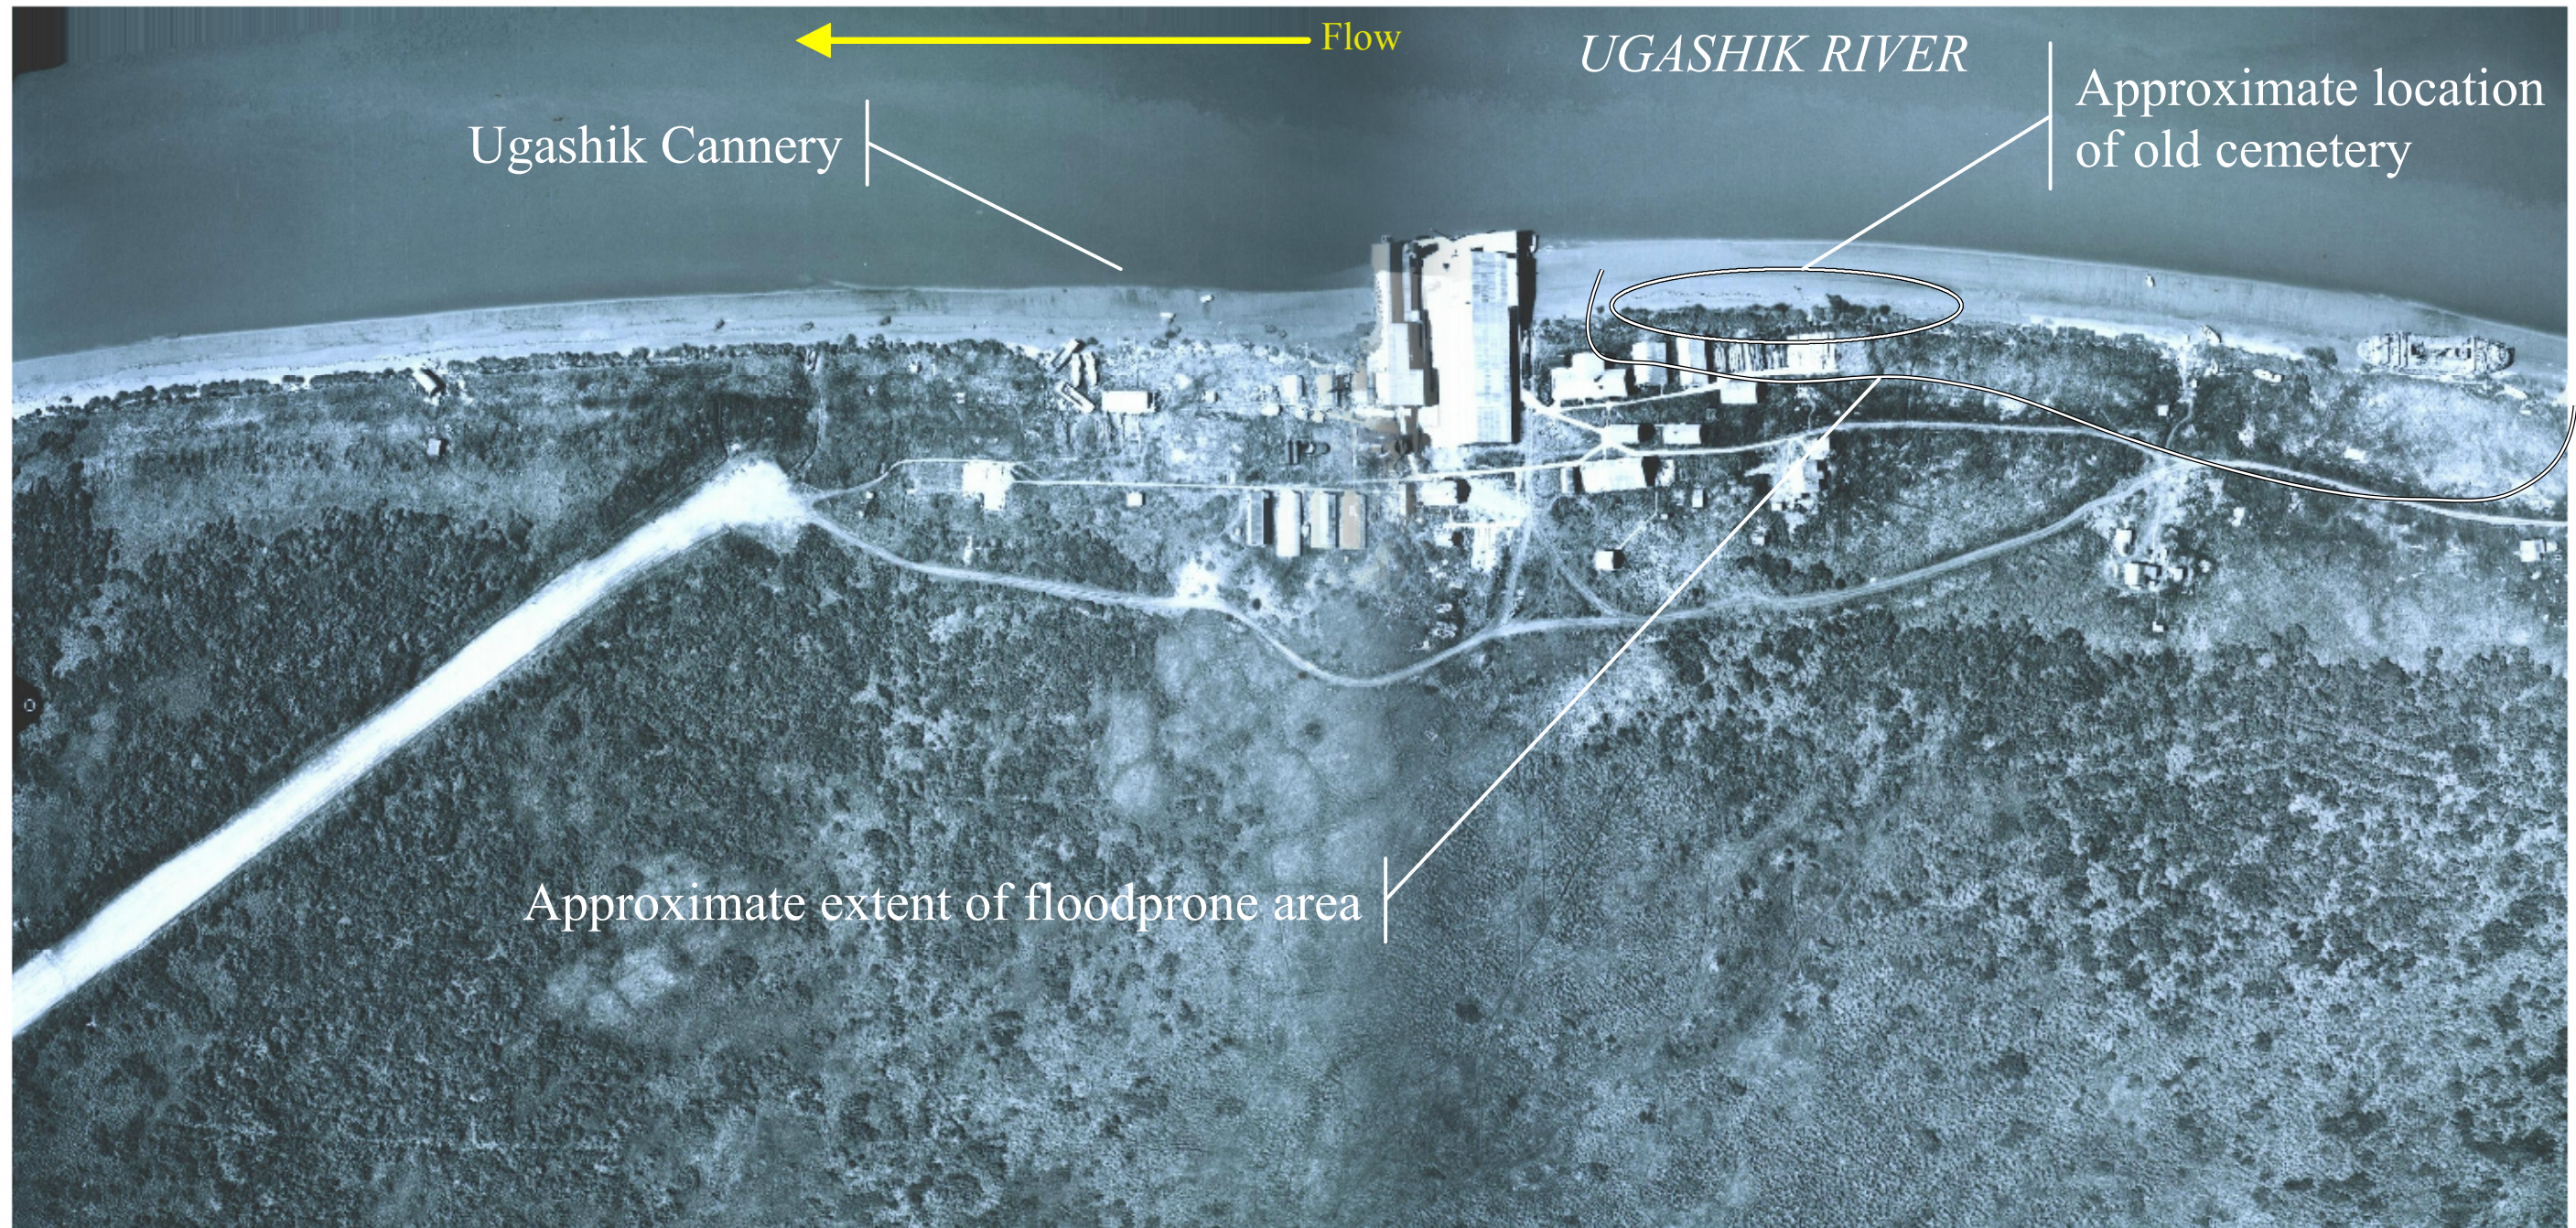
Linear Extent of Erosion
Part 1

NOTE: The extent of erosion shown on this figure is based on interviews with the community. This data has not been field verified. This figure is only intended to show areas of erosion, not rates or severity of erosion

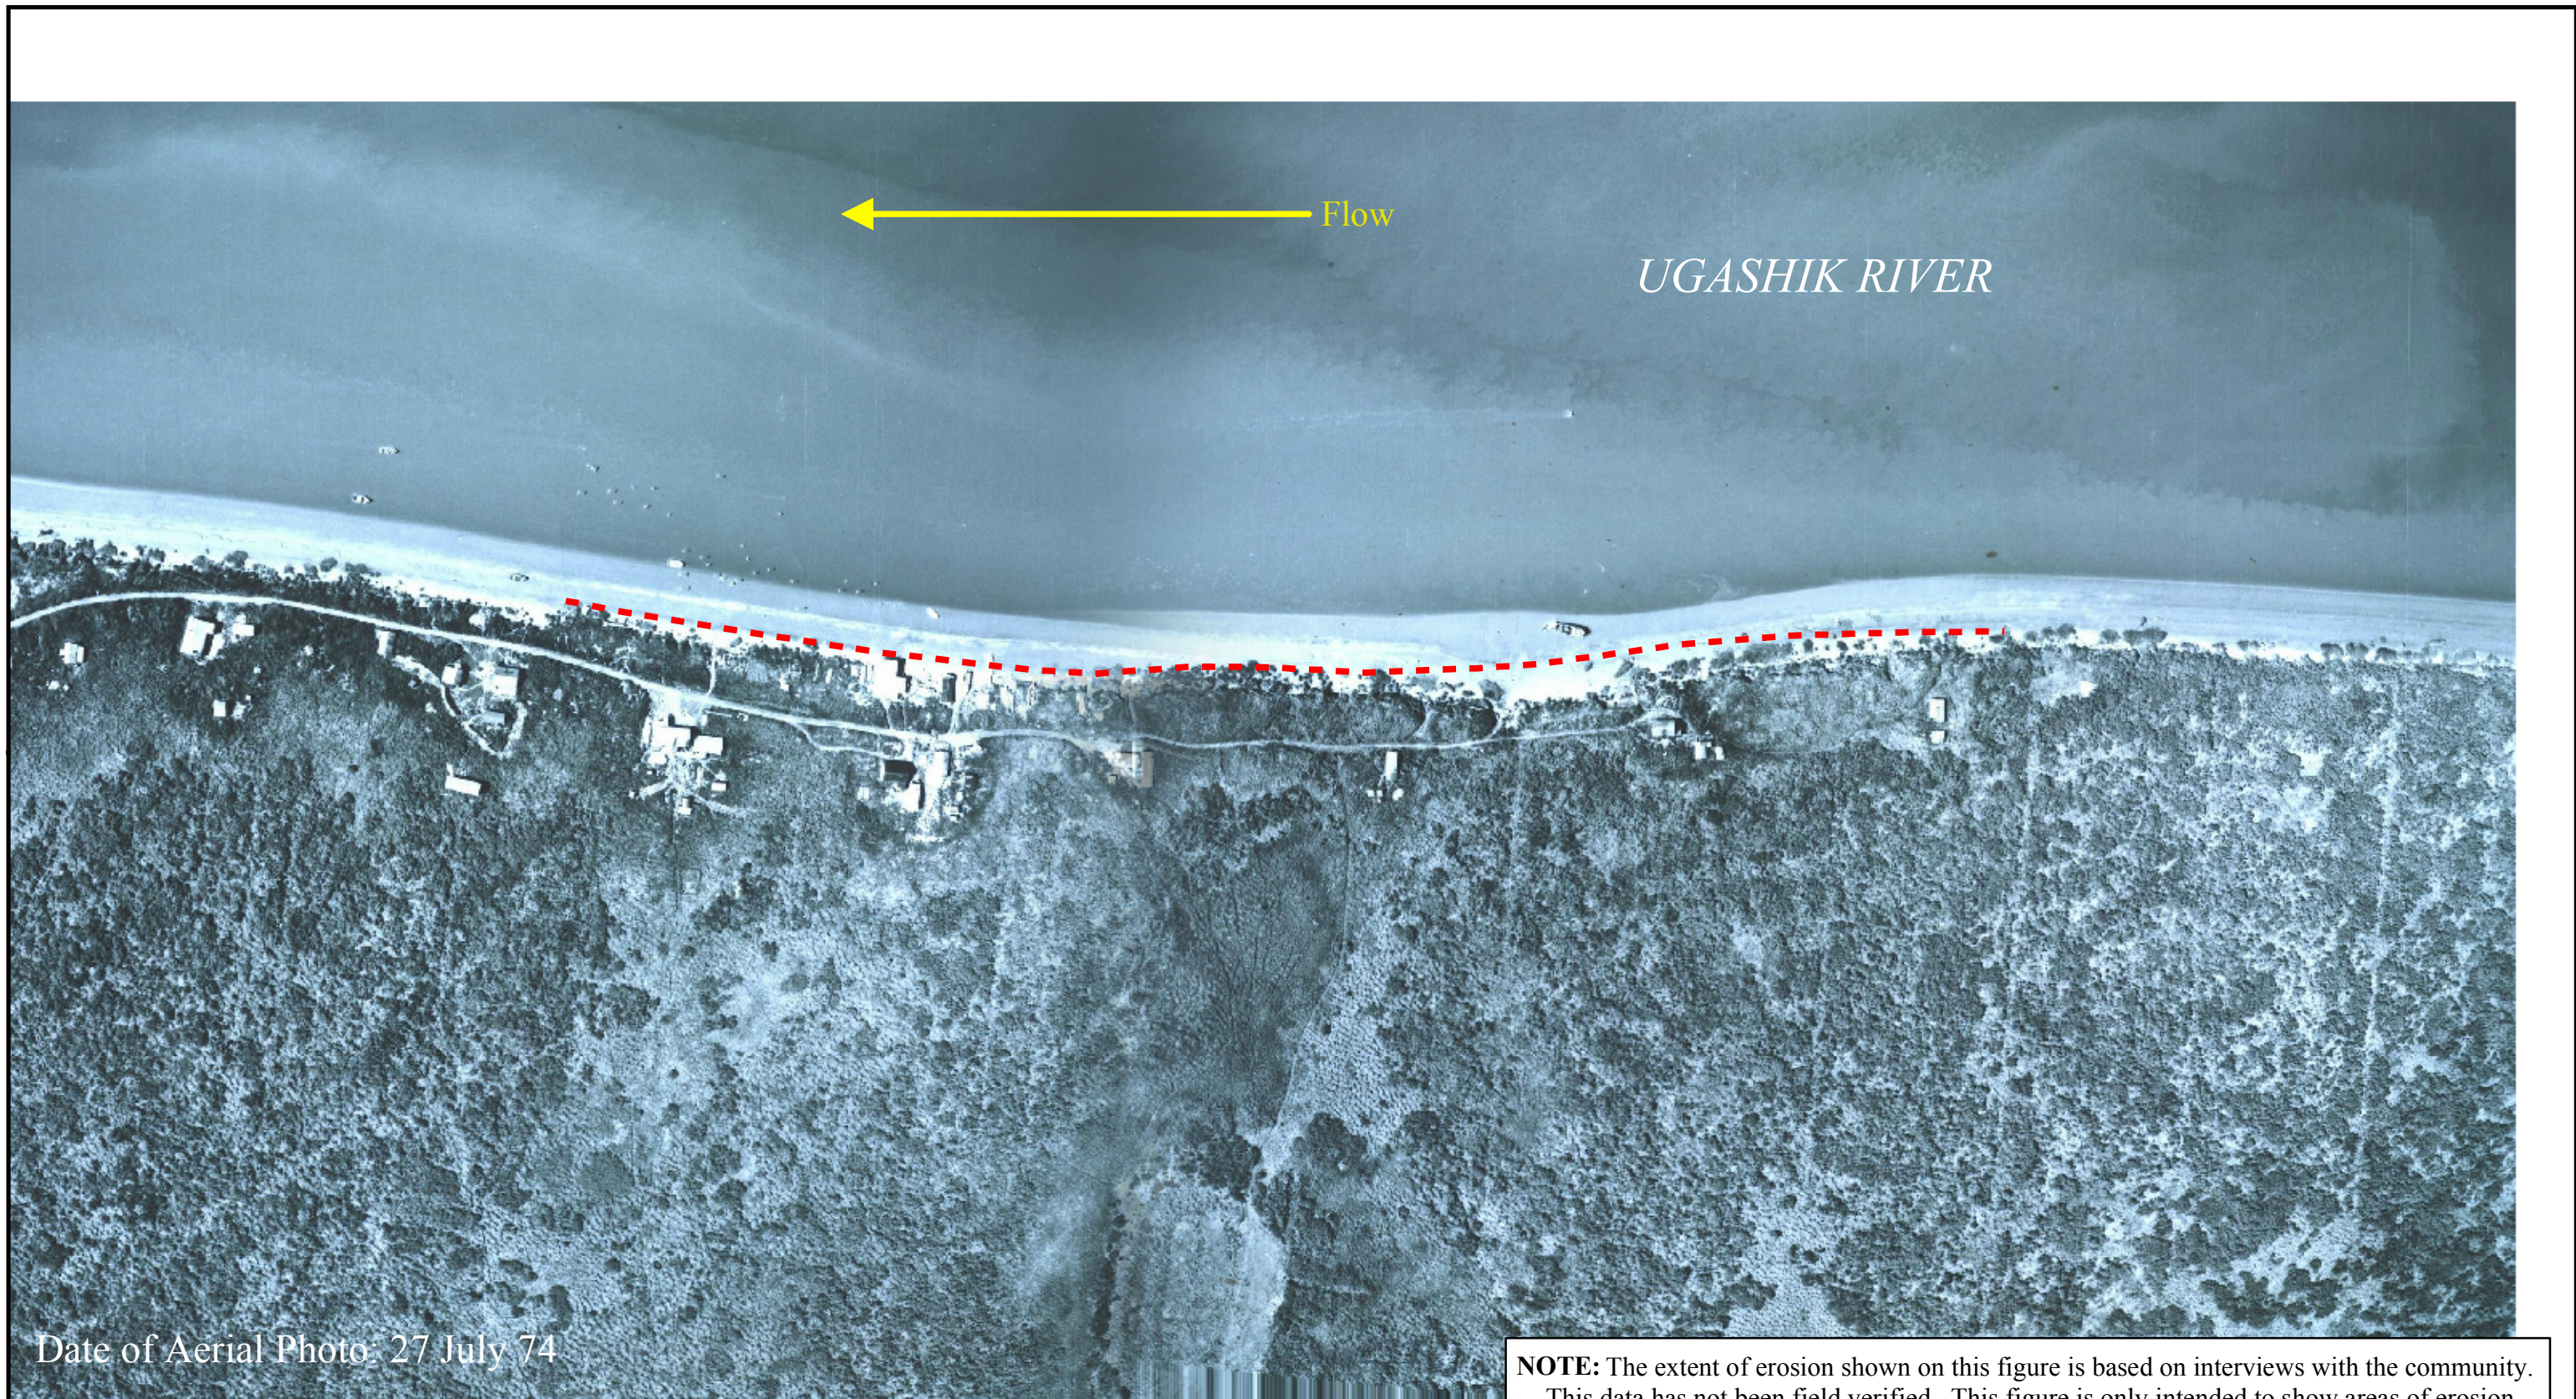
--- Linear Extent of Erosion
Part 2

NOTE: The extent of erosion shown on this figure is based on interviews with the community. This data has not been field verified. This figure is only intended to show areas of erosion, not rates or severity of erosion
