SALMON RIVER, ALASKA

(Hyder, Alaska)
(CWIS NO. 72857)

Condition of Improvement 30 September 2007

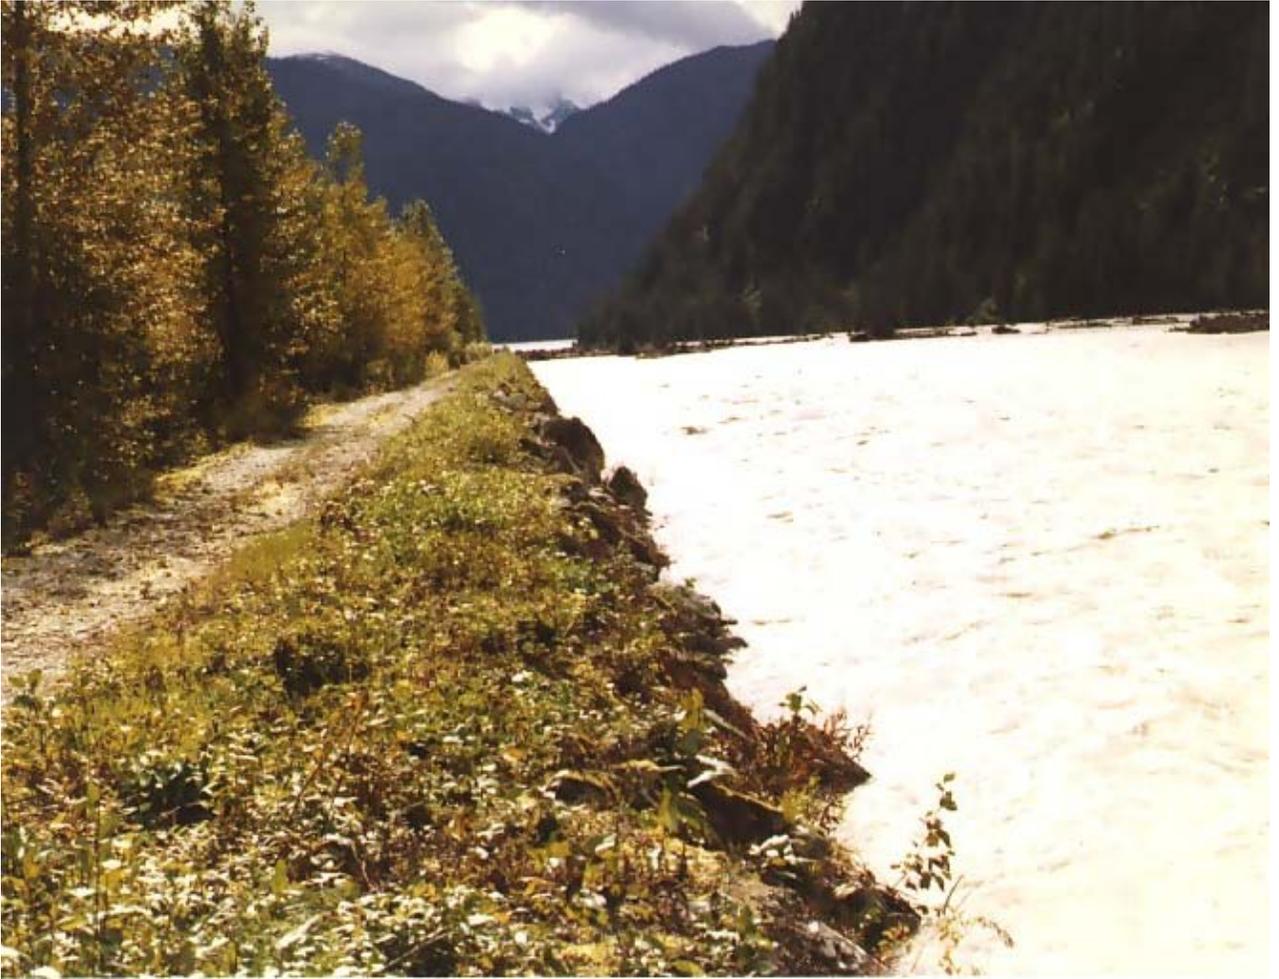
View downstream along the dike, September 1988.

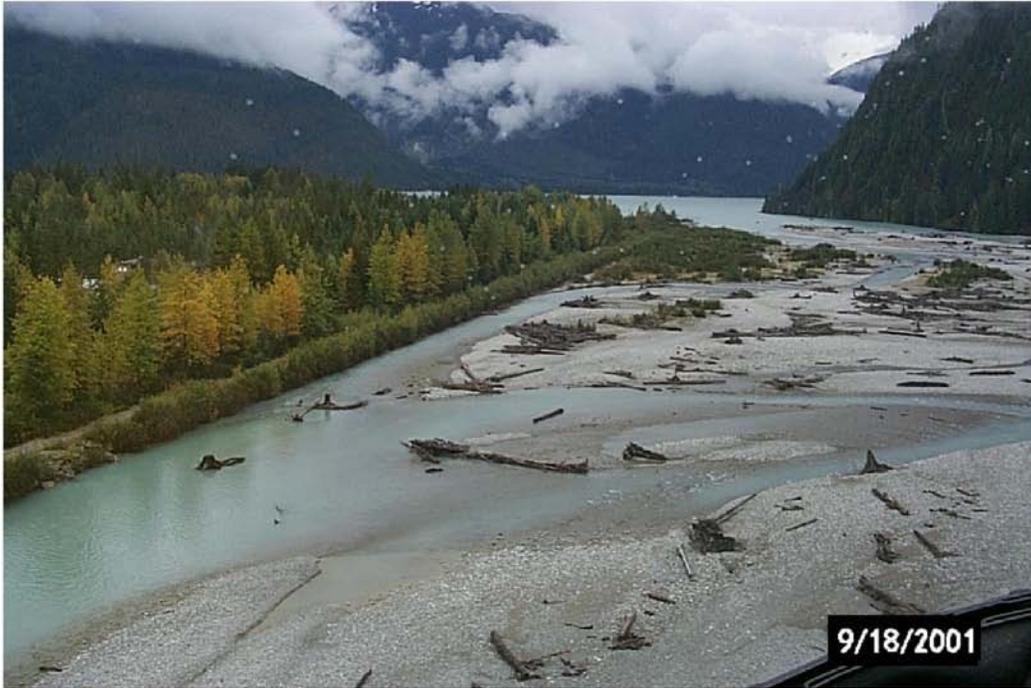
Aerial view downstream; project forms straight line to the left.

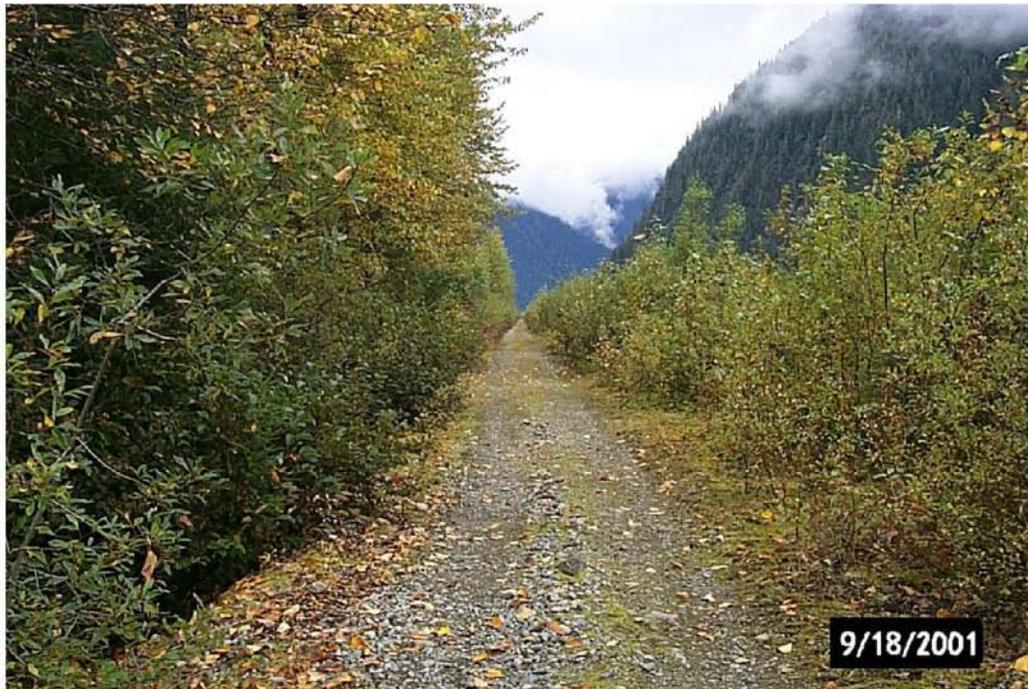
Looking down the crest of the levee.
