# **METLAKATLA EROSION PROTECTION**

**METALAKATLA EROSION PROTECTION, ALASKA**  
**Cemetery and Fuel Tank Facility**  
 (CWIS Nos. 92796 & 92830)

Condition of Improvement 30 September 2007

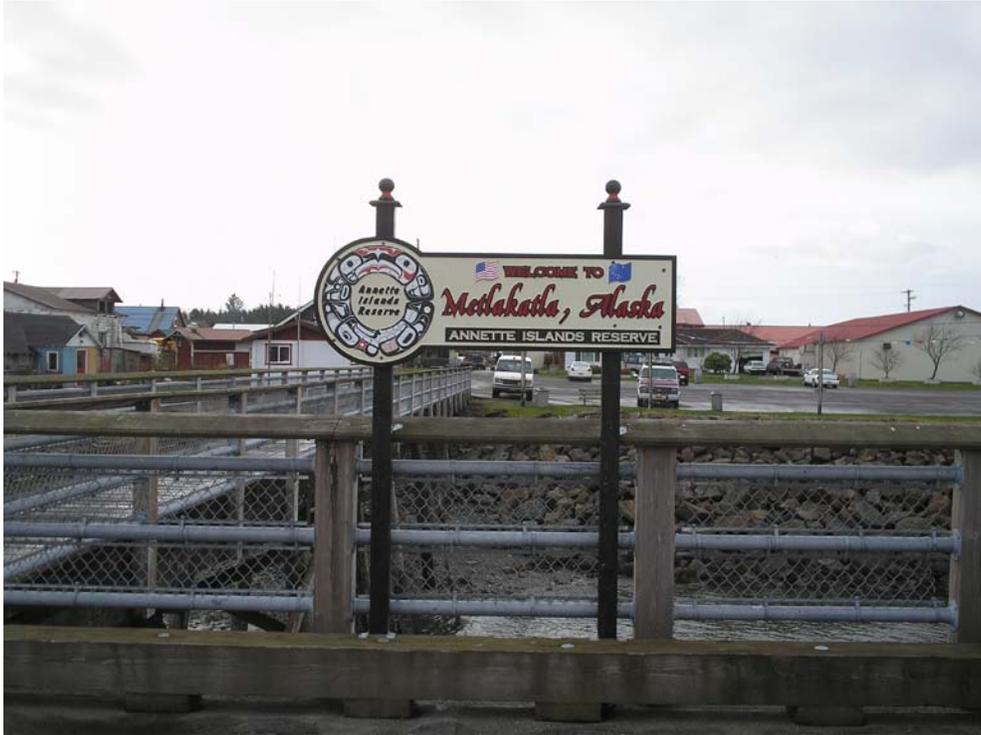
Sign on dock 2008, shore line protection in background.

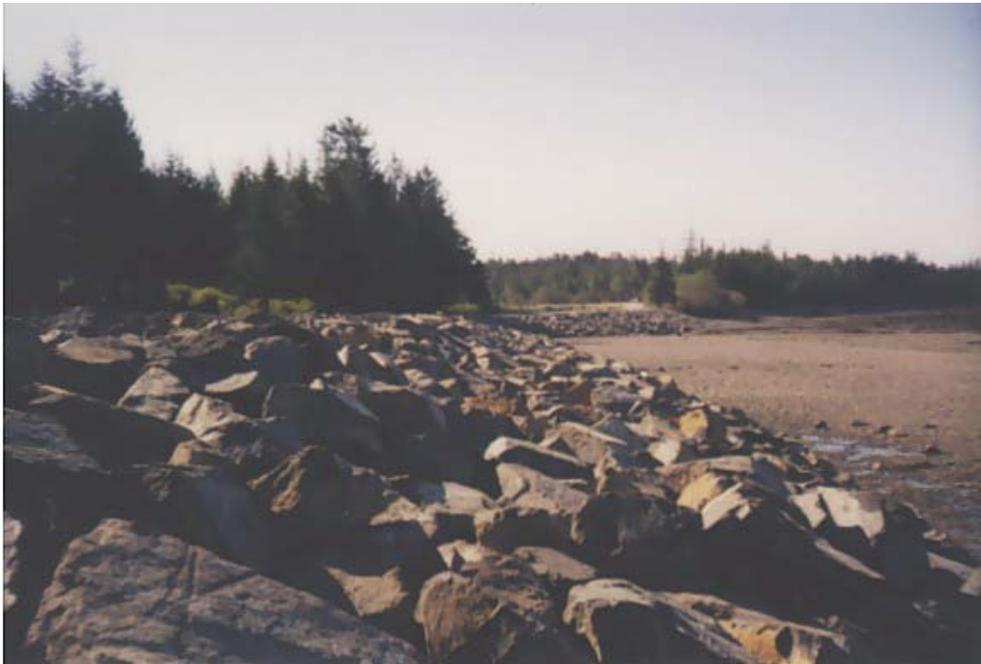
- 1998 - Both works are inspected and found to be in good condition.
- 1999 - An inspection in June finds both projects in excellent condition. A damaged culvert at station 9+00 of the cemetery revetment is functional but requires monitoring for debris build up.

Looking along the shore protection 1999.
