FLOOD CONTROL  
 SKAGWAY, SKAGWAY RIVER  
 ALASKA  
 REVISED 1998

**SKAGWAY RIVER, ALASKA**  
(CWIS NO. 00013, 91000, 16900)

Condition of Improvement 30 September 2010

## Skagway River Bank Stabilization, Skagway, Alaska

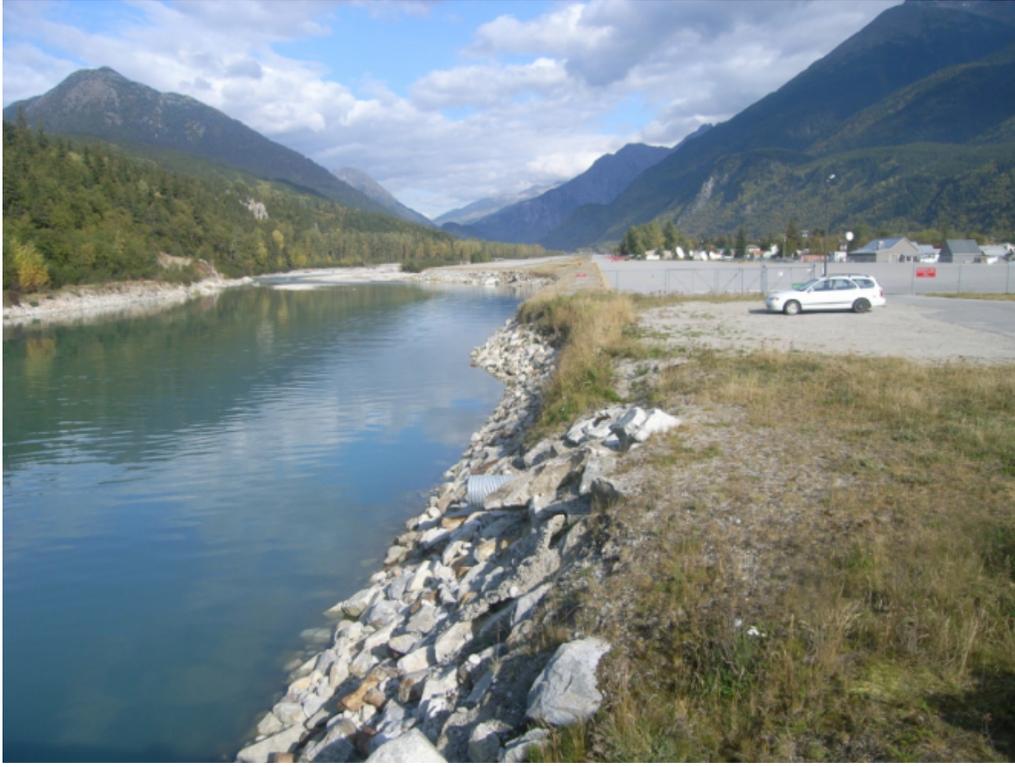
The majority of the landward side of the levee is the Skagway Airport, September 2010.
