Deering Streambank Protection

Condition of Improvements
30 December 2014
Deering Streambank Protection, Alaska
(CWIS No. 092906, 180355)

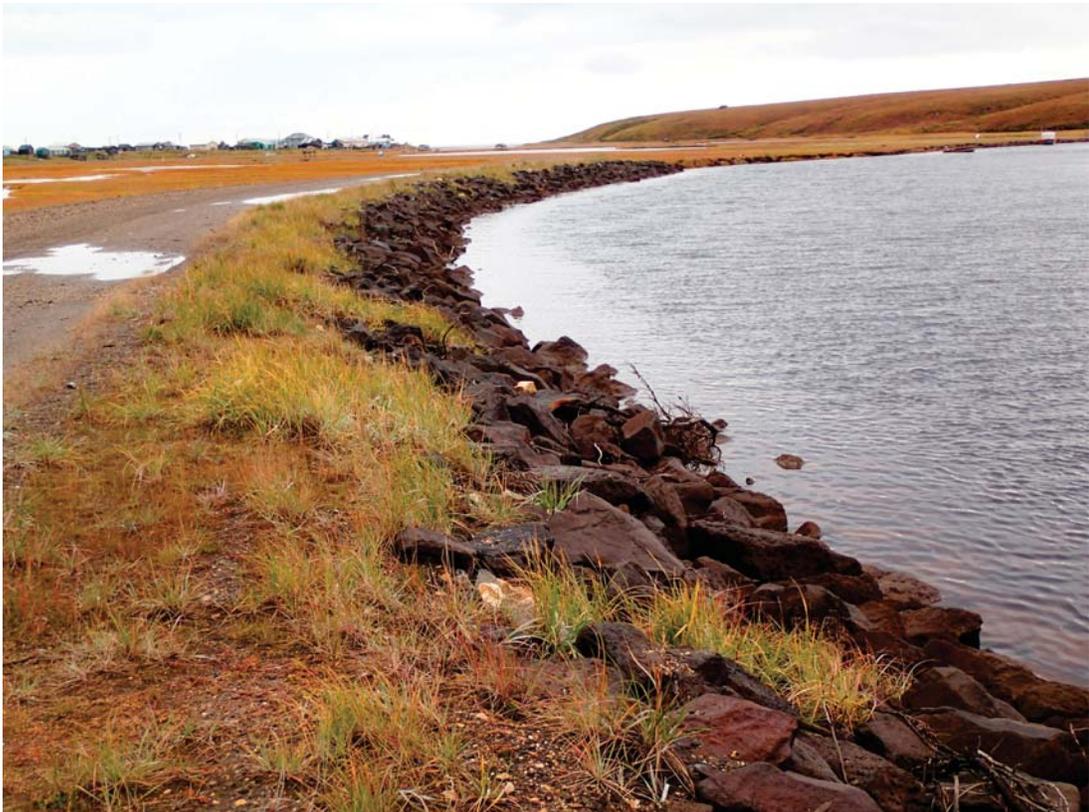
Looking downstream at the approximately 800-ft long revetment, September 2013.

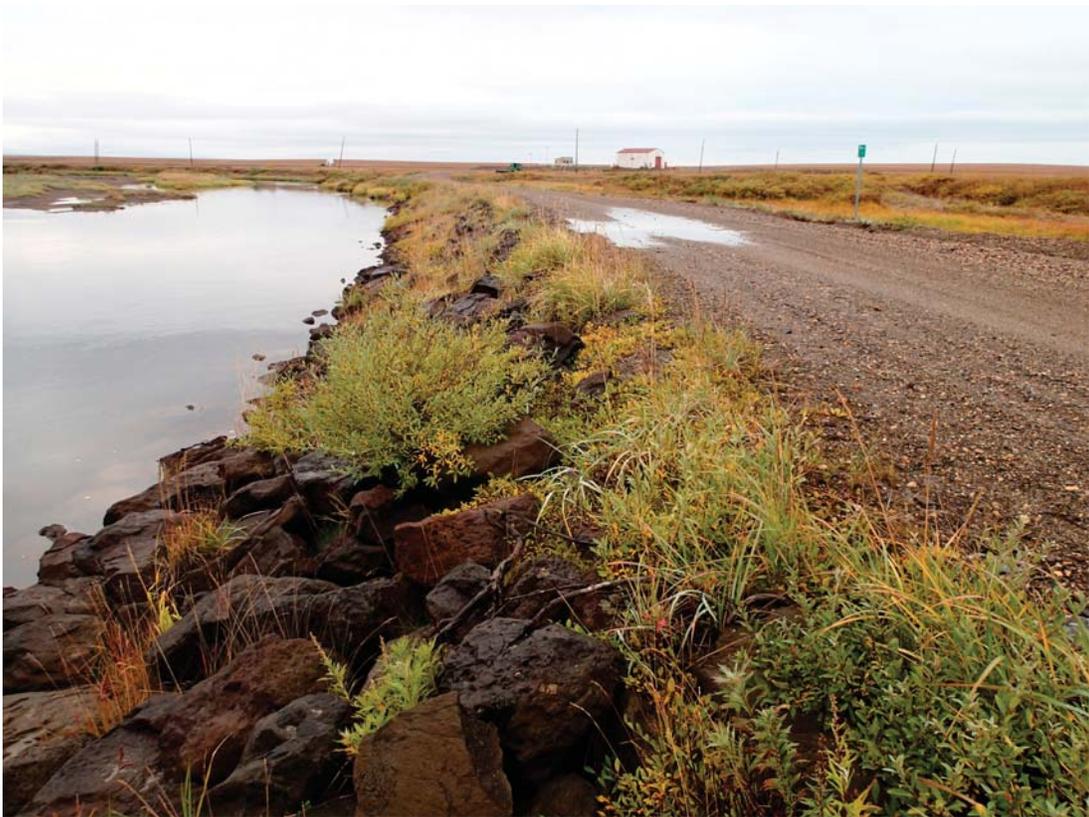
Looking upstream at the approximately 600-ft long revetment, September 2013.

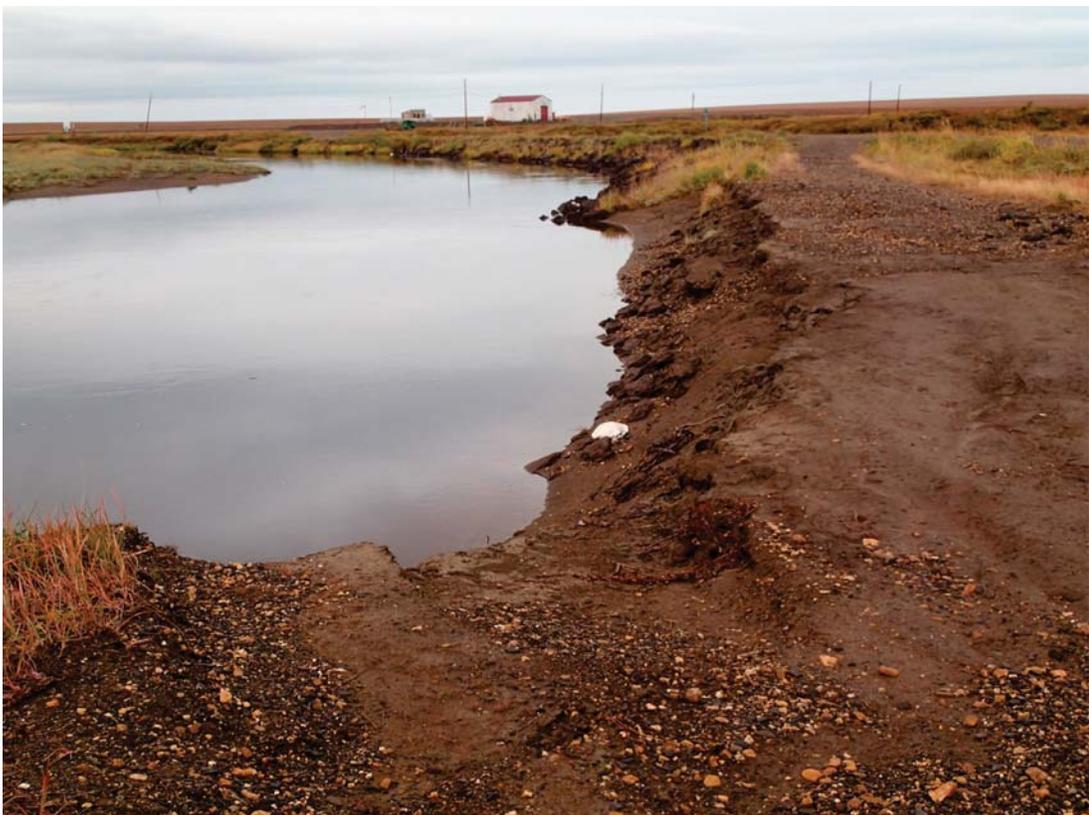
2014	The project is inspected in September: evidence of fracturing of the revetment rock is apparent throughout, some erosion of the stream banks downstream of the revetments is on-going and some stones are not keyed well, but both sections appear to be in good overall condition.

Erosion along the approximately 600-ft long revetment, September 2013.
