Dillingham Bank Stabilization

Condition of Improvements
 30 December 2014
Dillingham Bank Stabilization, Alaska
 (CWIS No. 075441)

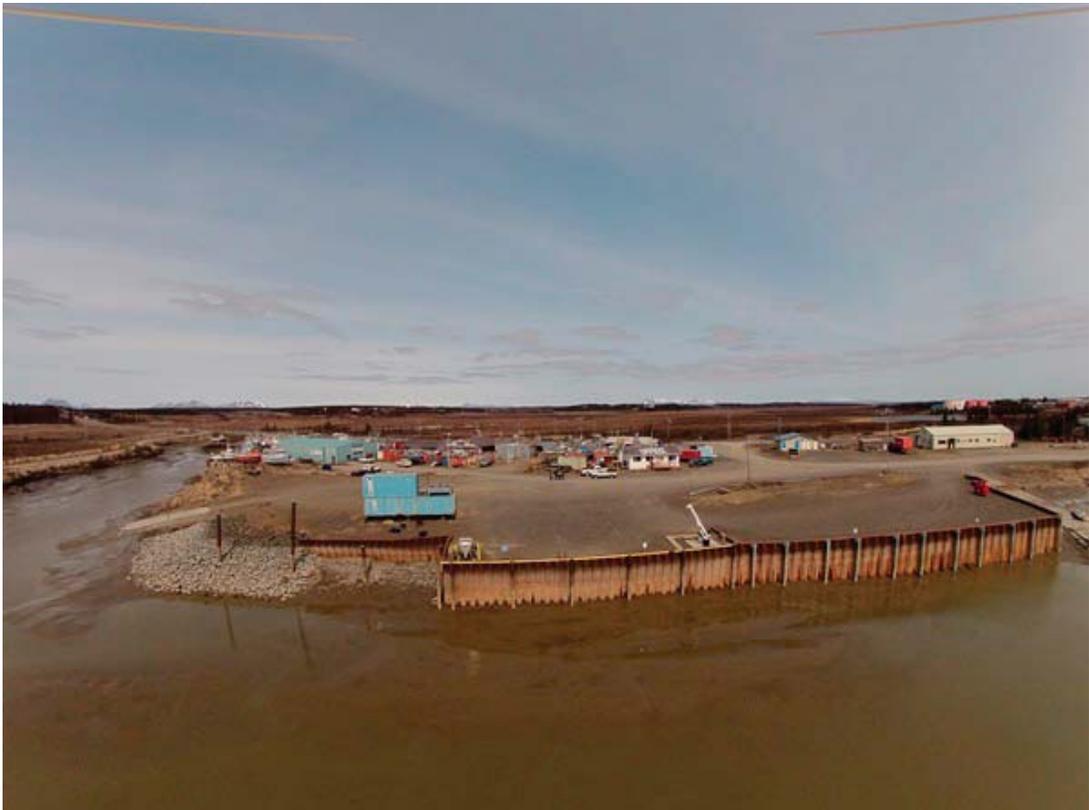
Riprap and sheetpile protection on the east side of the entrance channel, May 2014.

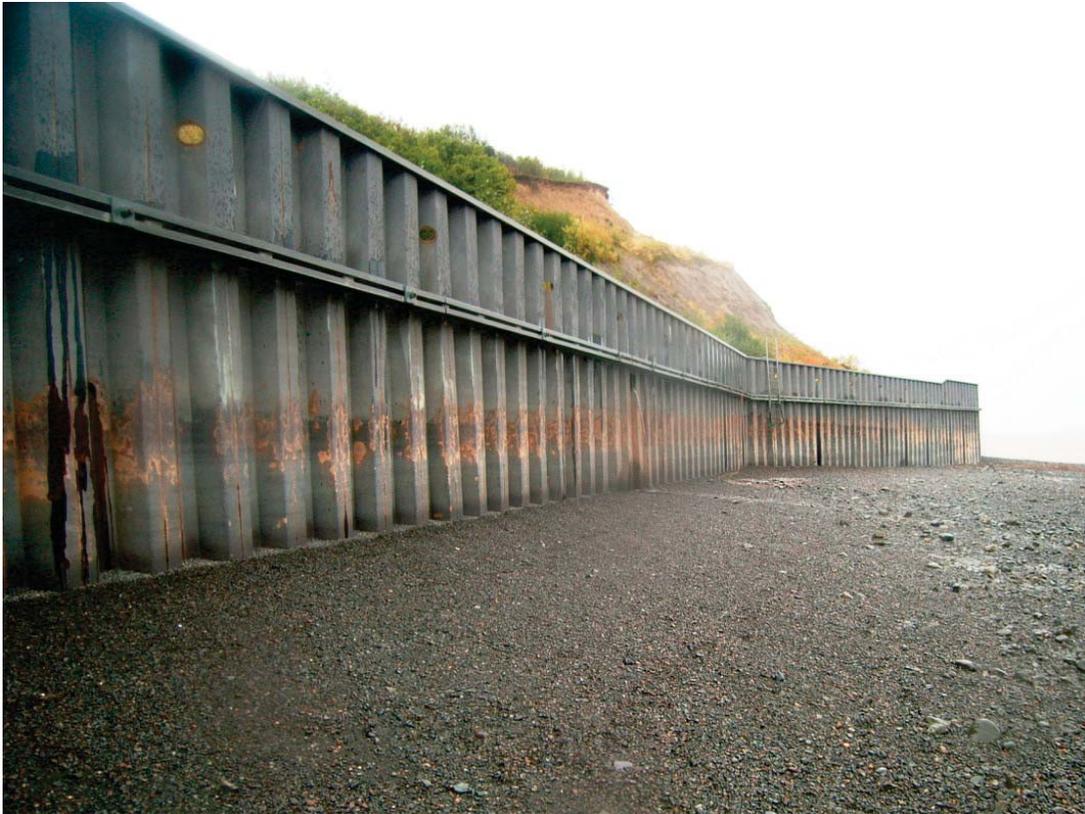
H-pile supported sheetpile bulkhead, September 2008.

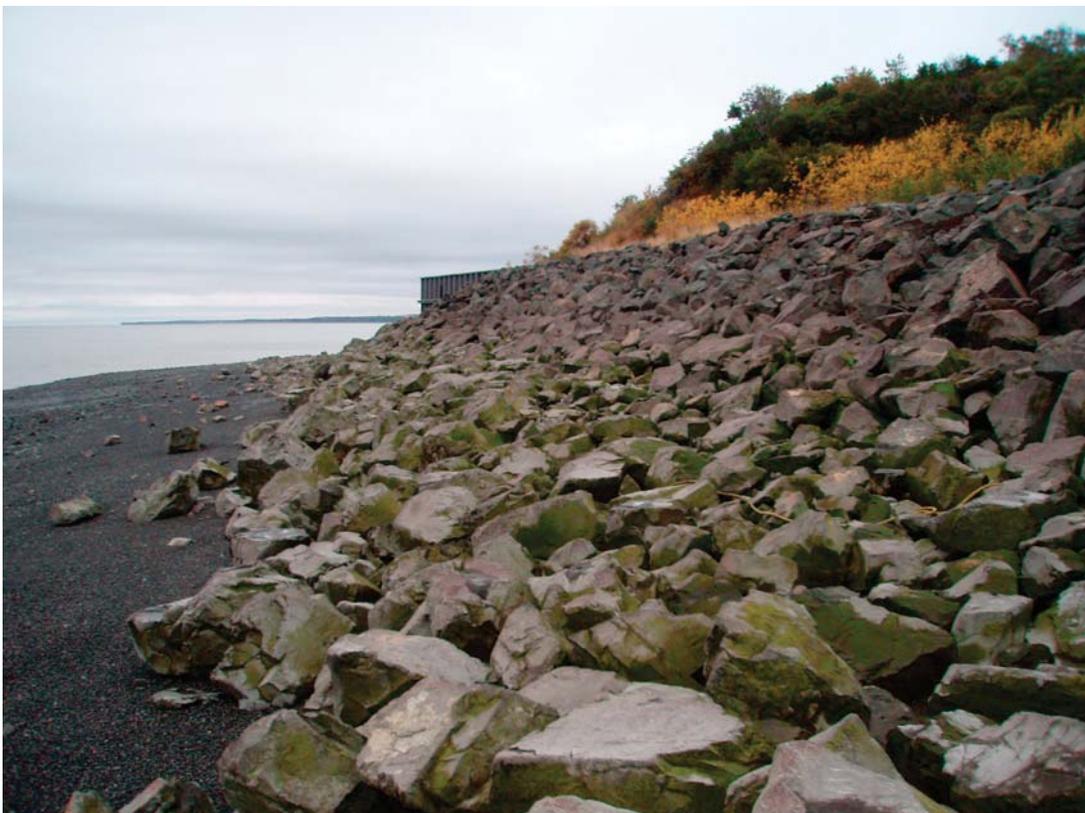
Riprap protection at the eastern extent of bank stabilization, 14 August 2008.

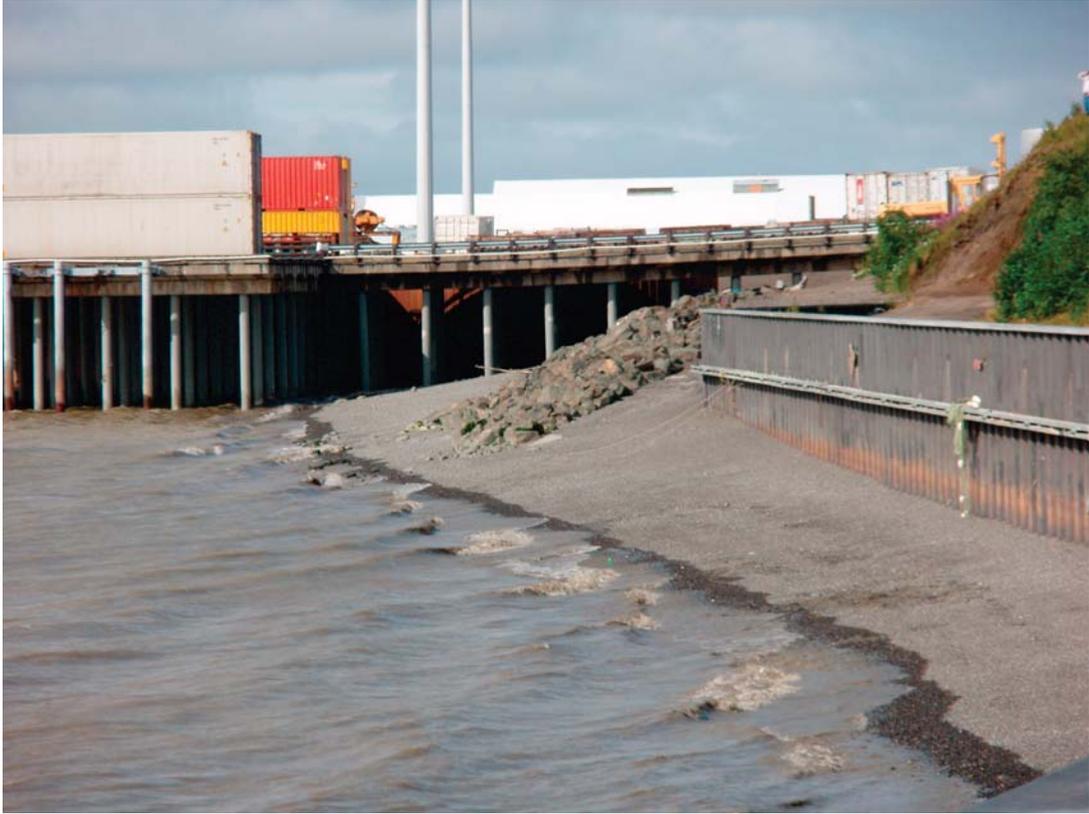
City dock and sheetpile protection, 14 August 2008.

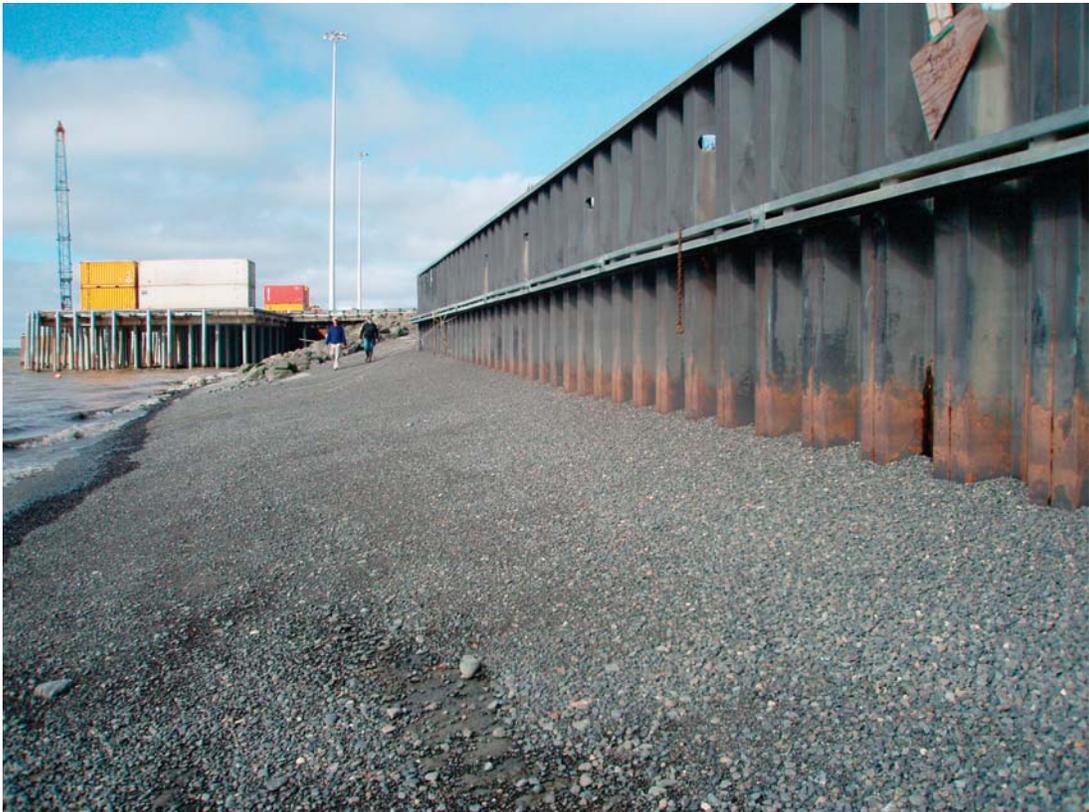
City dock and sheetpile protection, 14 August 2008.
