# Klutina River

**FLOOD CONTROL  
 KLUTINA RIVER  
 ALASKA  
 REVISED 1993**

Condition of Improvements  
30 December 2014  
**Klutina River at Copper Center, Alaska**  
(CWIS No. 003830)

# Klutina River Levee, Copper Center, Alaska

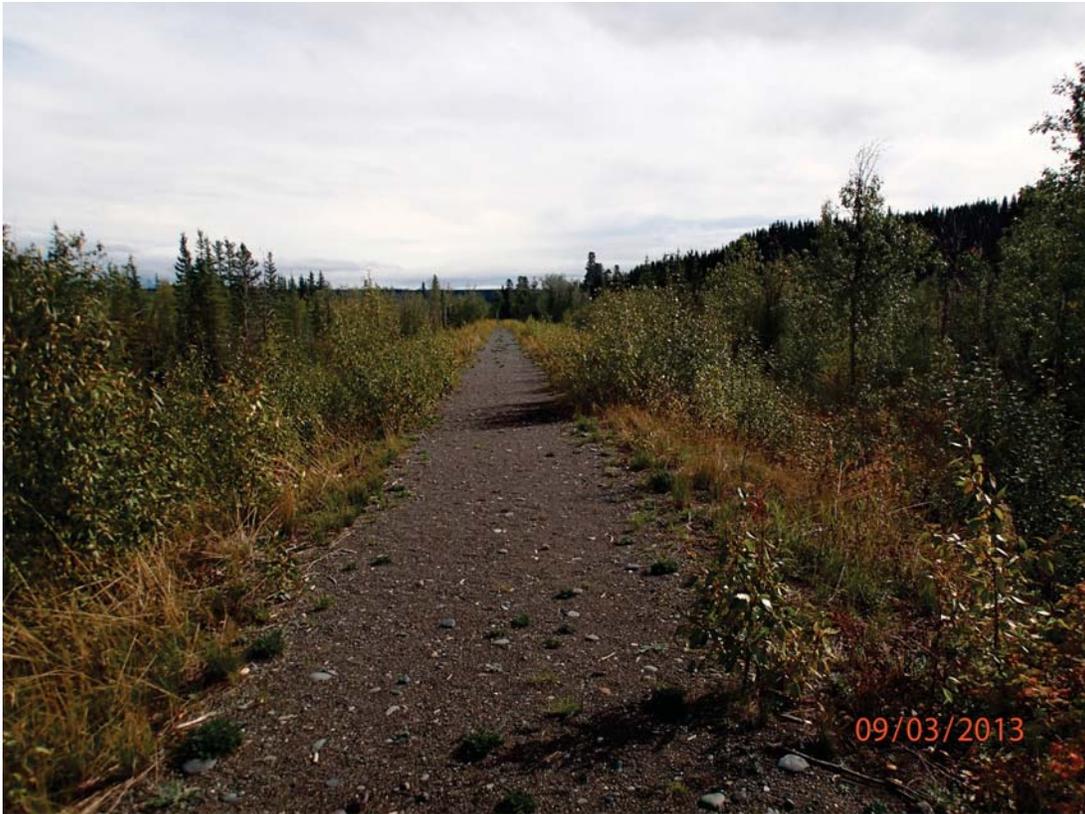
Klutina River Levee, 3 September 2013.

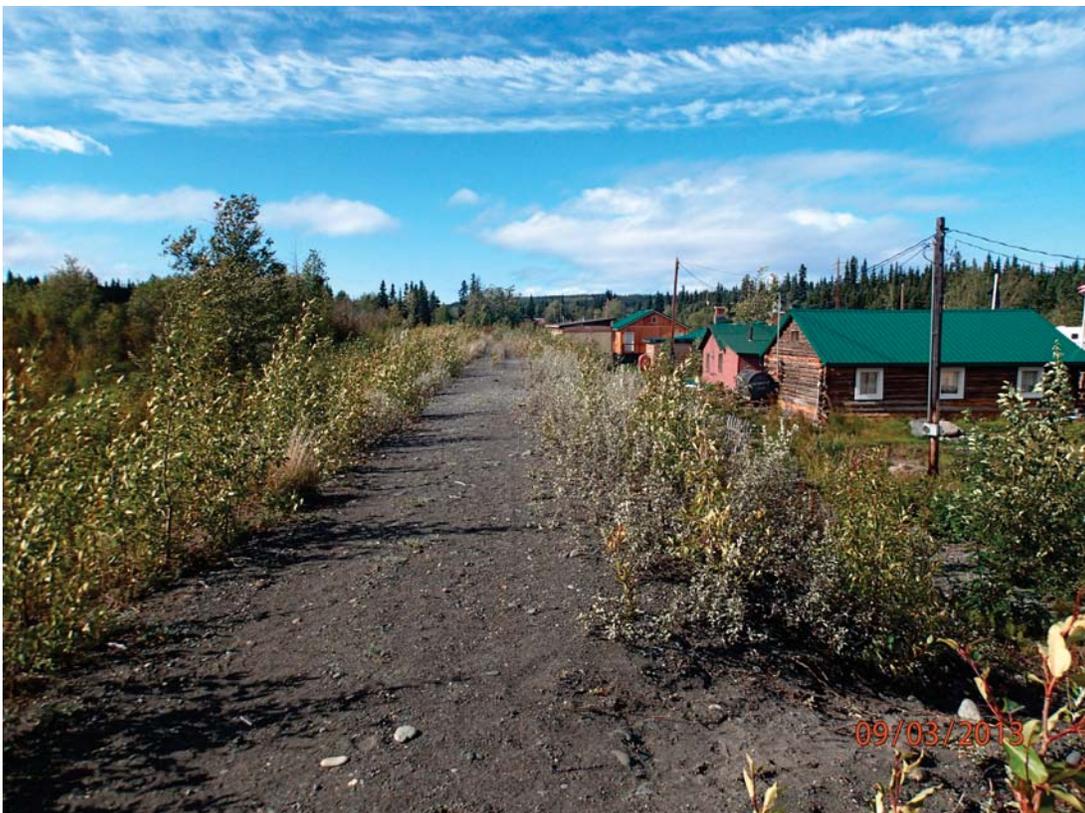
Encroachments within the levee footprint, 3 September 2013.
