# **Metlakatla Erosion Protection**

Metlakatla, Alaska  
**METLAKATLA  
 EROSION PROTECTION**

Condition of Improvements  
 30 December 2014  
**Metlakatla Erosion Protection, Alaska**  
 Cemetery and Fuel Tank Facility  
 (CWIS No. 092796, 092830)

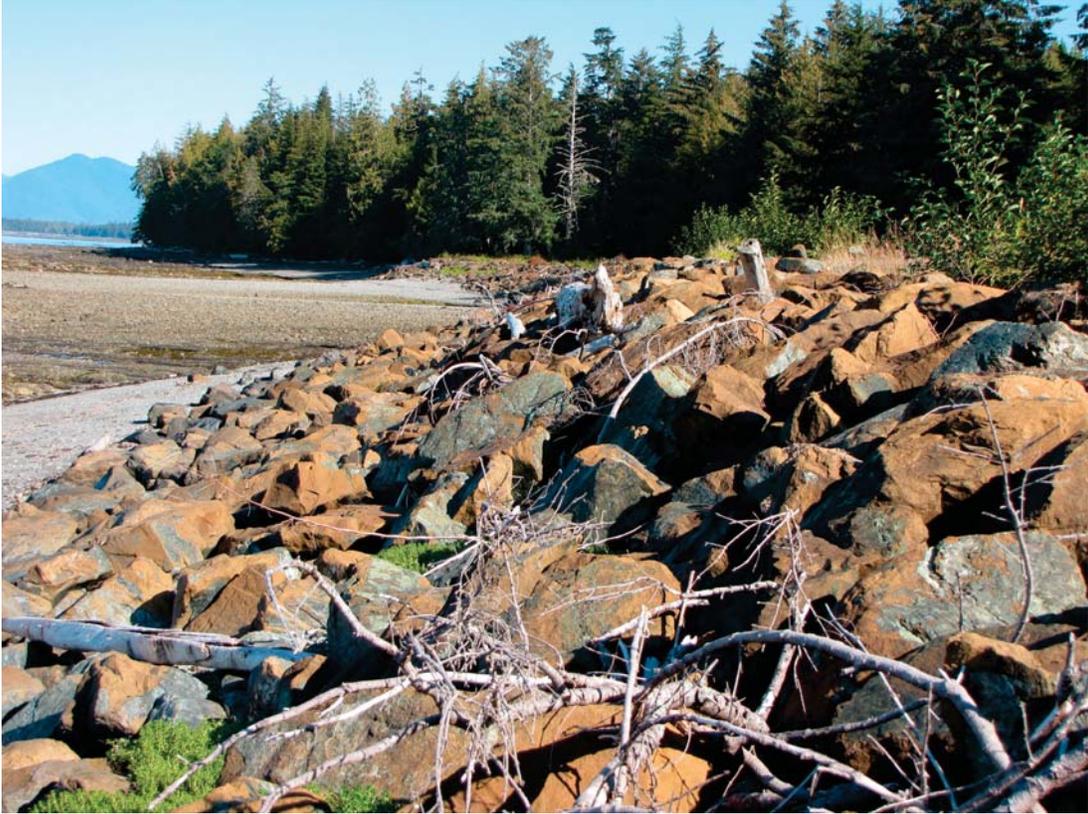
The cemetery rock revetment , September 2010.

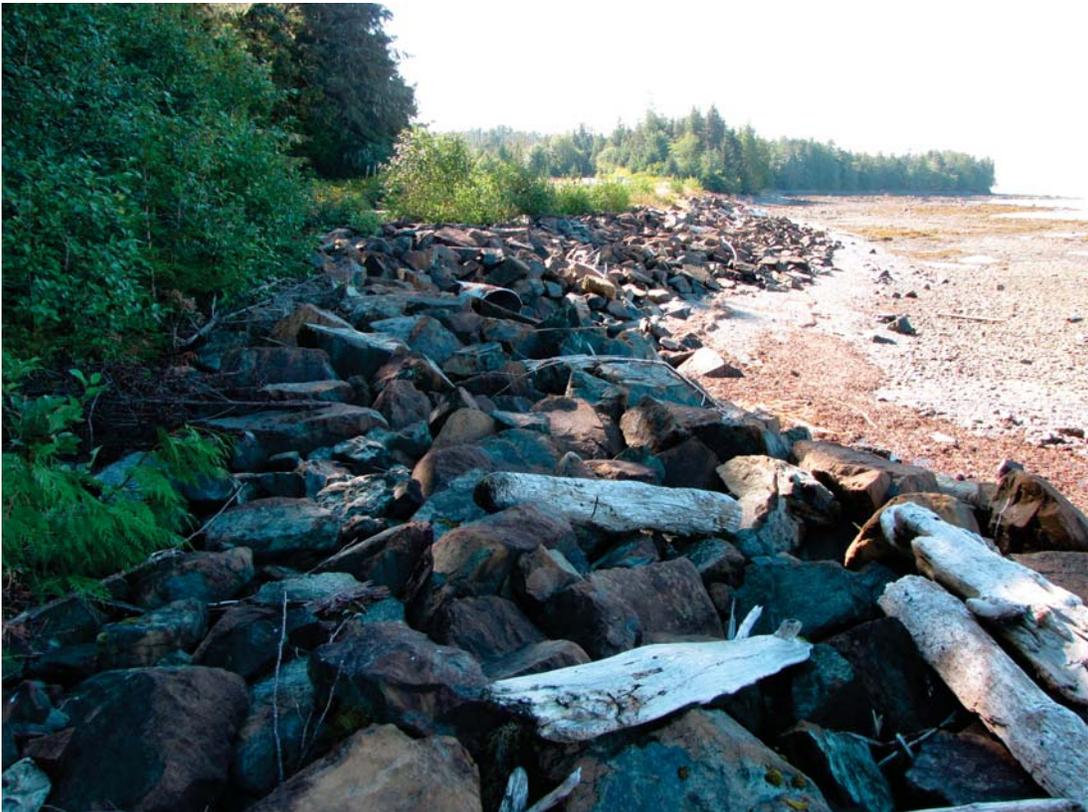
The cemetery rock revetment , September 2010.

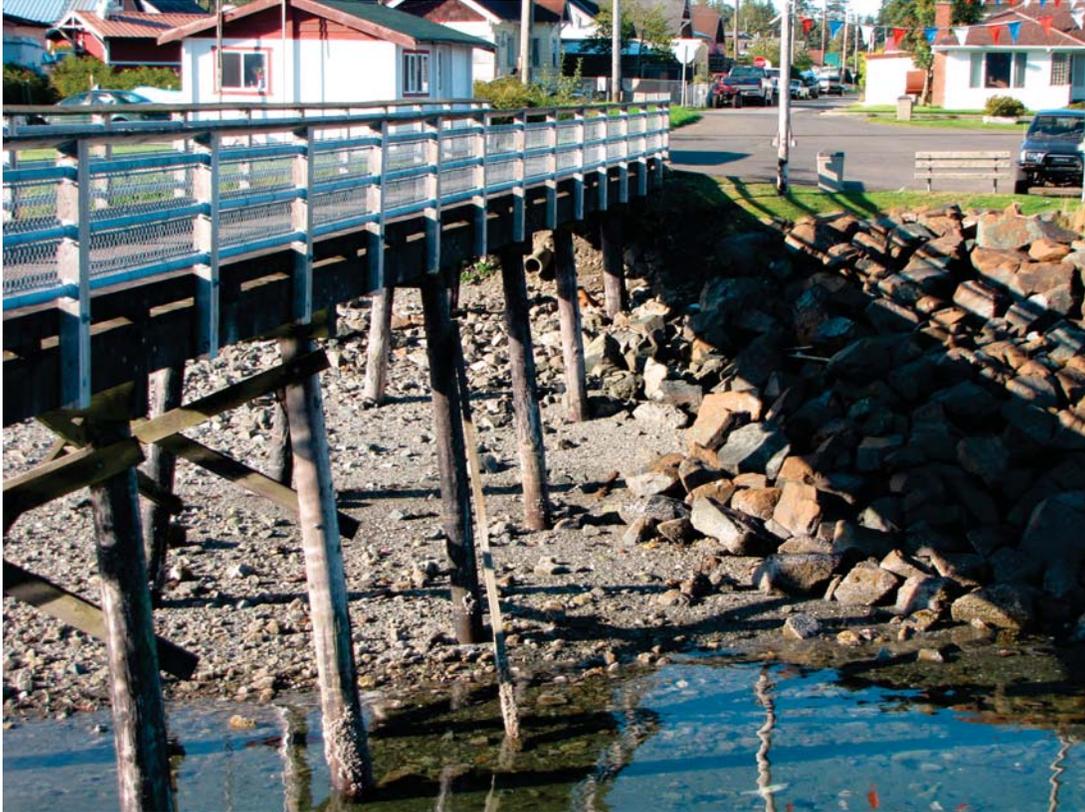
The east extent of the tank farm rock revetment , September 2010.

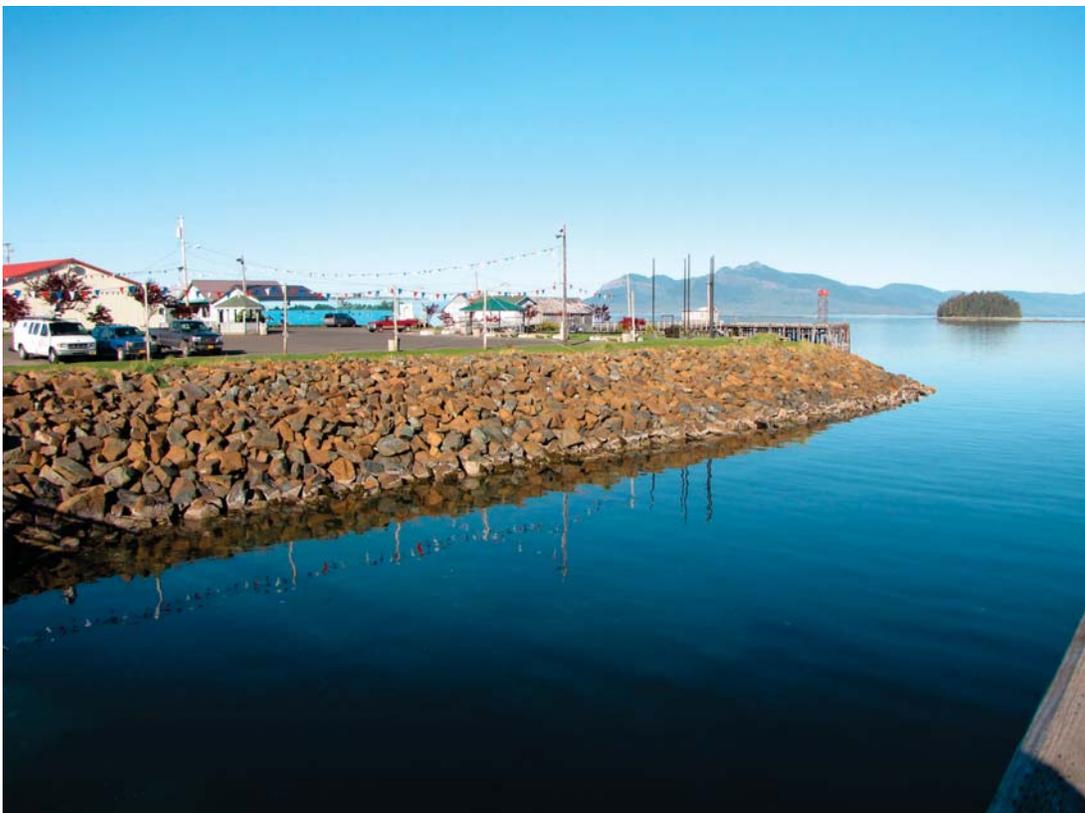
The tank farm rock revetment, September 2010.
