Salmon River

**FLOOD CONTROL
SALMON RIVER
ALASKA
REVISED 1993**

Condition of Improvements
30 December 2014
Salmon River, Hyder, Alaska
(CWIS No. 072857)

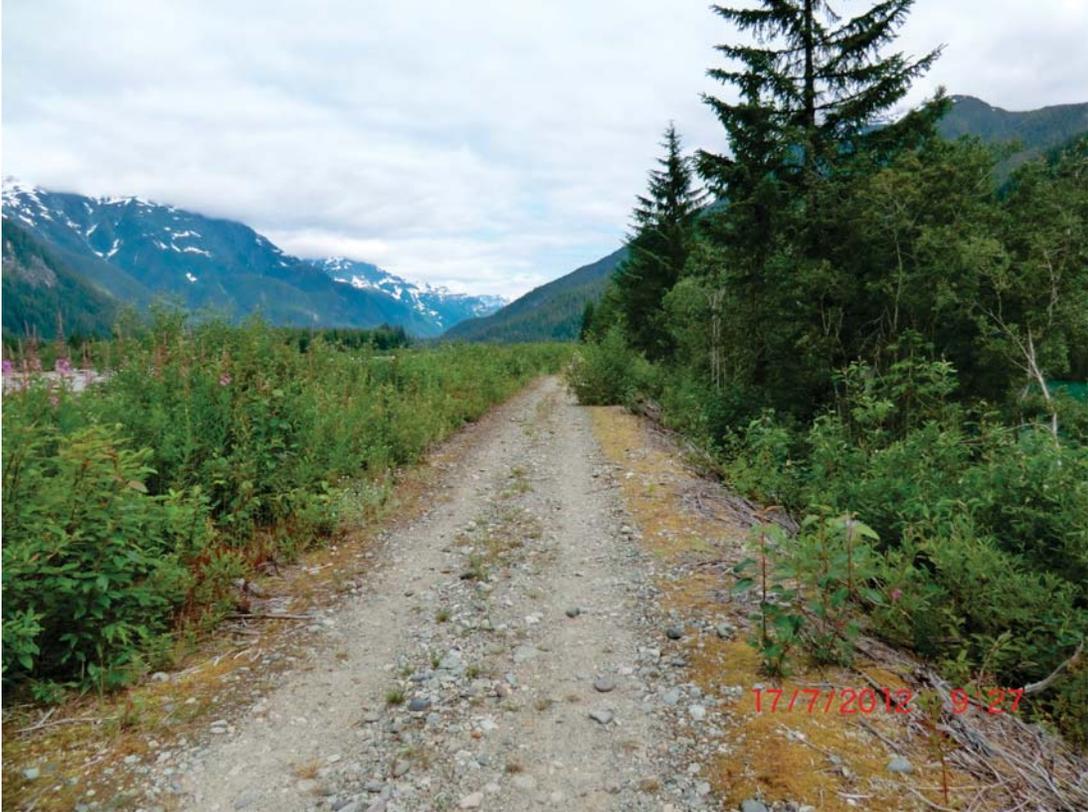
Salmon River Dike , July 2012.

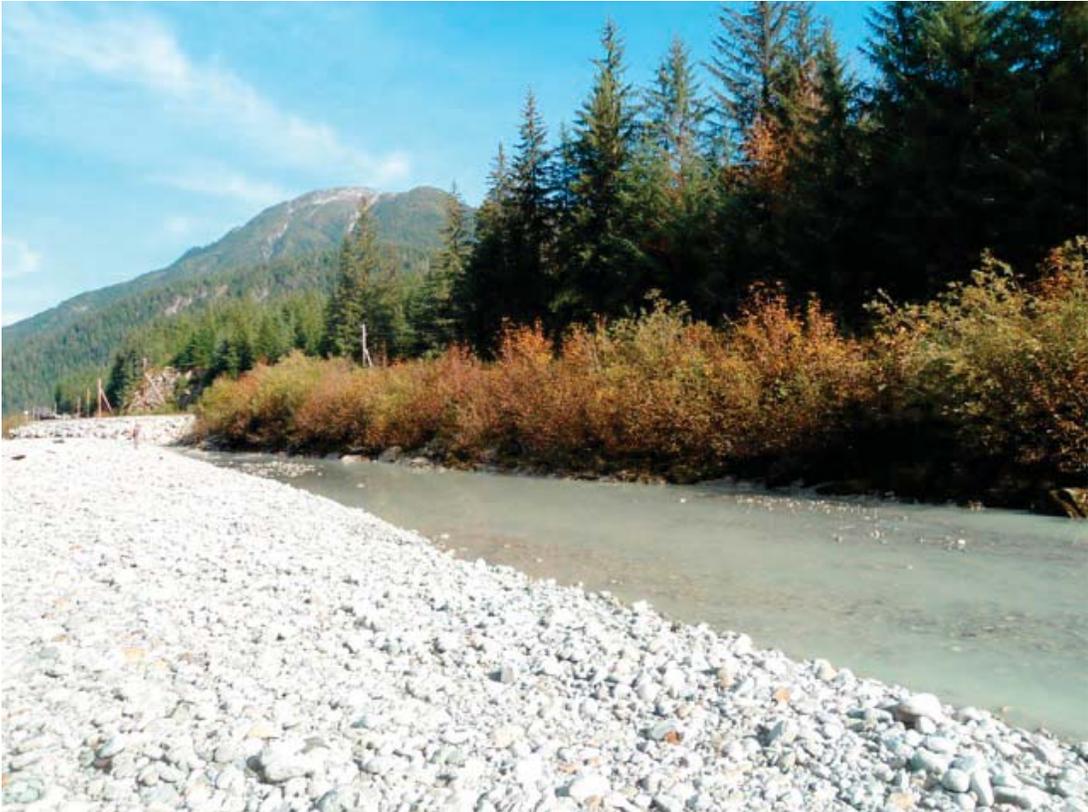
2014	The dike was inspected in September and found to be in “poor” condition.

Salmon River Dike , September 2014.
