**HAINES HARBOR
ALASKA**

HAINES HARBOR, ALASKA
 (CWIS NO. 87015)
 (CWIS NO. 150037)
 (CWIS NO. 13576)

Condition of Improvement 30 September 2008

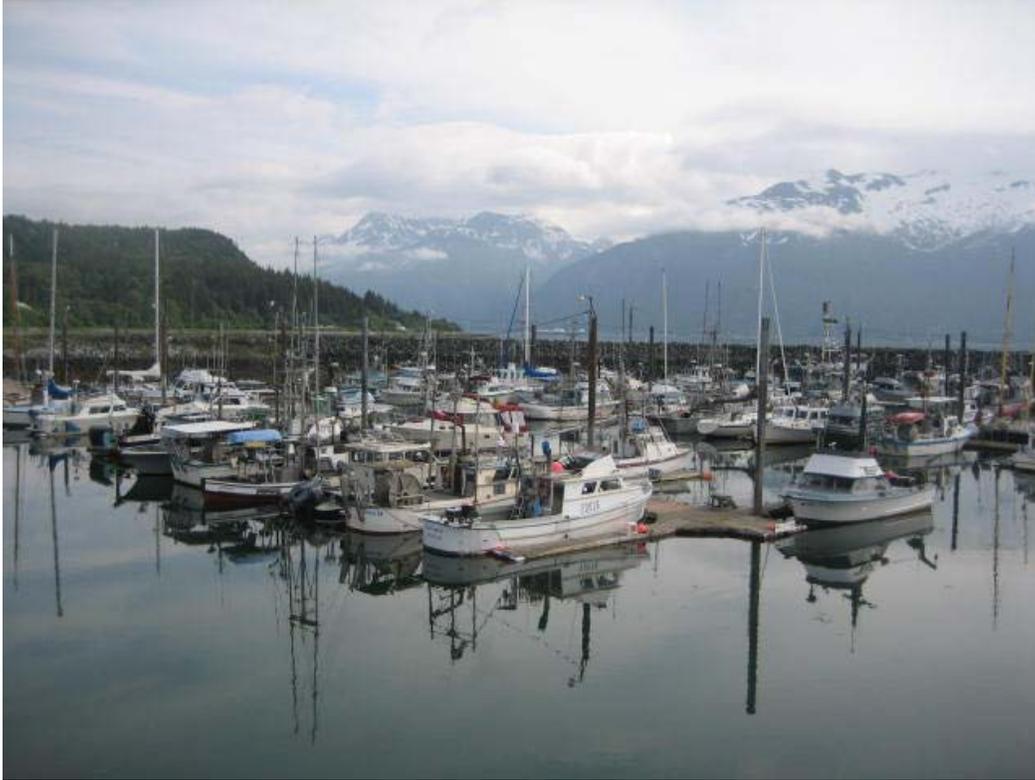
View of the small boat harbor taken during project condition survey in June, 2008.

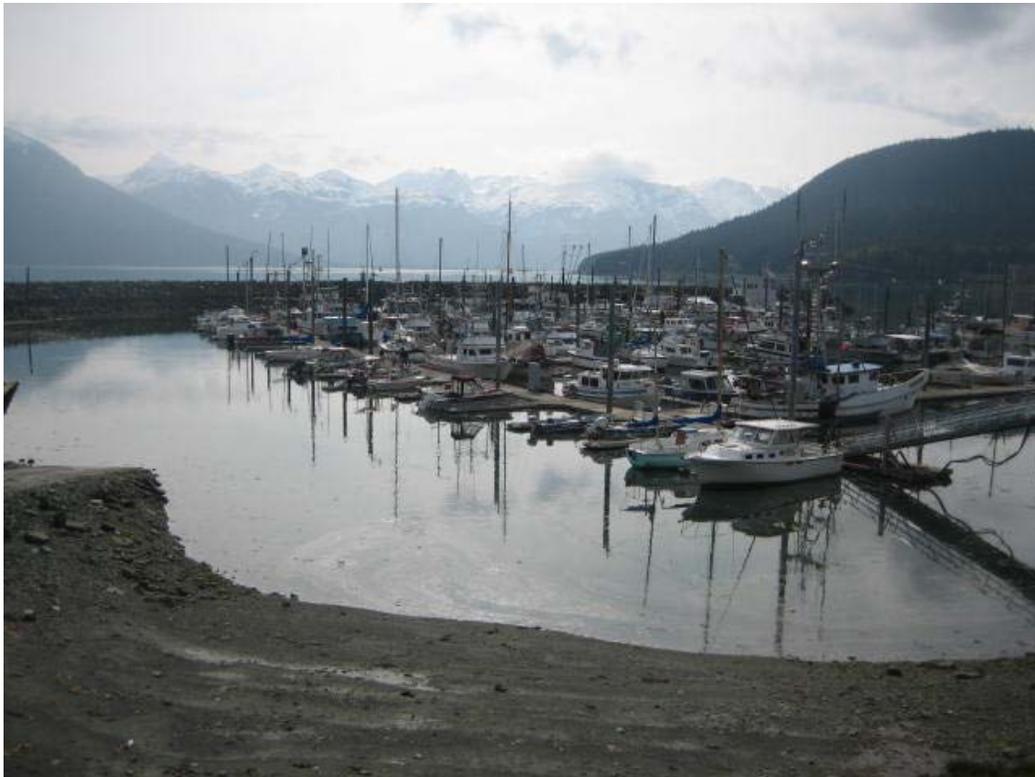
View from the Haines boat launch in June, 2008.
