Port Lions Harbor

Condition of Improvements
30 December 2014
Port Lions Harbor, Alaska
(CWIS No. 087202, 087744, 010599)

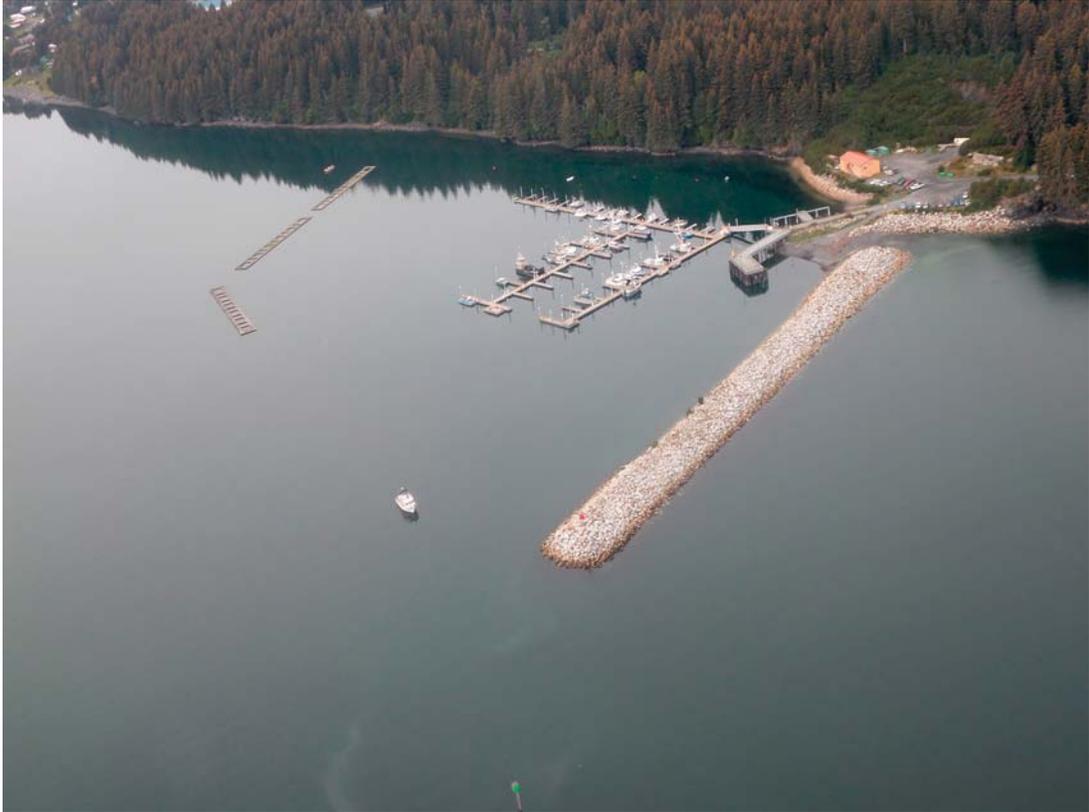
Northwest oblique of Port Lions Harbor, 24 September 2014.

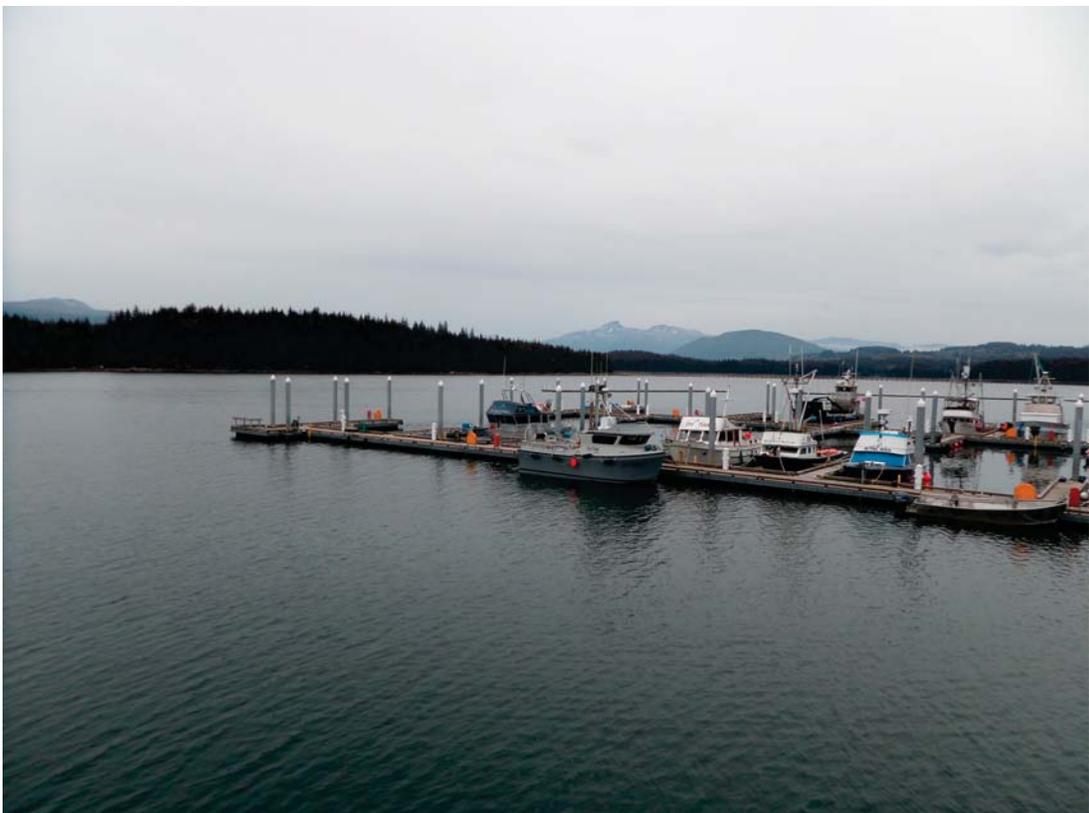
Port Lions Harbor, 3 September 2014.
