Ketchikan Bar Point Harbor

Condition of Improvements
31 December 2022
Bar Point Harbor
Ketchikan, Alaska
(CWIS No. 087071)

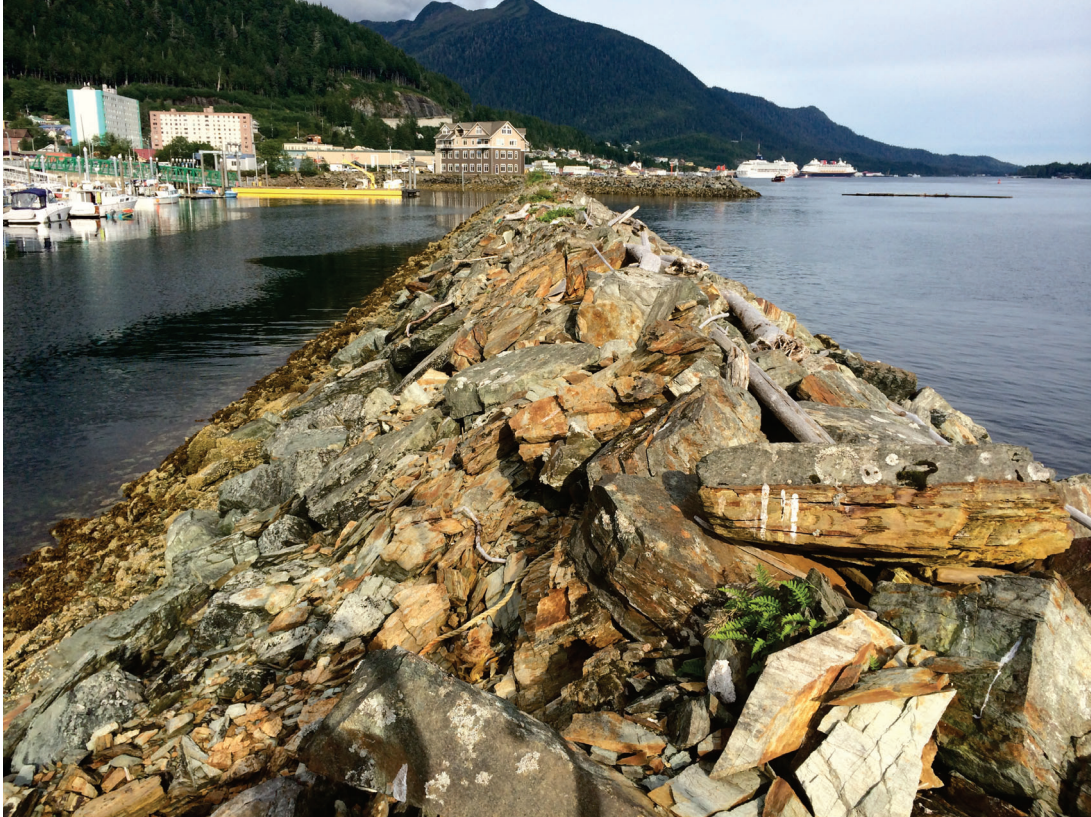
Looking Southeast from the West breakwater, August 2015

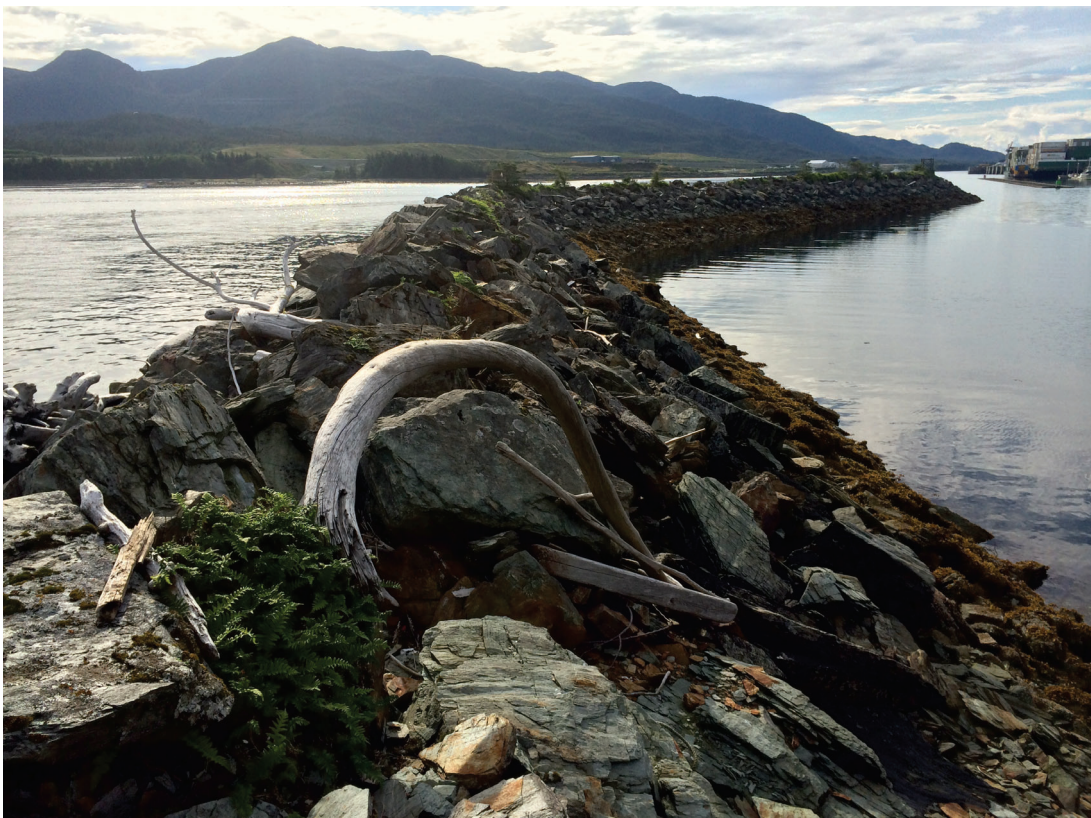
Looking Northwest from the West breakwater, August 2015

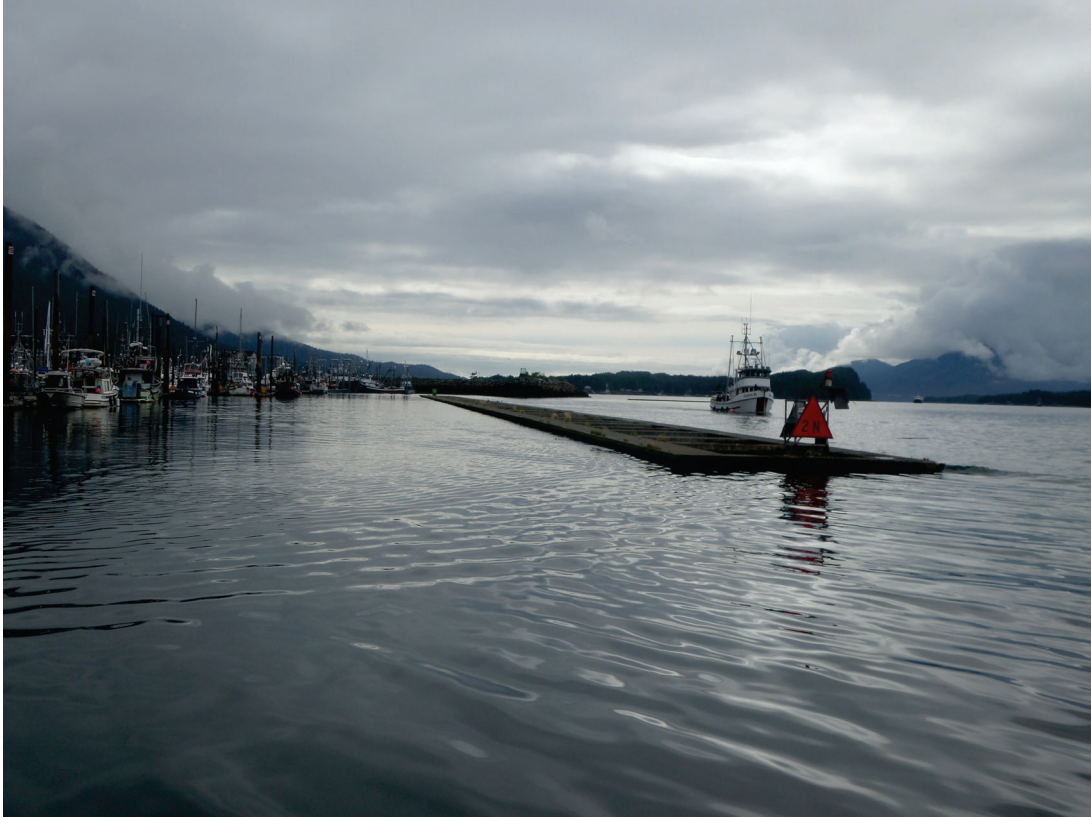
Large floating breakwater protecting the expanded harbor, August 2015

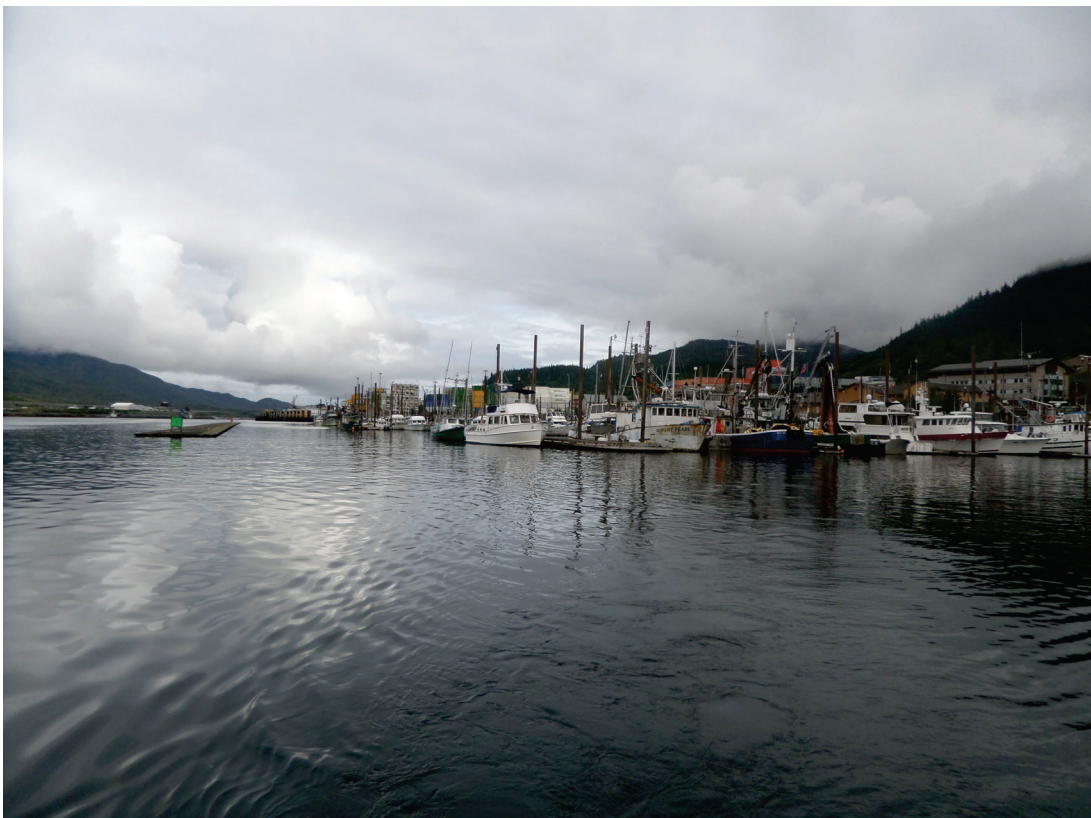
Looking Northwest across the expanded harbor, August 2015
