# **Shishmaref Coastal Erosion**

Condition of Improvements  
31 December 2022  
**Shishmaref Coastal Erosion, Alaska**  
(CWIS No. 086131, 086259, 180892)

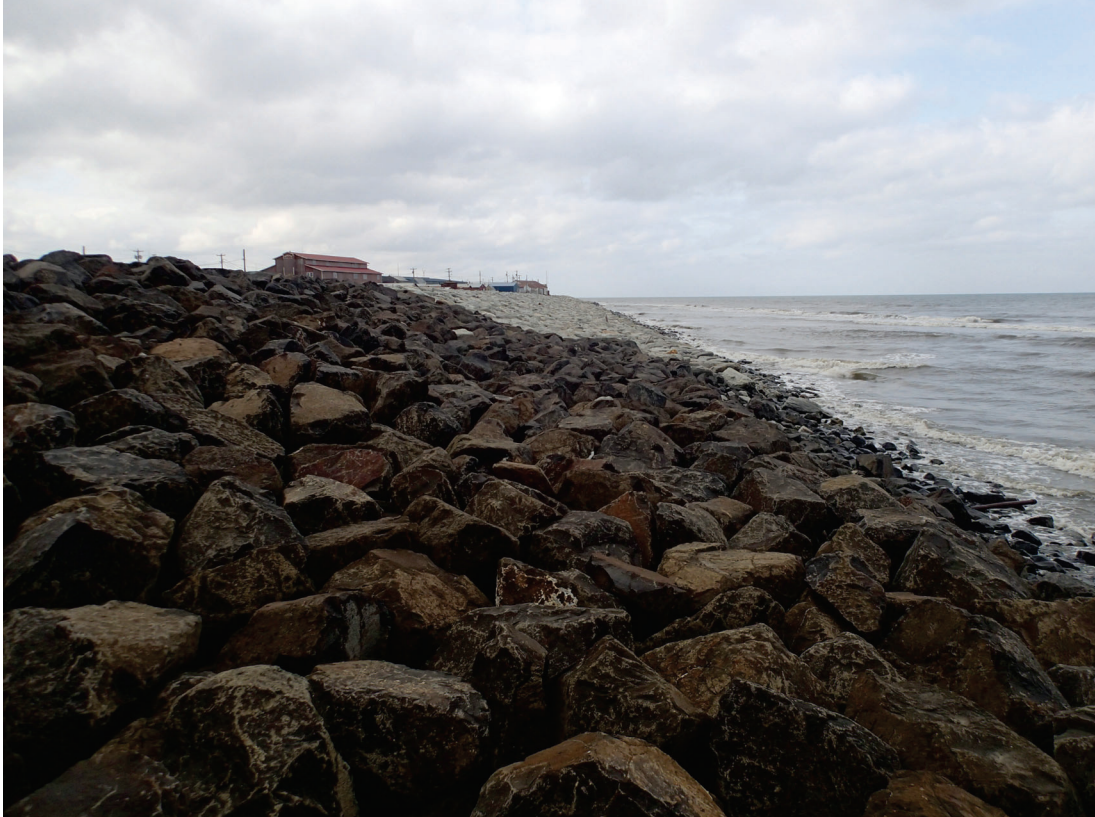
Rock revetment , July 2019

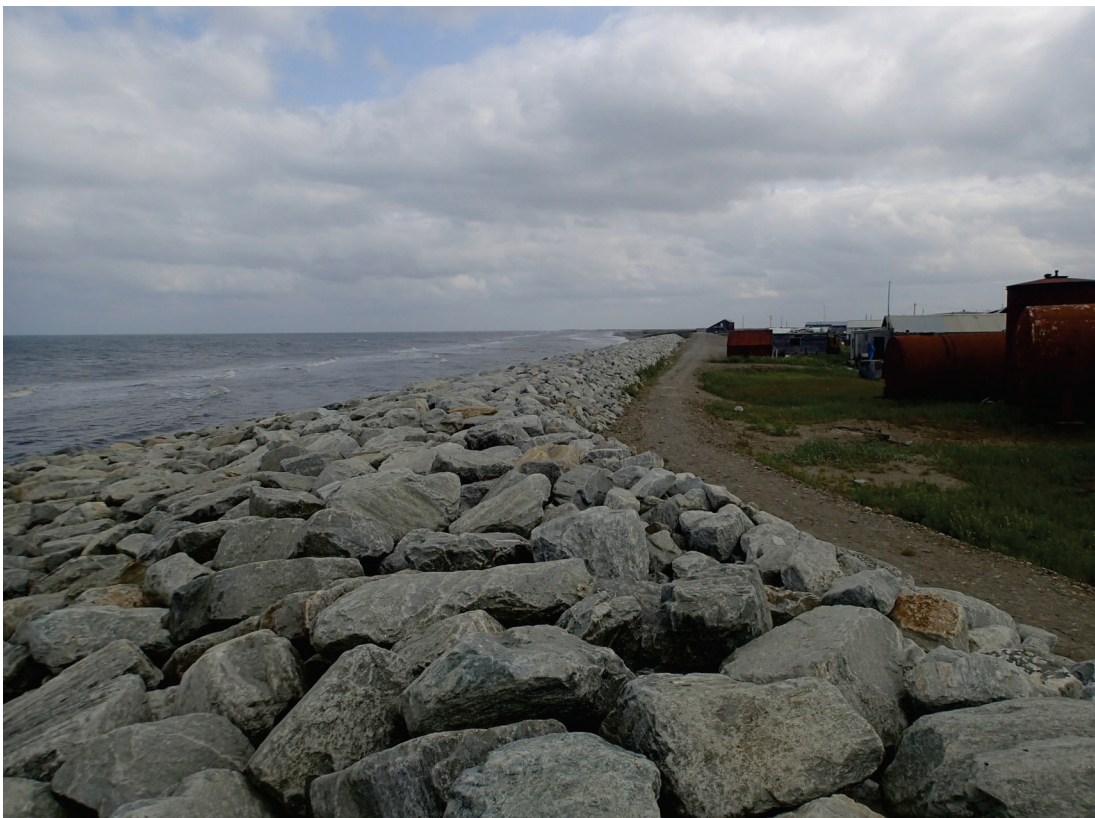
Rock revetment , July 2019
