Chignik Harbor

Condition of Improvements
31 December 2022
Chignik Harbor, Alaska
(CWIS No. 010375, 087214, 087394)

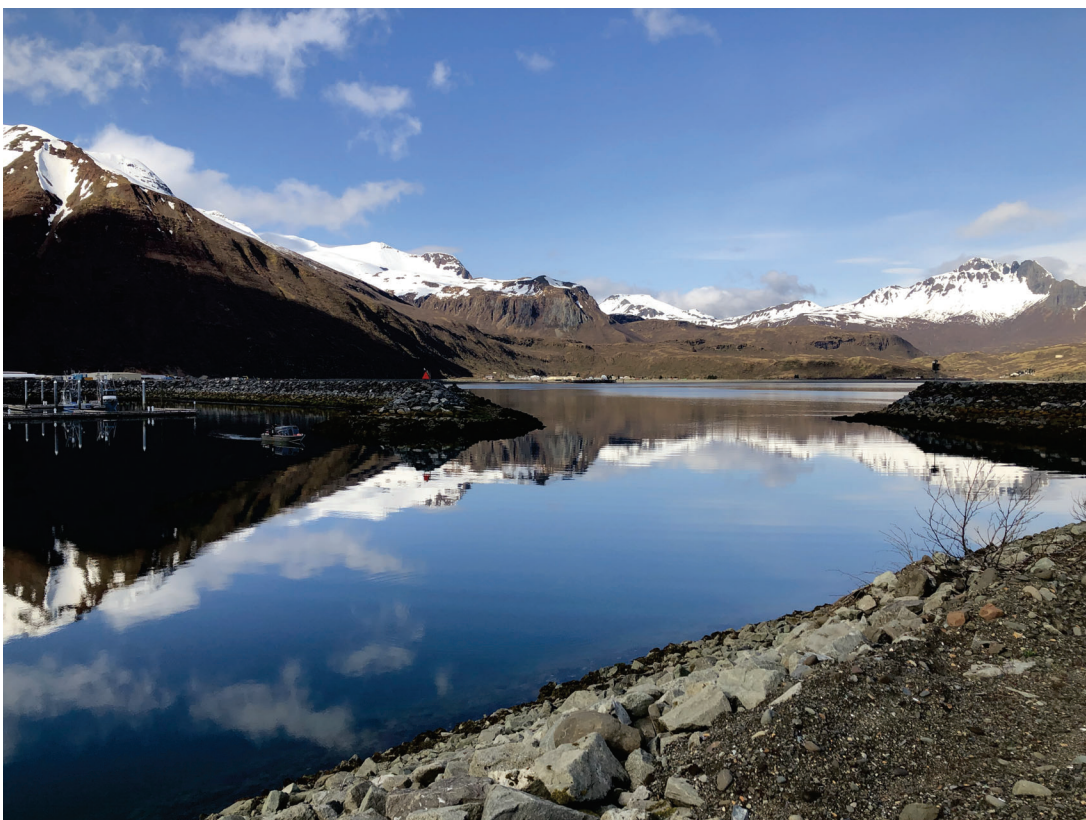
Controlling Depth Based on the May 2019 survey the majority of the entrance channel meets or exceeds project depth. The northwest boundary along the toe of the north breakwater has a shoal to -18.9 feet MLLW. In the inner part of the entrance channel, the controlling depth is -19.5 feet MLLW in the middle of the channel.

Chignik Harbor Entrance Channel, May 2019

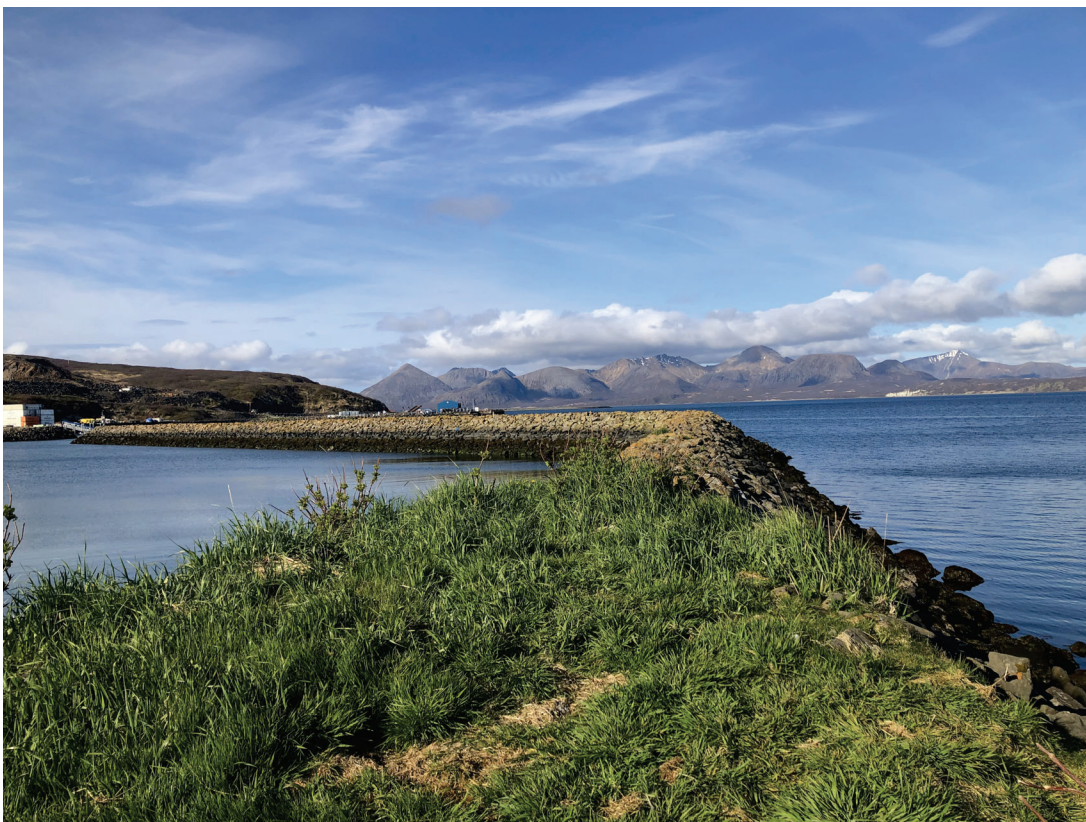
Chignik Breakwater May 2019
