Deering Streambank Protection

Condition of Improvements
31 December 2022
Deering Streambank Protection, Alaska
(CWIS No. 092906, 180355)

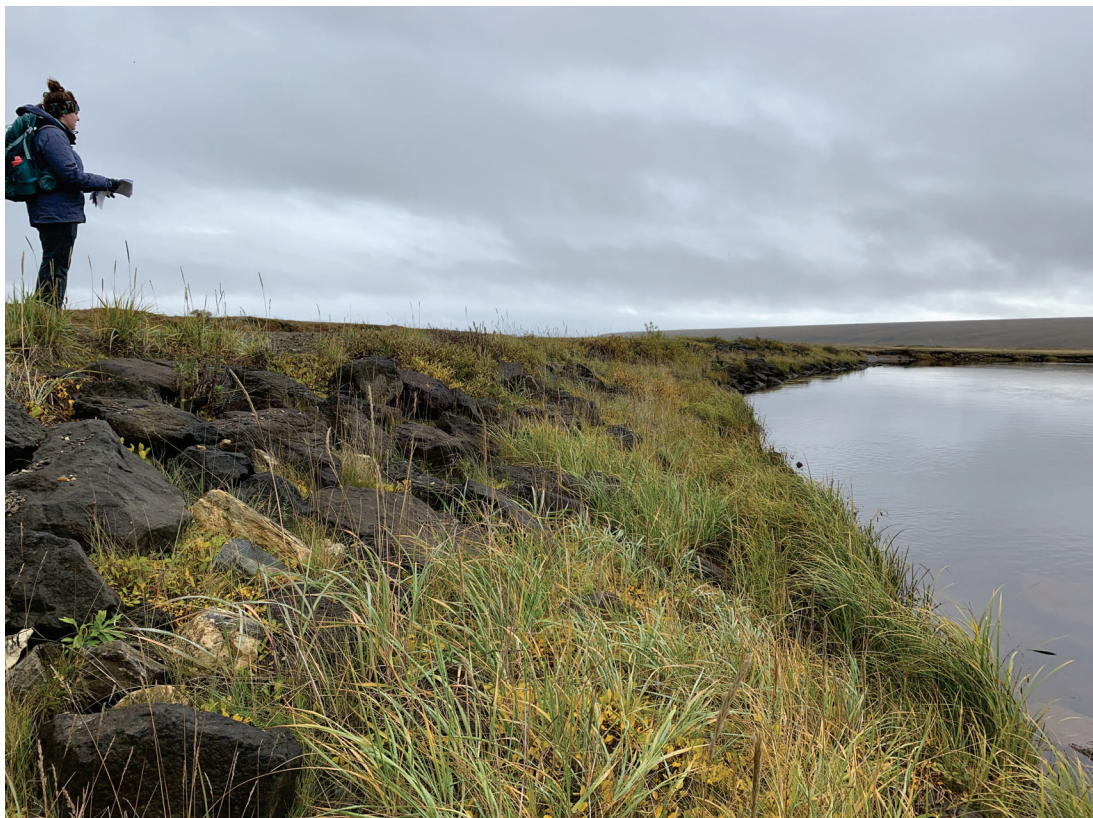
Looking downstream at the approximately 800-ft long revetment, September 2021

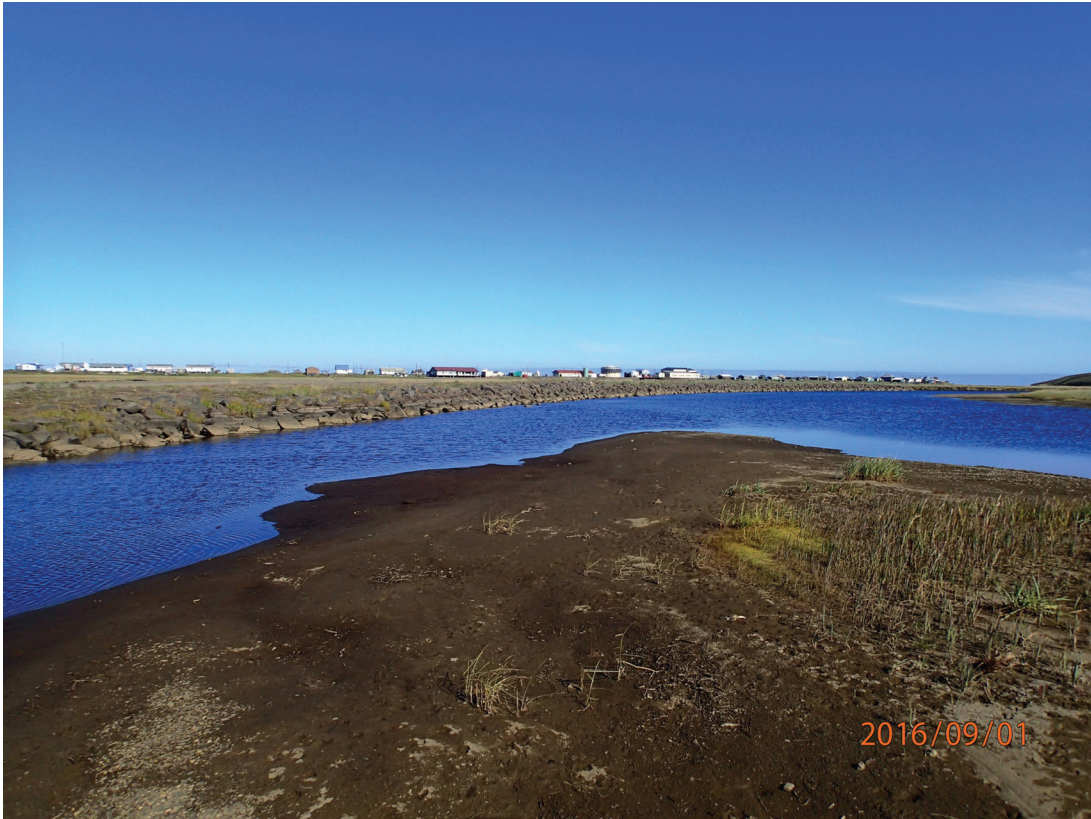
Looking at the revetment along the airport road, September 2016

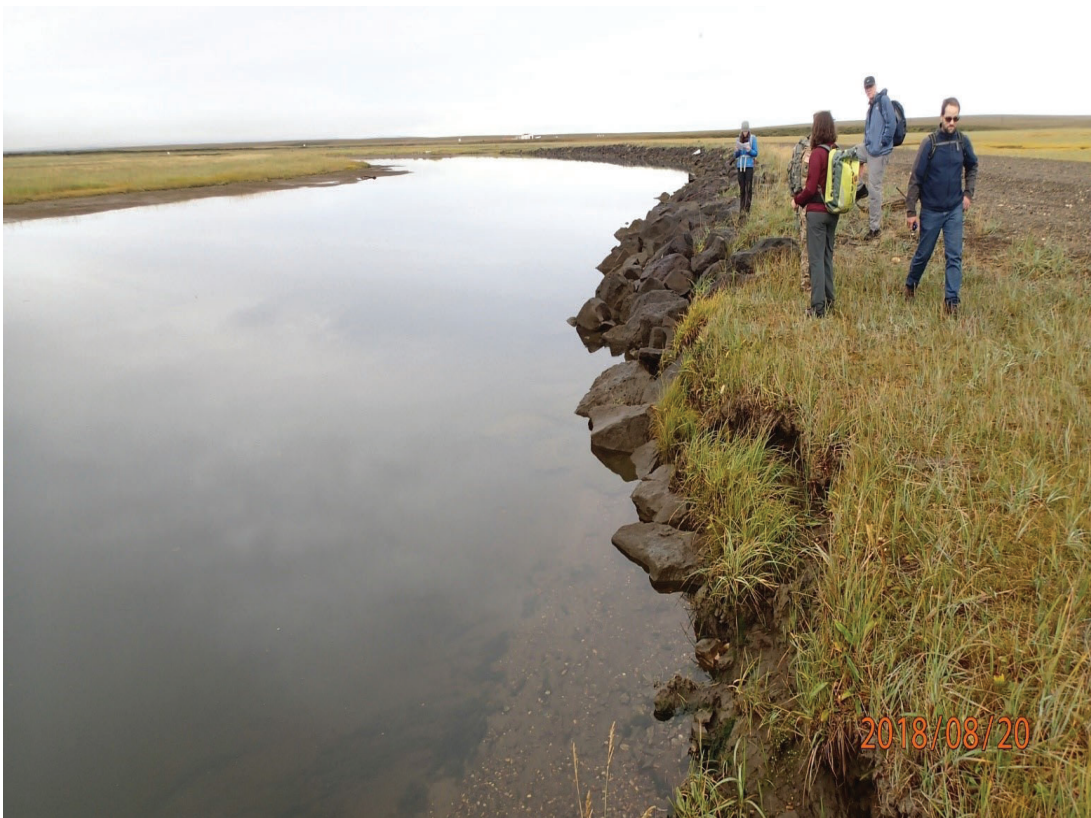
Revetment near the airport, August 2018
