**NUIQSUT REPAIR BRIDGE CROSSINGS**

**PROJECT ANALYSIS REPORT**

**CIP No. 68-041**

February 10, 2016

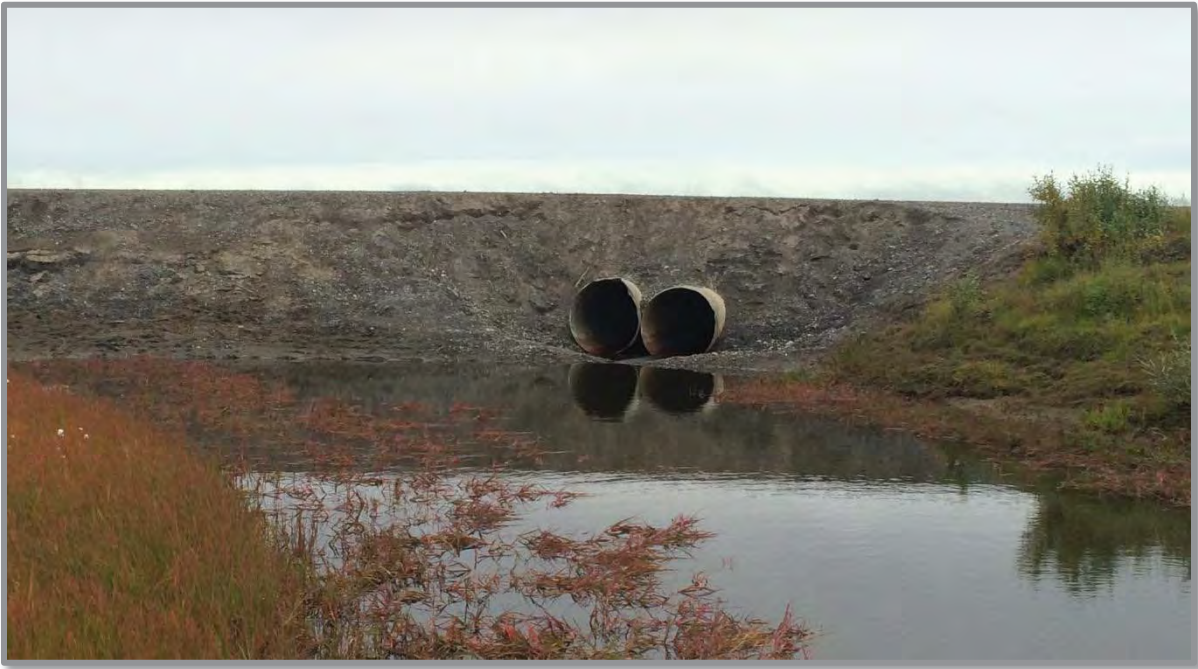
Figure 3: Site 1 Culverts

The Lower Stream Crossing at Site 1 is a culvert crossing constructed after the upstream bridge failed. See **Figure 3**. The road was rerouted and culverts were installed approximately 1,250 feet downstream from the bridge to provide access to the boat ramp and village material source stockpile. The temporary culvert crossing is two 48-inch corrugated metal pipes (CMP) 42-feet in length. These pipes sit atop another series of five to seven buried steel pipes that are estimated to range in sizes from 18-inch to 24-inch. A 16-foot wide gravel roadway crosses the

existing 48-inch diameter culverts. Due to the proximity of the lower stream crossing to the Nigliq Channel (approximately 300-feet) it is subjected to major damage during the spring breakup events and often times has to be reconstructed when the water levels recede.

Currently, it provides the only access to the community boat ramp and material source stockpile. This low profile road is approximately three feet above the surrounding terrain. This crossing is reported to fail almost every spring from overtopping, high flows and ice floes which erode the gravel embankment and scours around the culverts.

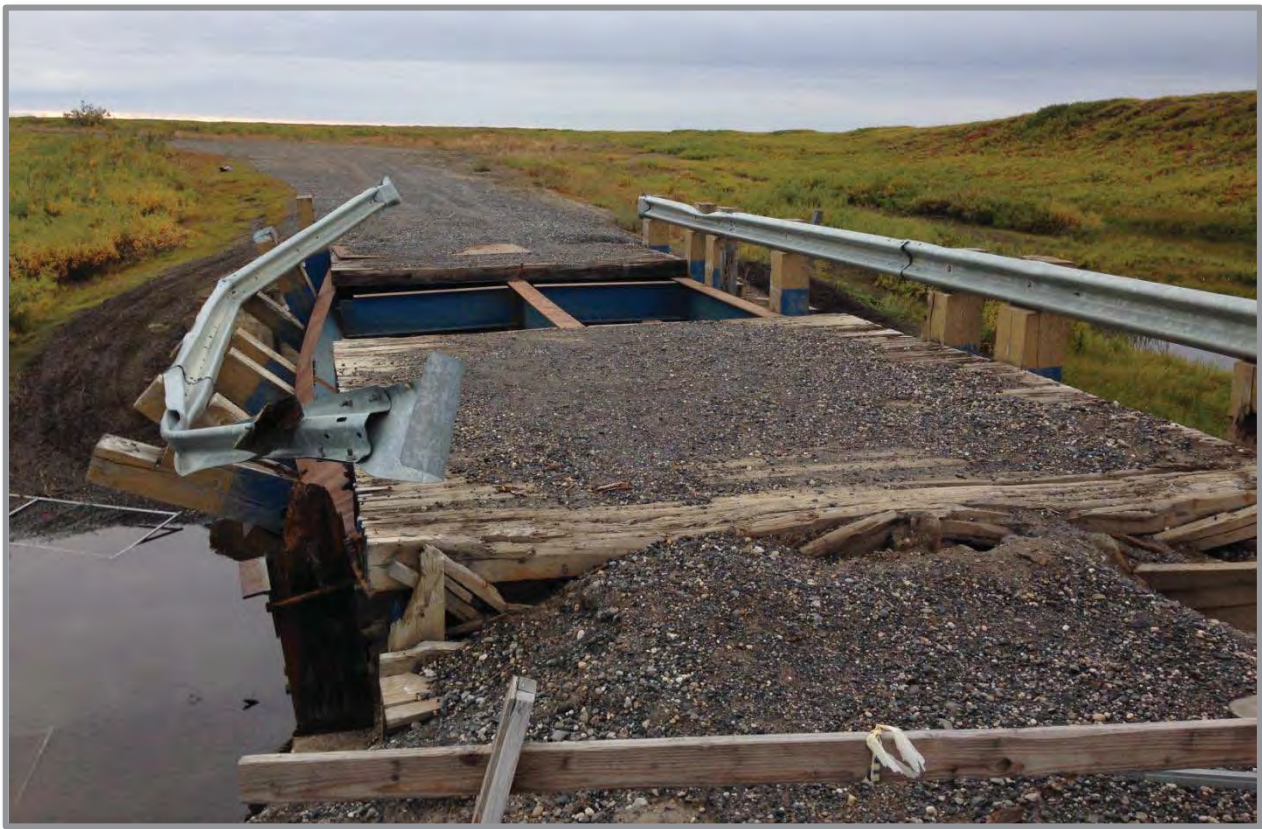
Figure 4: Failed Bridge at Site 2

The Upper Stream Crossing at Site 2 is a steel bridge constructed in 1974. This crossing originally provided the access to the old airport in the 1970s and then the village boat ramp and material source stockpile until its failure a few years ago. The bridge is a steel girder bridge supported by steel H-piles with abutments retained by timber lagging between piles. The bridge span length is 42 feet, measured from end of girder to end of girder. The bridge has a 14-foot wide overall deck width and decking consists of 2 x 8-inch treated timbers bolted together and attached to the steel girders. Railing consists of 12 x 12-inch timber posts and galvanized guardrail.

The decking, girders and guardrail have failed. See **Figure 4**. Physical evidence from debris lines indicate that the Colville River spring flood waters overtop the bridge and the bridge elements have failed from the hydraulic pressures and/or impacts from ice floes. The steel pile and timber abutments have survived 40 years with only minor damage and displacement. See **Figure 5**. Steel elements show heavy surficial rust.

Currently, half of the bridge decking is missing and a wooden barricade with a single warning sign is the only safety measure implemented. Leaving the site as-is is a potential hazard and liability for the Borough and therefore this alternative is not recommended. The bridge and abutments should be removed and the slopes graded to match the existing contours.

The existing bridge should be removed and all salvageable materials shall be delivered to the Borough. The existing piles may be able to be pulled, salvaged, and returned to the City; otherwise, the piling should be cut two feet below grade. In late fall, the sheet pile walls should be installed when the active layer is at its maximum depth. These walls are to be driven through the active layer and to refusal in the permafrost layer below. The sheet pile walls should be left high, about to the spring line of the culverts. Under frozen ground conditions, the Contractor would excavate and install a layer of rigid insulation and install approximately 4-feet of sacrificial fill material to protect the crossing during spring runoff and breakup. After breakup, culverts would be installed and remaining thawed fill placed and compacted under low flow conditions. The sheet piles would be trimmed and attached to culverts using a double rolled angle. Fill slopes should be armored with Class II riprap 32-inches deep over a geotextile fabric with keyed edges. The culvert inlets would be armored with a riprap apron.

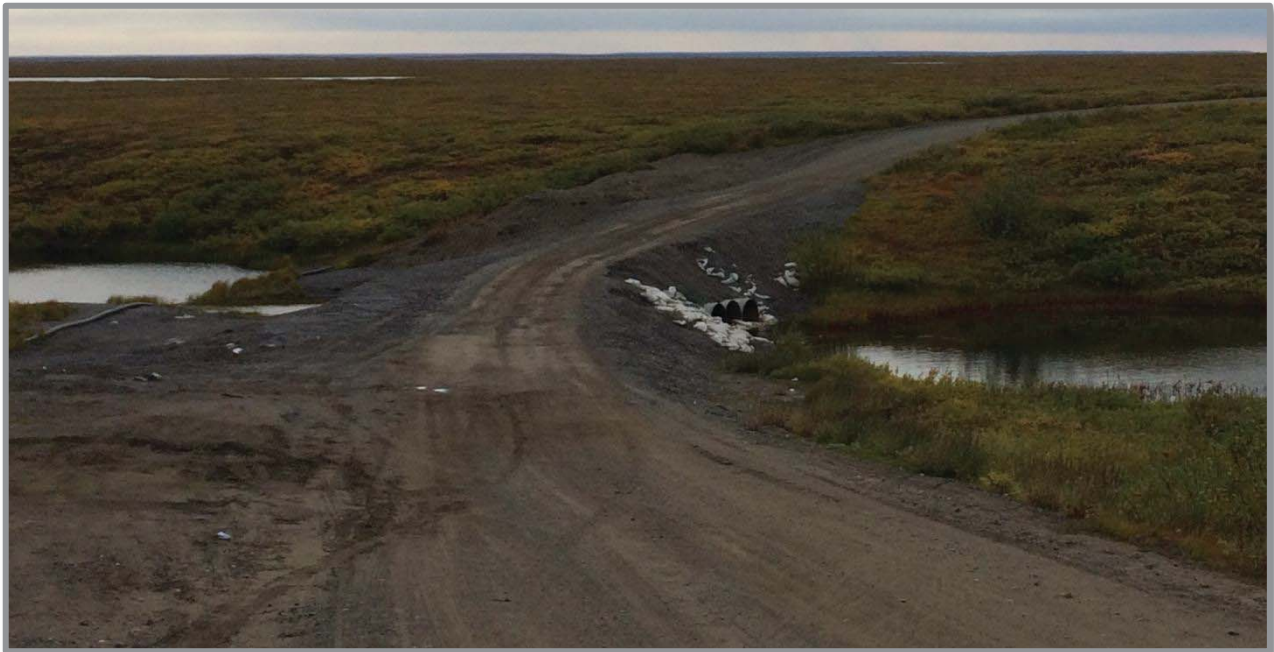
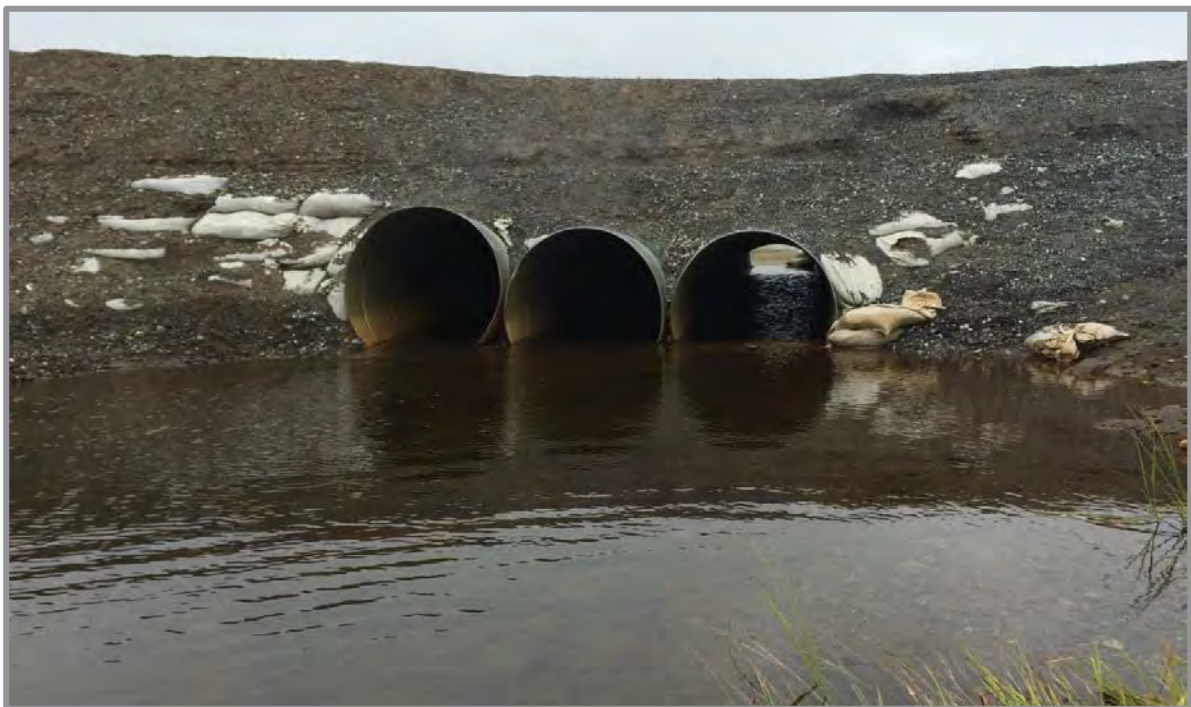
The crossing consists of three 48-inch diameter by 40-foot long galvanized corrugated steel culverts. See **Figures 6 and 7**. Physical evidence of a debris line and anecdotal information indicate the roadway overtops yearly at spring breakup. To help protect the structure, the Borough has armored the inlets and outlets with sandbags. According to the Public Works Supervisor for Nuiqsut, the addition of sandbags has greatly extended the life of the structure. The condition of the sandbags is fair. The sandbags are easily accessible to vandalism. This crossing requires minimal maintenance and reconstruction after spring breakup, according to local public works staff.

The crossing appears to be in the floodplain of the Colville River, but primarily drains snowmelt in a basin defined later in this report south and west of Nuiqsut. The overtopping is likely caused by high spring breakup flows and undersized culverts.

Figure 6: Site 3 Crossing Looking South

Figure 7: Site 3 Culverts - Downstream Face

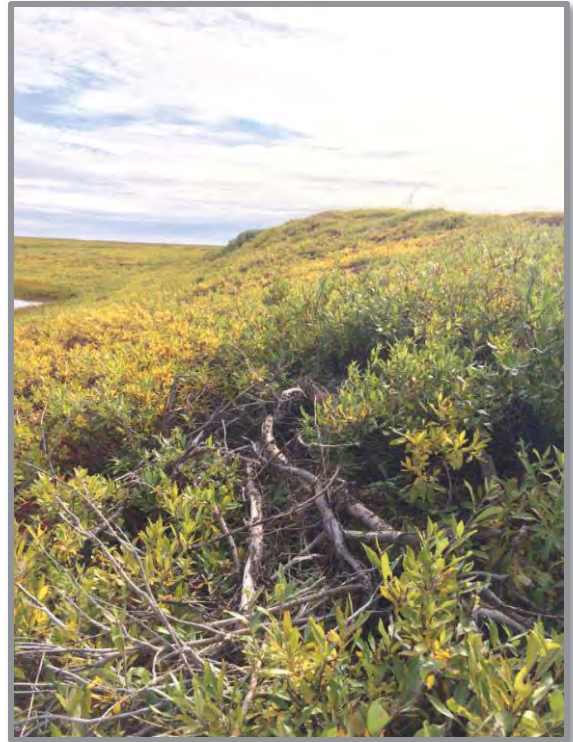
Figure 8: Upper Stream Crossing (Site 2), High Water Debris Line

for evidence of past high water events, such as woody debris deposited at a consistent elevation. See **Figure 8**. We found two locations with evidence of debris

from high water events. We estimated that the lower of the two debris lines represented a normal high water event due to the large amount of debris in the area. The relative elevation of this debris line was approximately 2-feet higher than the centerline of the bridge deck. We estimated the higher of the debris lines represented an extreme high water event. This debris line was measured to be approximately 8.5-feet higher than the bridge deck.
