## Gold Creek

**Condition of Improvements**  
**31 December 2022**  
**Gold Creek, Alaska**  
**(CWIS No. 006630, 150225)**

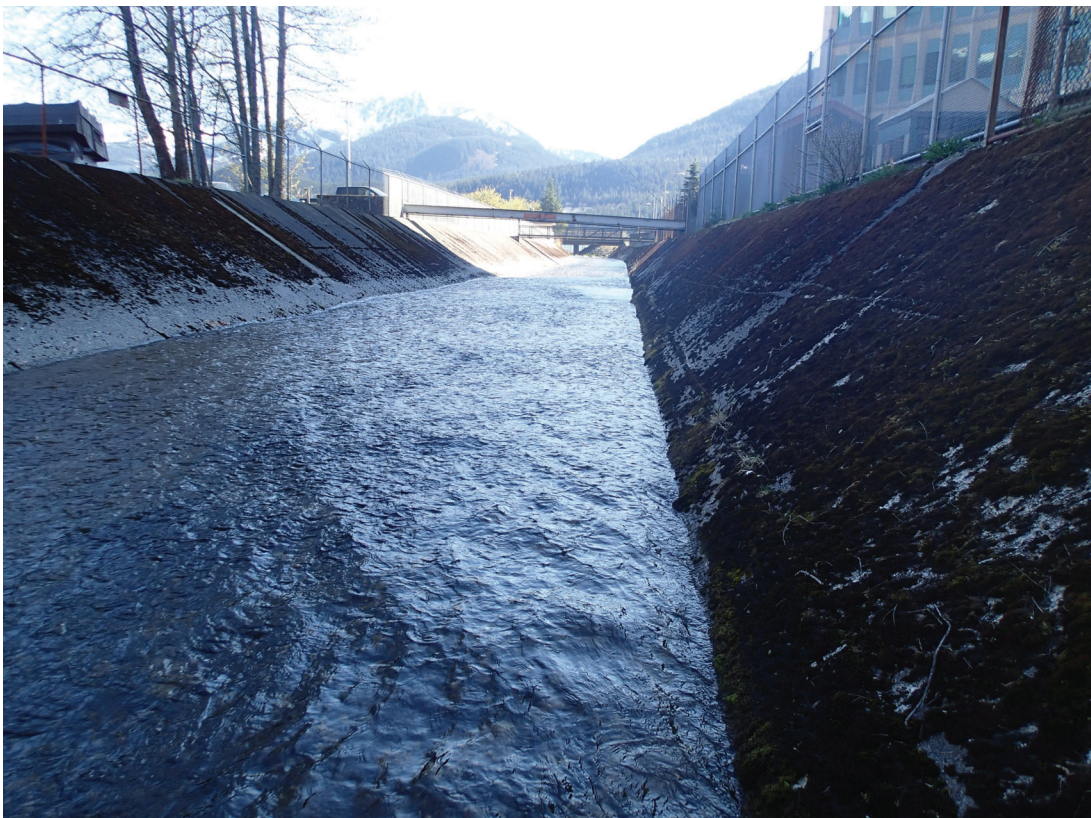
Concrete channel downstream from 9th Street, April 2019

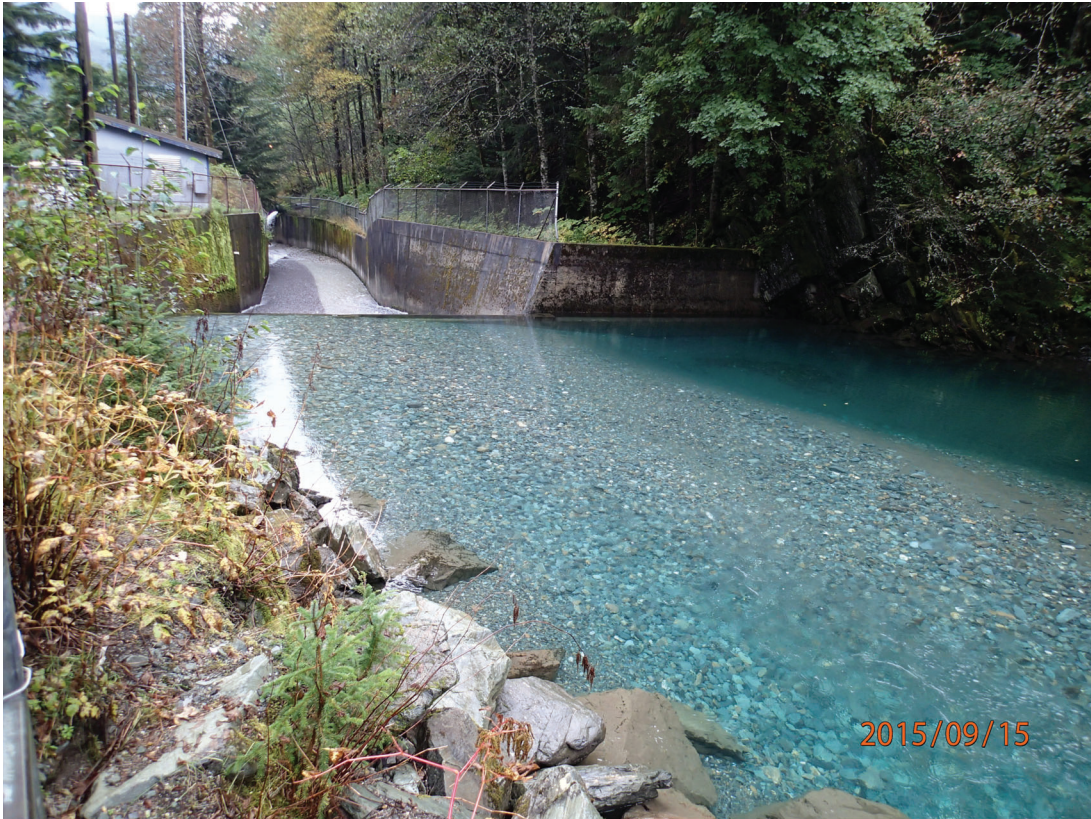
Weir and debris basin at upstream end of channel, September 2015

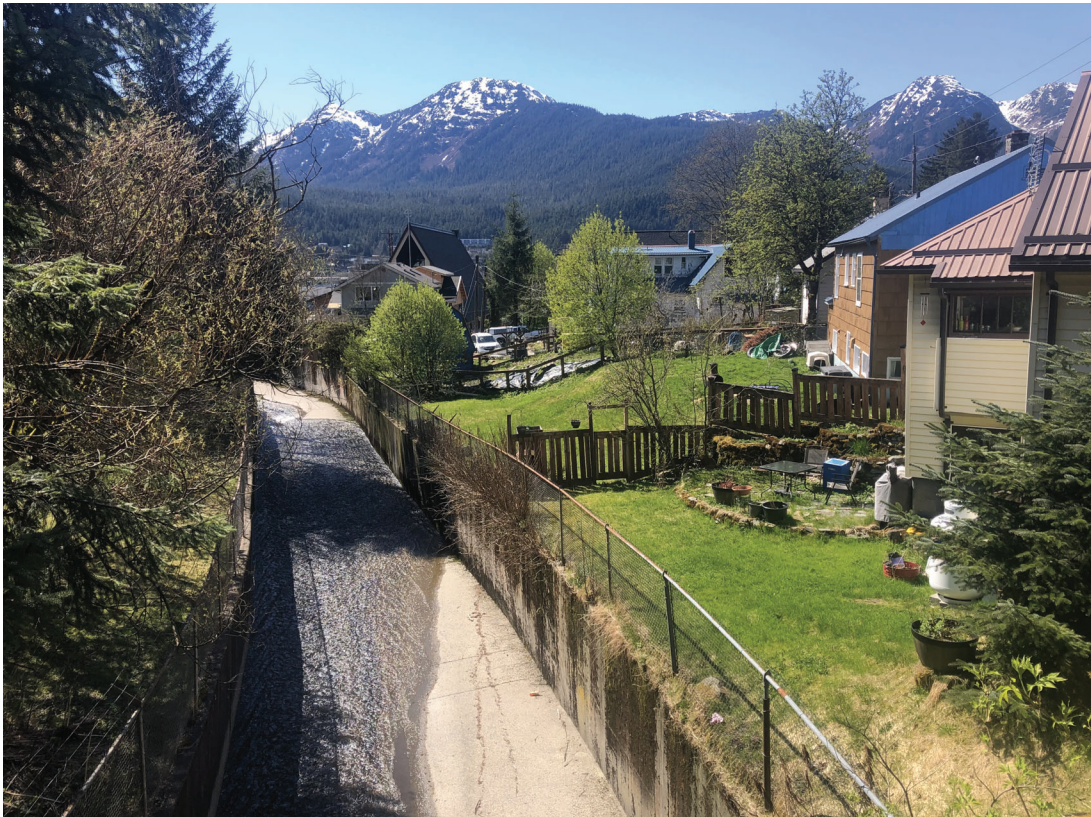
Concrete channel from Irwin Street, April 2019
