Emmonak Streambank Protection

Condition of Improvements
31 December 2022
Emmonak Streambank Protection, Alaska
(CWIS No. 092872, 325884)

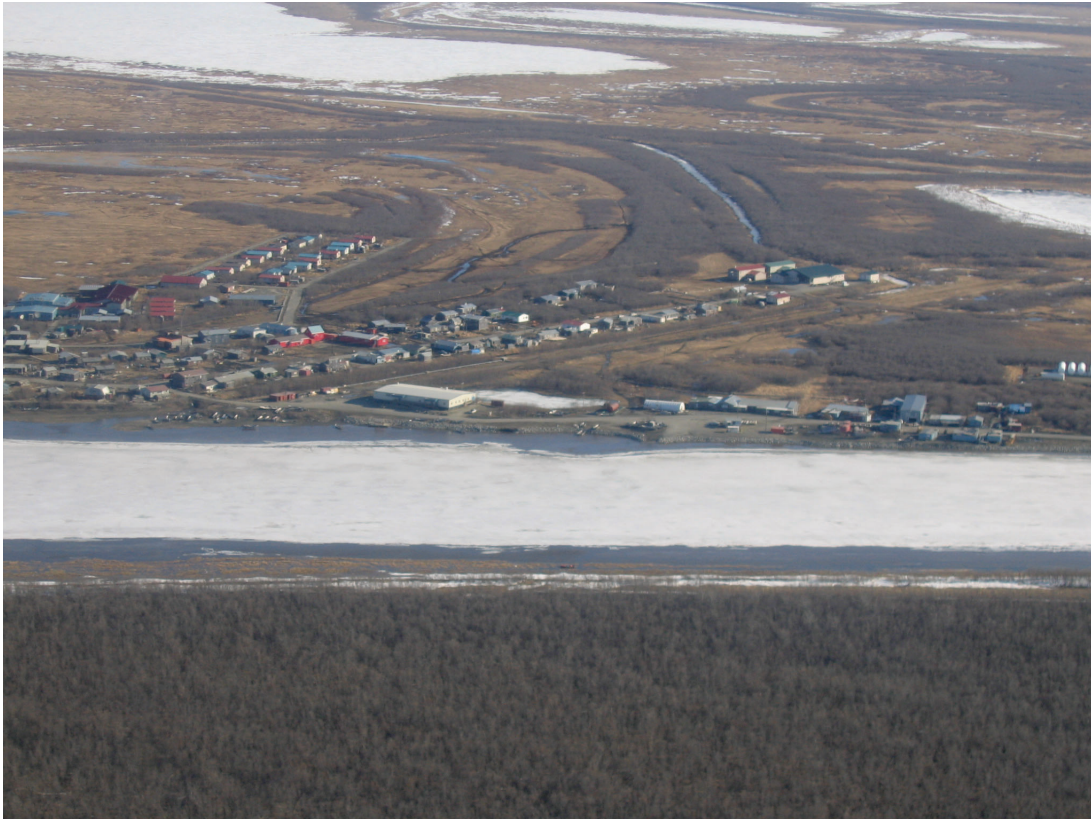
Oblique of the Emmonak streambank protection, May 2007

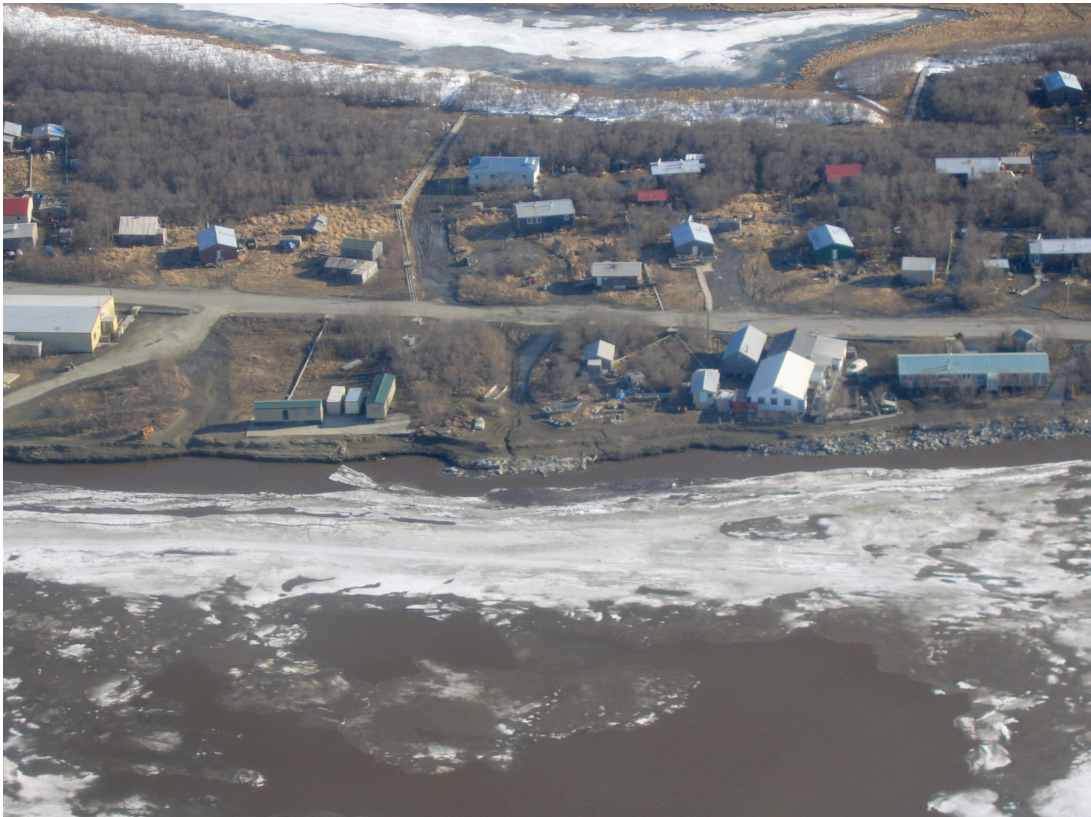
Oblique of the Emmonak streambank protection, May 2007

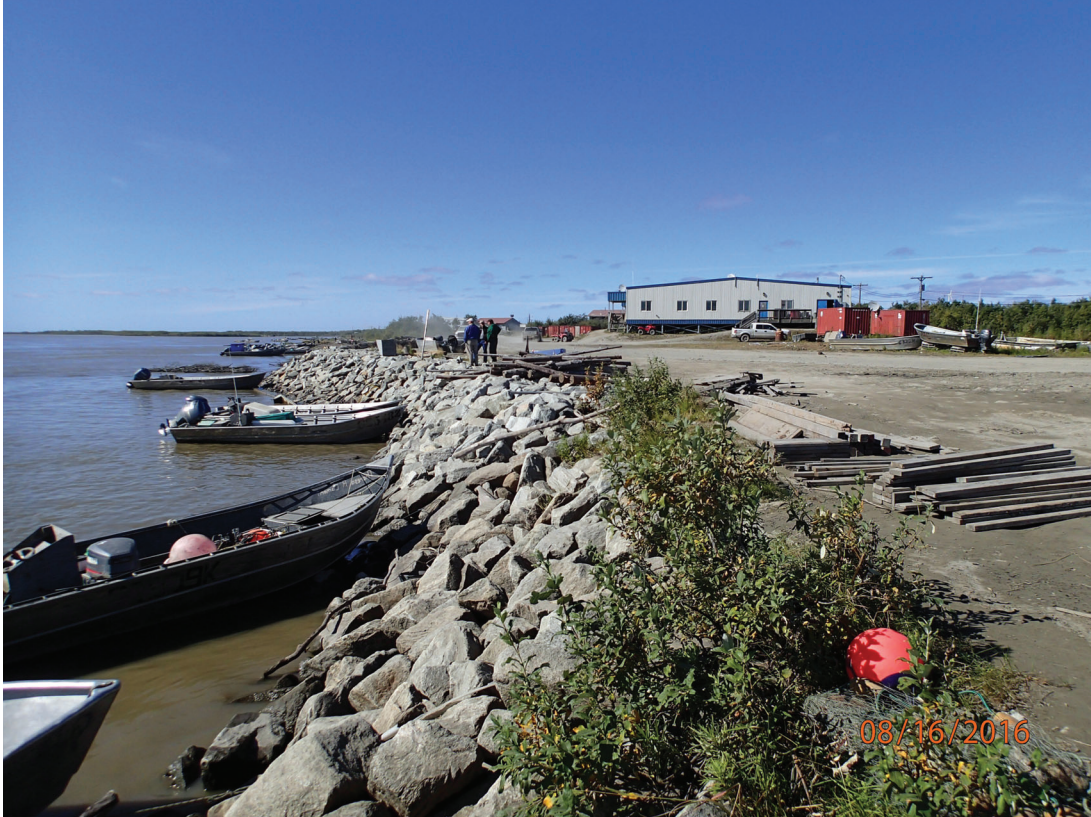
Emmonak revetment downstream of fish processor, August 2016

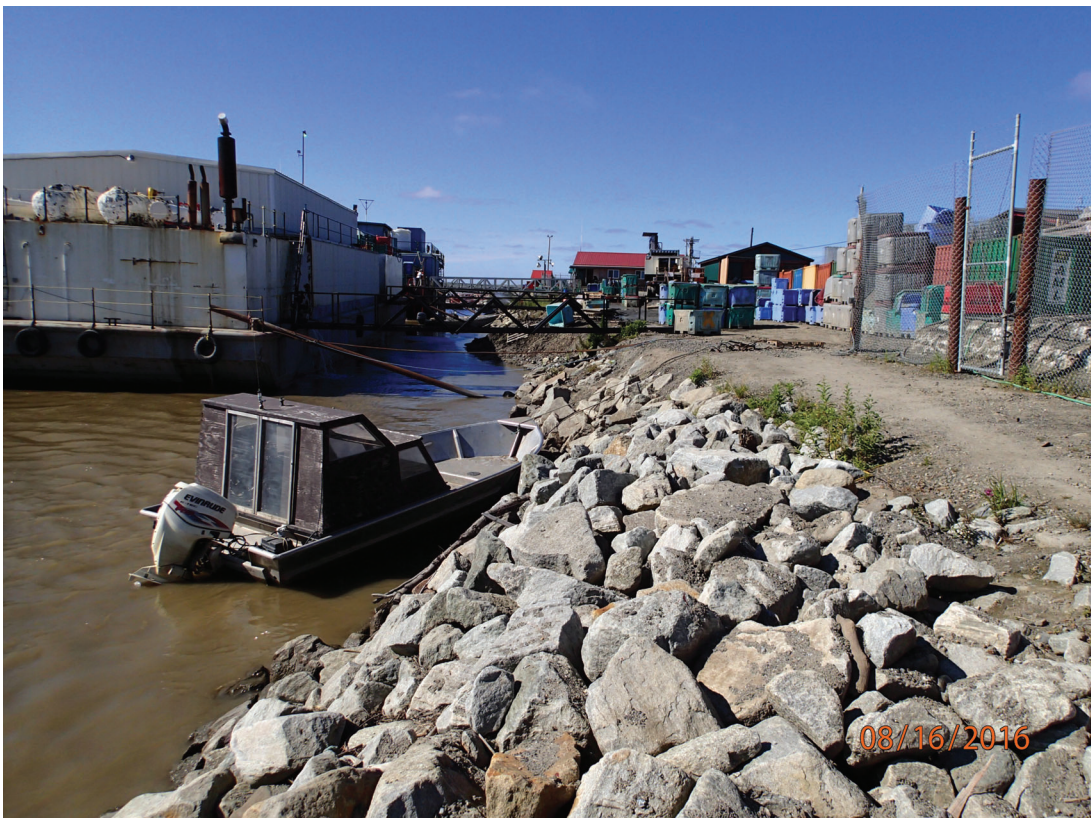
Emmonak revetment near fish processor, August 2016

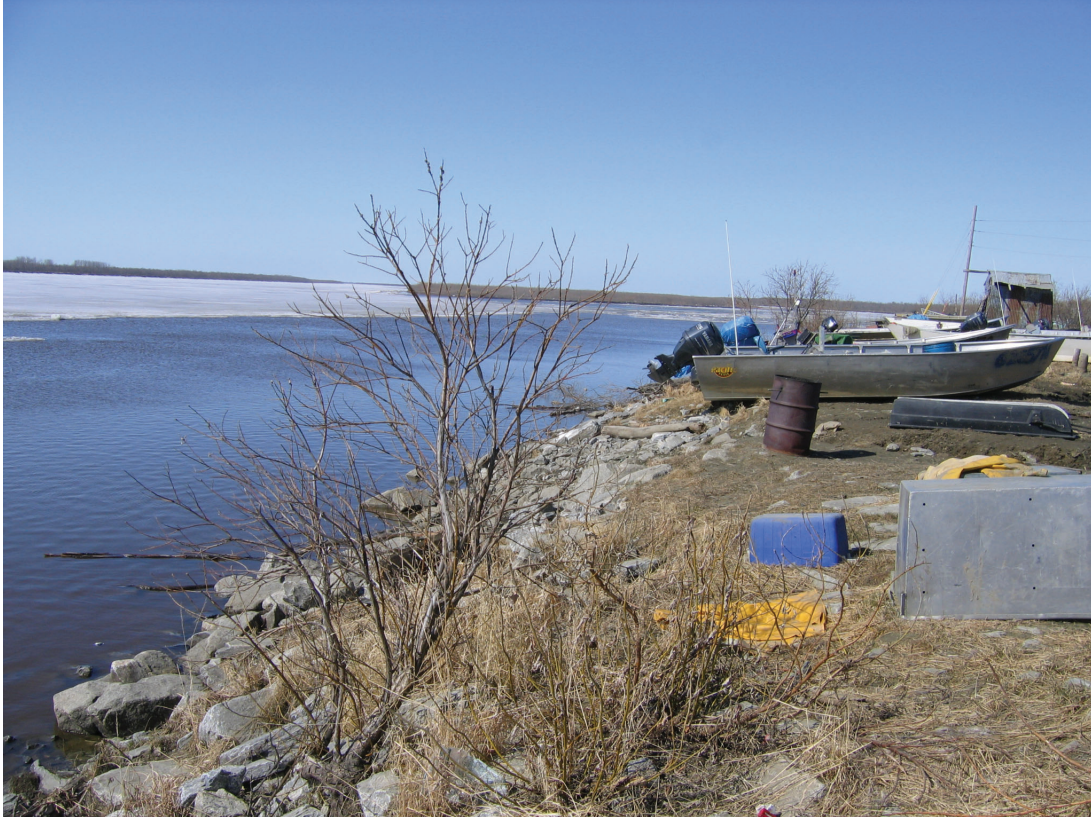
Emmonak streambank protection, 16 May 2007

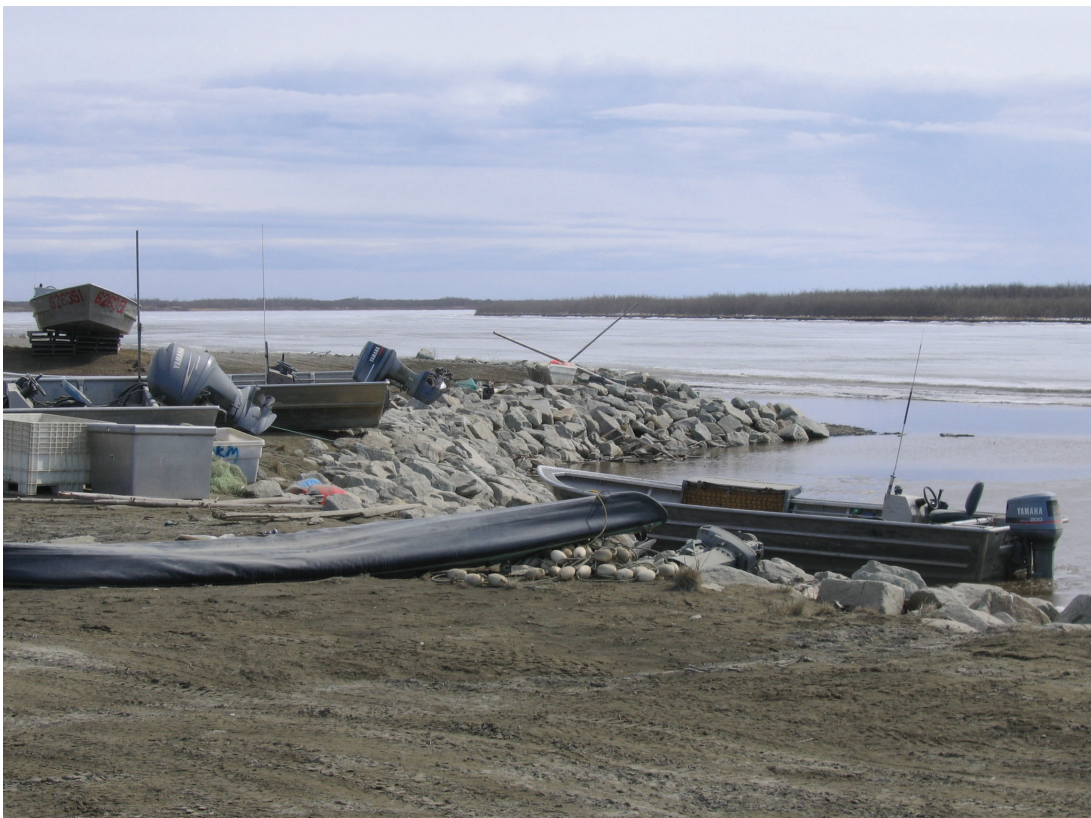
Emmonak streambank protection, 16 May 2007
