# Talkeetna River

# Condition of Improvements

## 31 December 2022

### Talkeetna River, Alaska

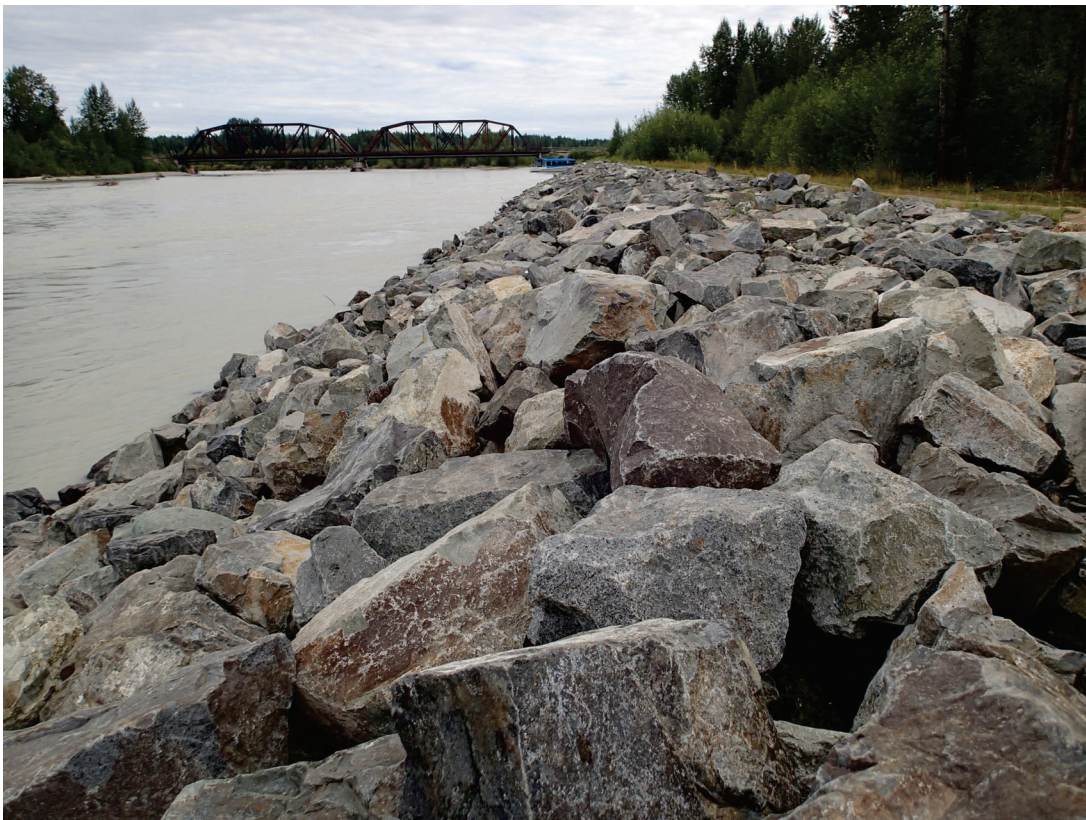
Upstream view of the rock revetment and the railroad bridge, August 2019

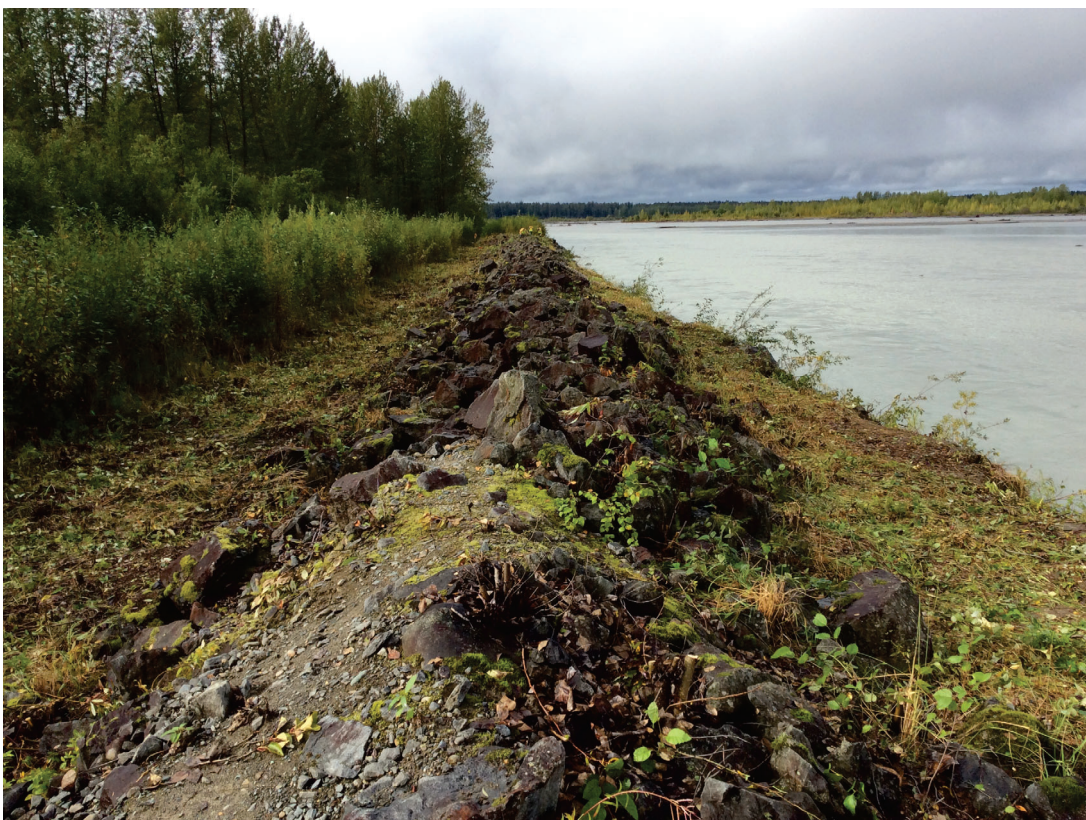
2013	Inspection performed in July notes heavy vegetation growth and damage to facine pilings.
2014	Inspection performed in August notes vegetation removal in progress and active erosion along the entire length of the dike. Armor stone repairs with a weighted toe were recommended.
2017	Inspection performed in September notes no significant change from the previous inspection of dike and revetment. Community repaired dike extension to original extents using the original rock specifications.
2018	Inspection performed in June notes active erosion at end of dike extension repair and scalloping of dike extension at water line. No significant changes in dike and revetment from previous inspection.
2019	Inspection performed in August notes movement of armor rock along dike due to boats tying up along dike to bolted D-rings into armor rock, increased erosion at the end of the dike extension repair, and erosion at the toe of the revetment bend. Vegetation had been removed from the crest of the revetment. It was recommended that boat moorage be prohibited along the dike and armor stone repairs performed.

Downstream view of the rock revetment, October 2014
