Salmon River

Condition of Improvements
31 December 2022
Salmon River, Hyder, Alaska
(CWIS No. 072857)

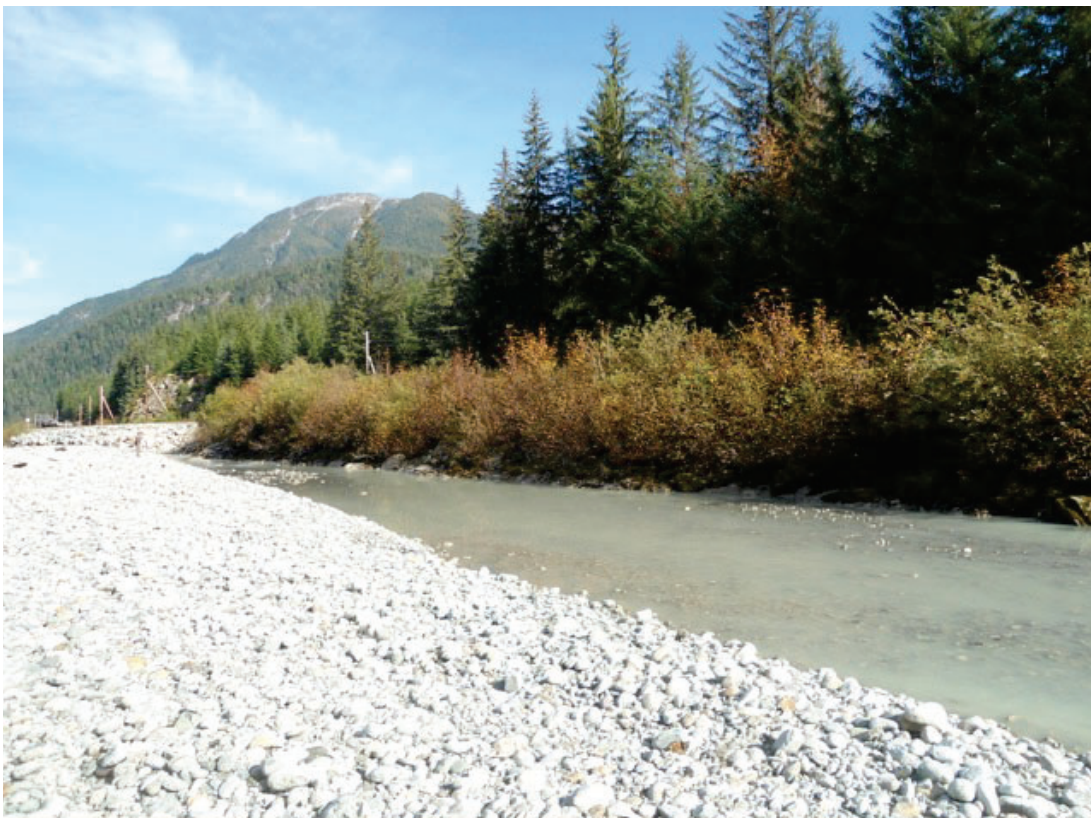
Salmon River Dike , September 2014

2014	The dike was inspected in September and found to be in "poor" condition.
2018	A periodic inspection found the levee to be in an unacceptable condition, primarily due to erosion of riprap revetments and unwanted vegetation on the levee embankment slopes and crown. The extent of vegetation limited the inspection team's ability to identify and assess issues with the levee. The team recommended clearing vegetation in accordance with EM 1110-2-301.
