Dillingham Bank Stabilization

Condition of Improvements

31 December 2022

(CWIS No. 075441)

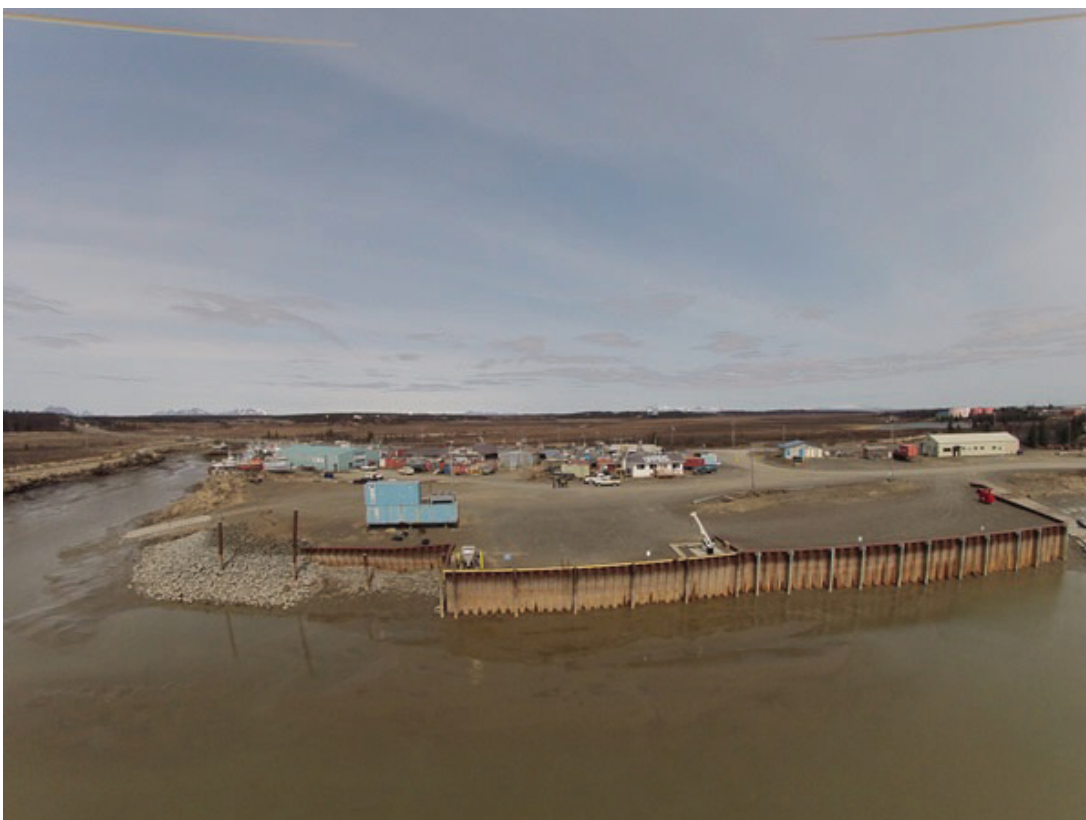
Riprap and sheetpile protection on the east side of the entrance channel, May 2014

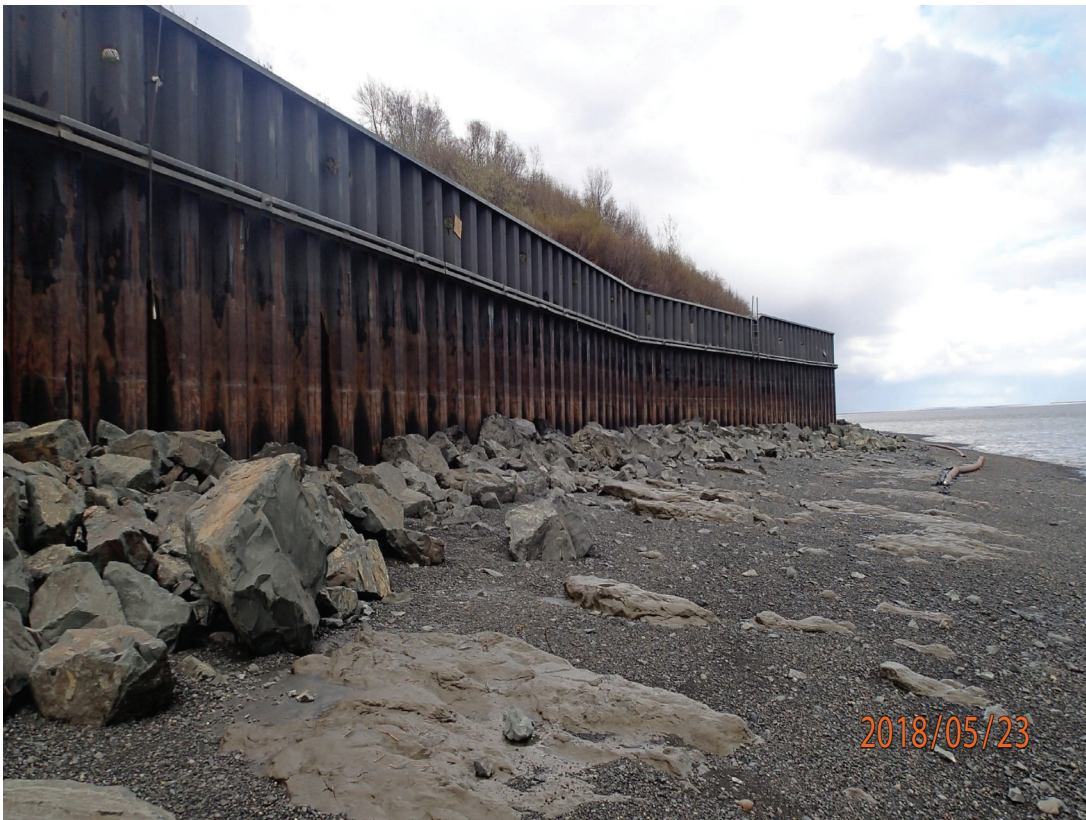
H-pile supported sheetpile bulkhead, May 2018

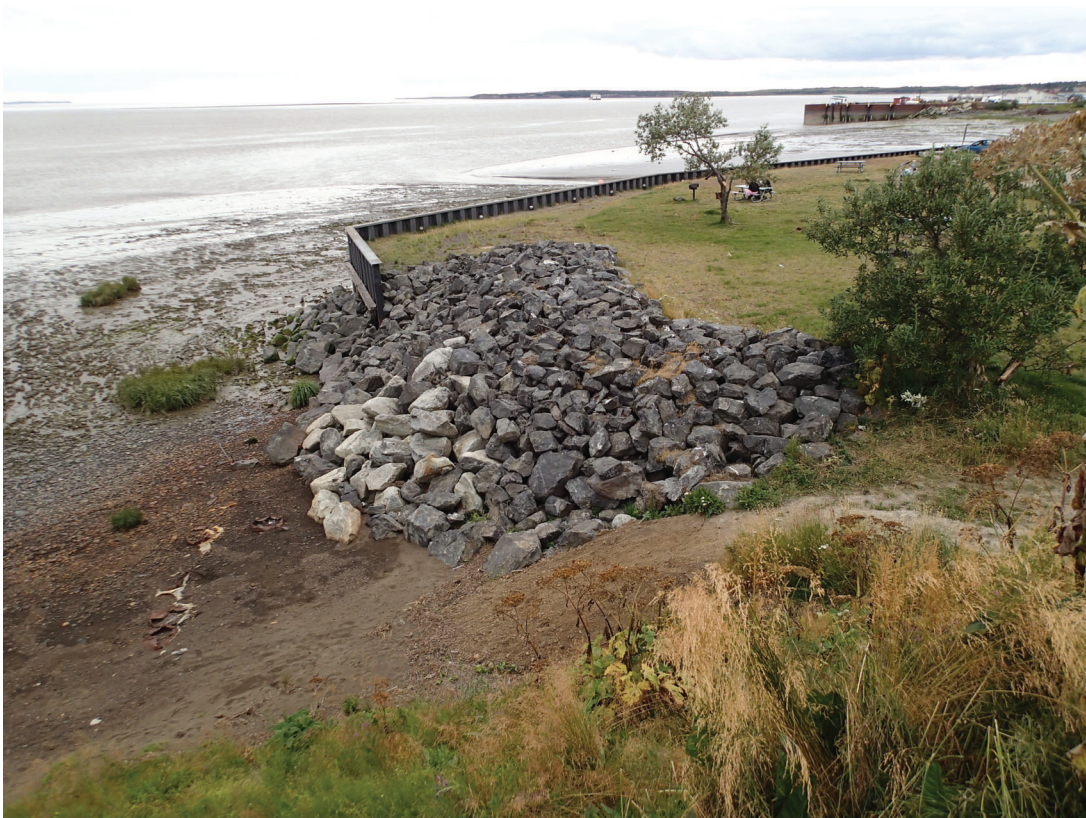
Rip-rap protection at the eastern extent of bank stabilization, August 2019
