Klutina River

Condition of Improvements
31 December 2022
Klutina River at Copper Center, Alaska
(CWIS No. 003830)

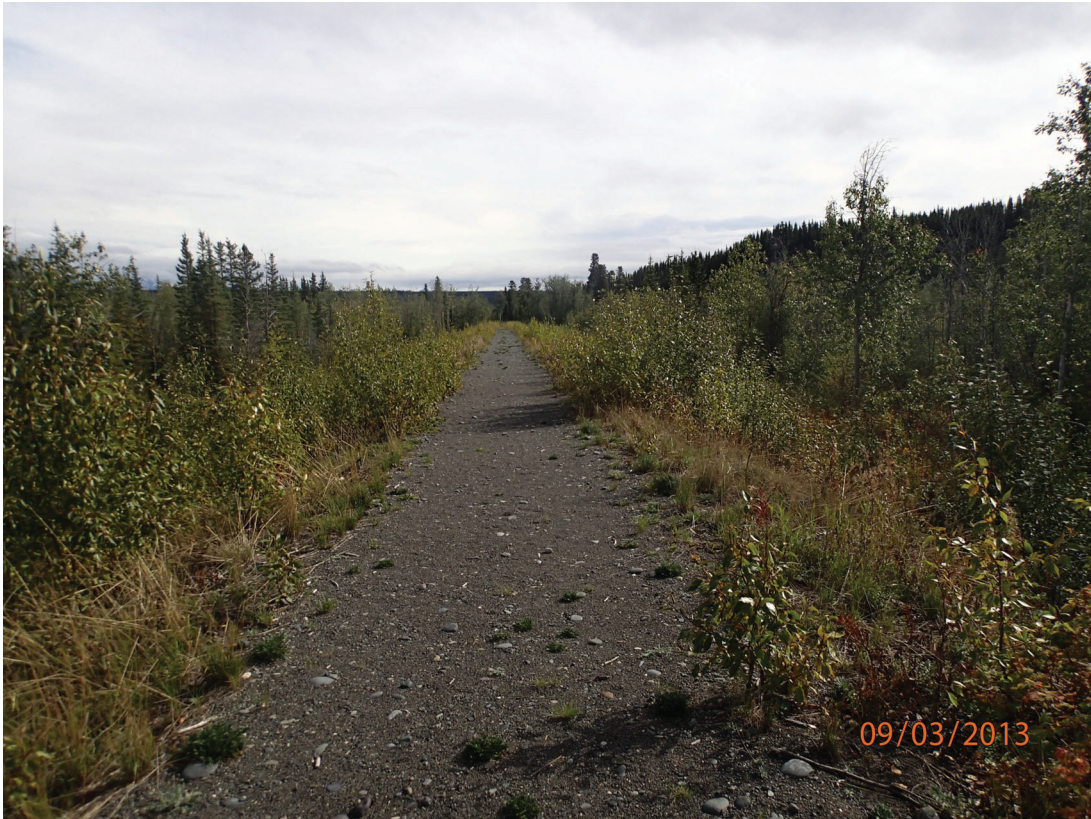
Klutina River Levee, September 2013

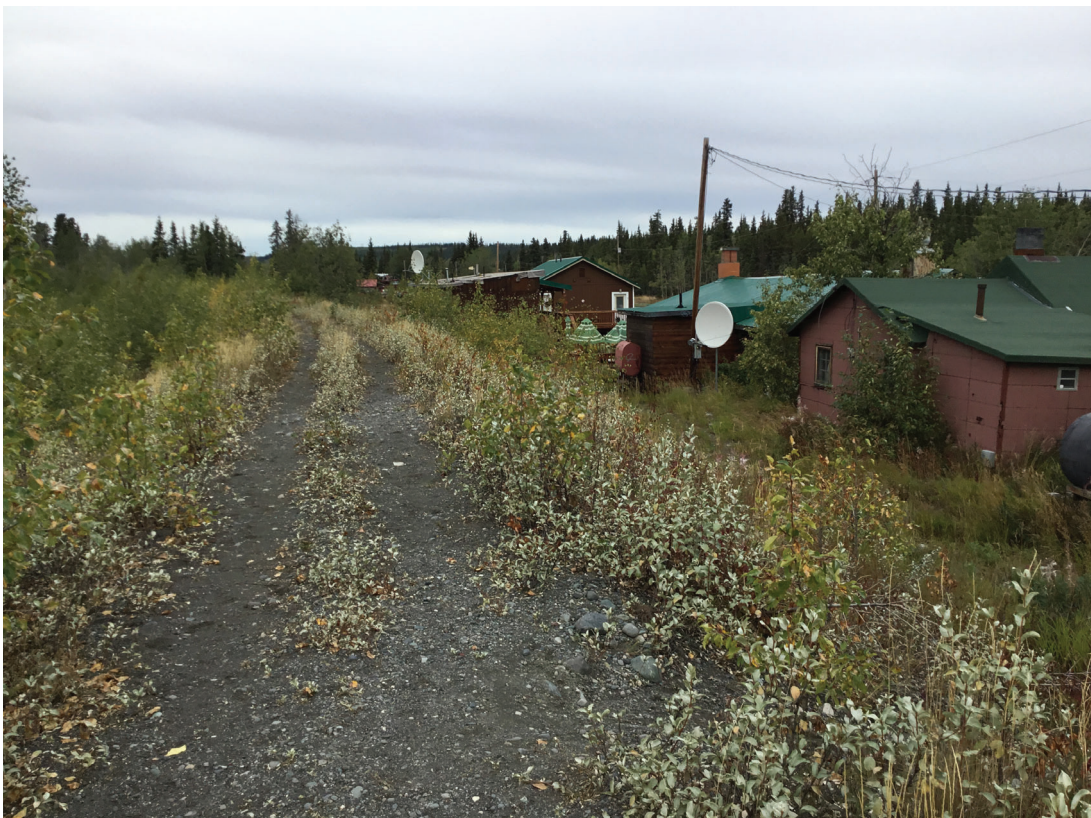
Encroachments within the levee footprint, August 2017
