Metlakatla Erosion Protection

Condition of Improvements
31 December 2022
Metlakatla Erosion Protection, Alaska
Cemetery and Fuel Tank Facility
(CWIS No. 092796, 092830)

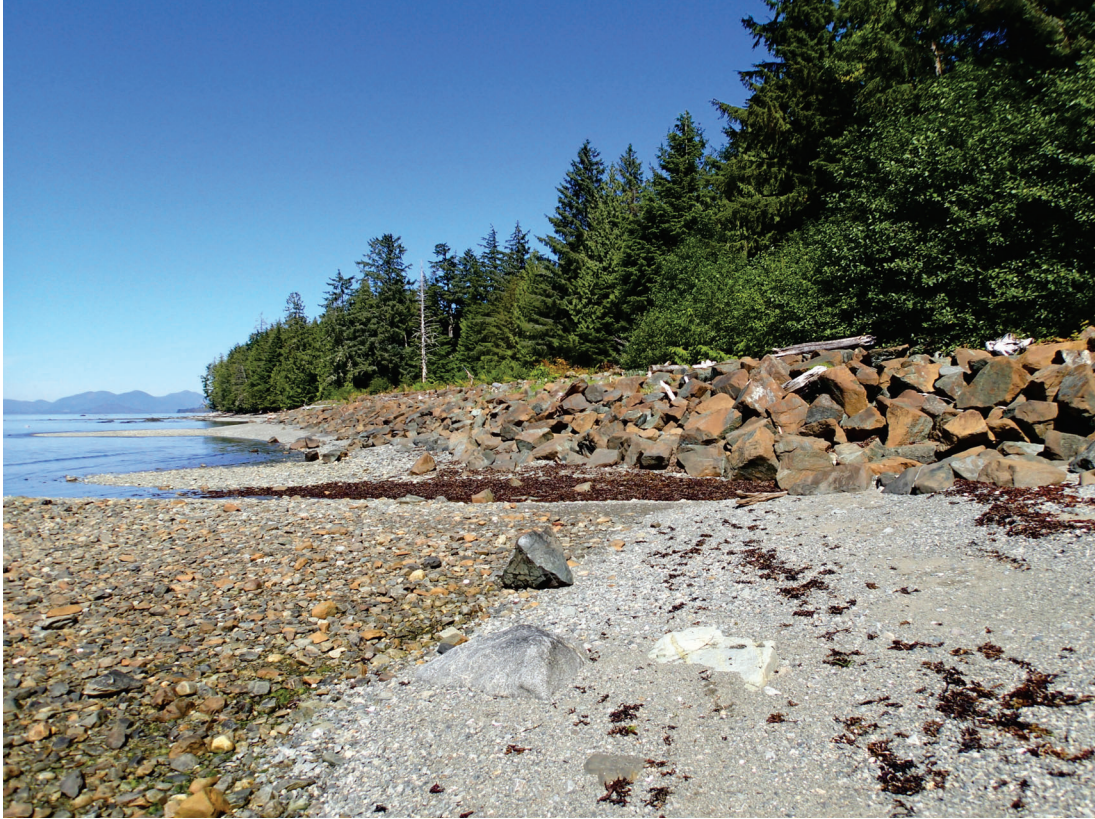
The cemetery rock revetment , August 2017

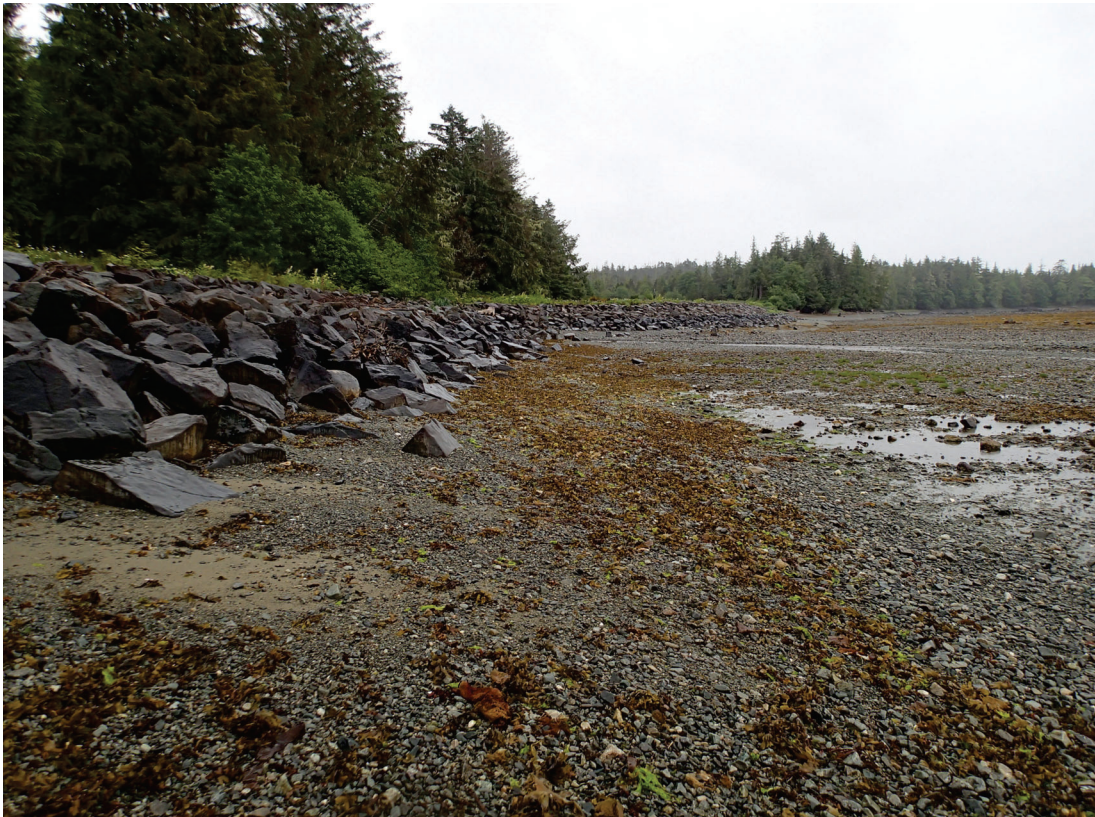
The cemetery rock revetment , June 2019

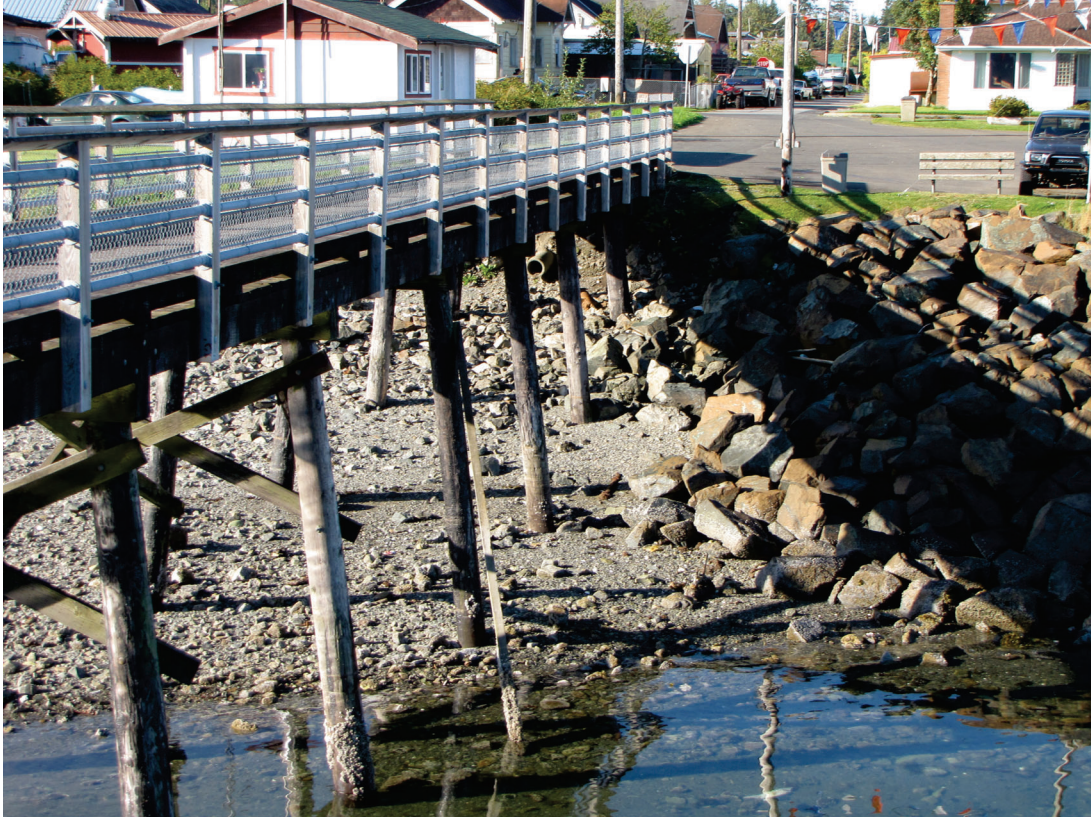
The east extent of the tank farm rock revetment , September 2010

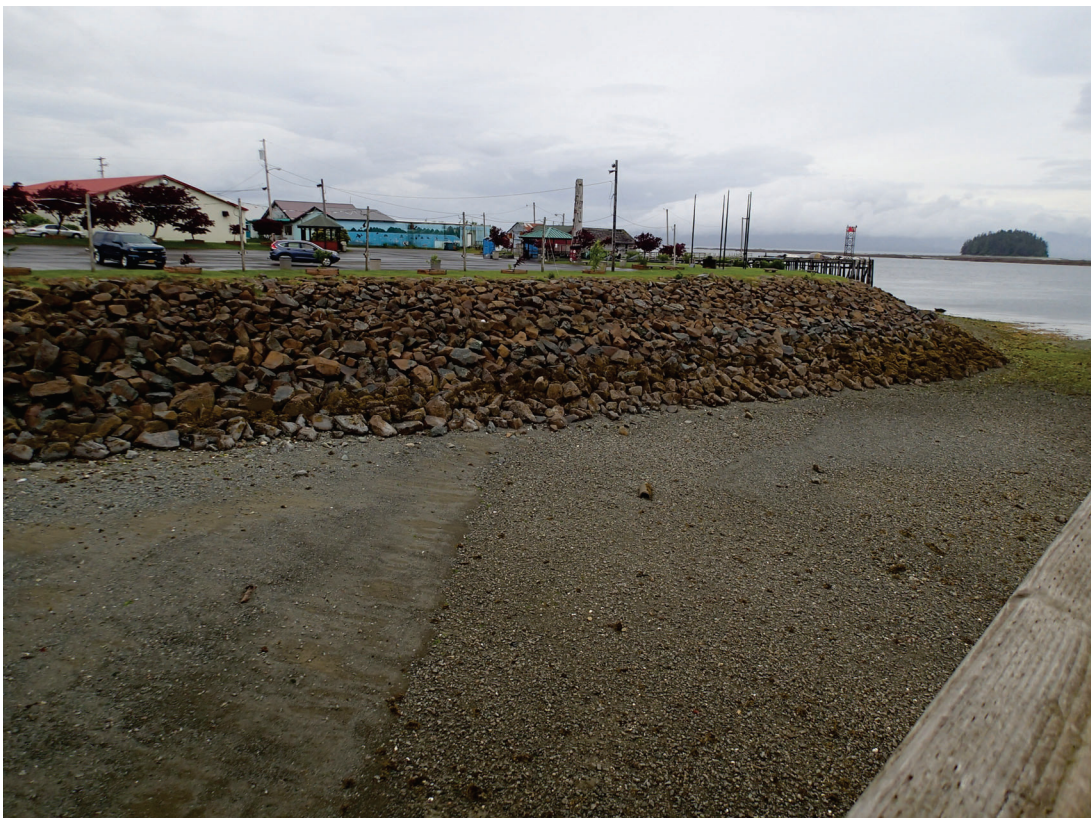
City Park rock revetment, June 2019
