# REPAIR FUEL PIER-LONG TERM EARECKSON AIR STATION SHEMYA, ALASKA (EAR063)

Welcome to all prospective offerors and interested parties. USACE Alaska District is advertising a firm-fixed price Design-Build (DB) Sustainment, Restoration, and Modernization project: Repair Fuel Pier-Long Term (EAR063) at Eareckson Air Station, Shemya, Alaska to provide a **50yr** pier repair solution.

# PROJECT OVERVIEW

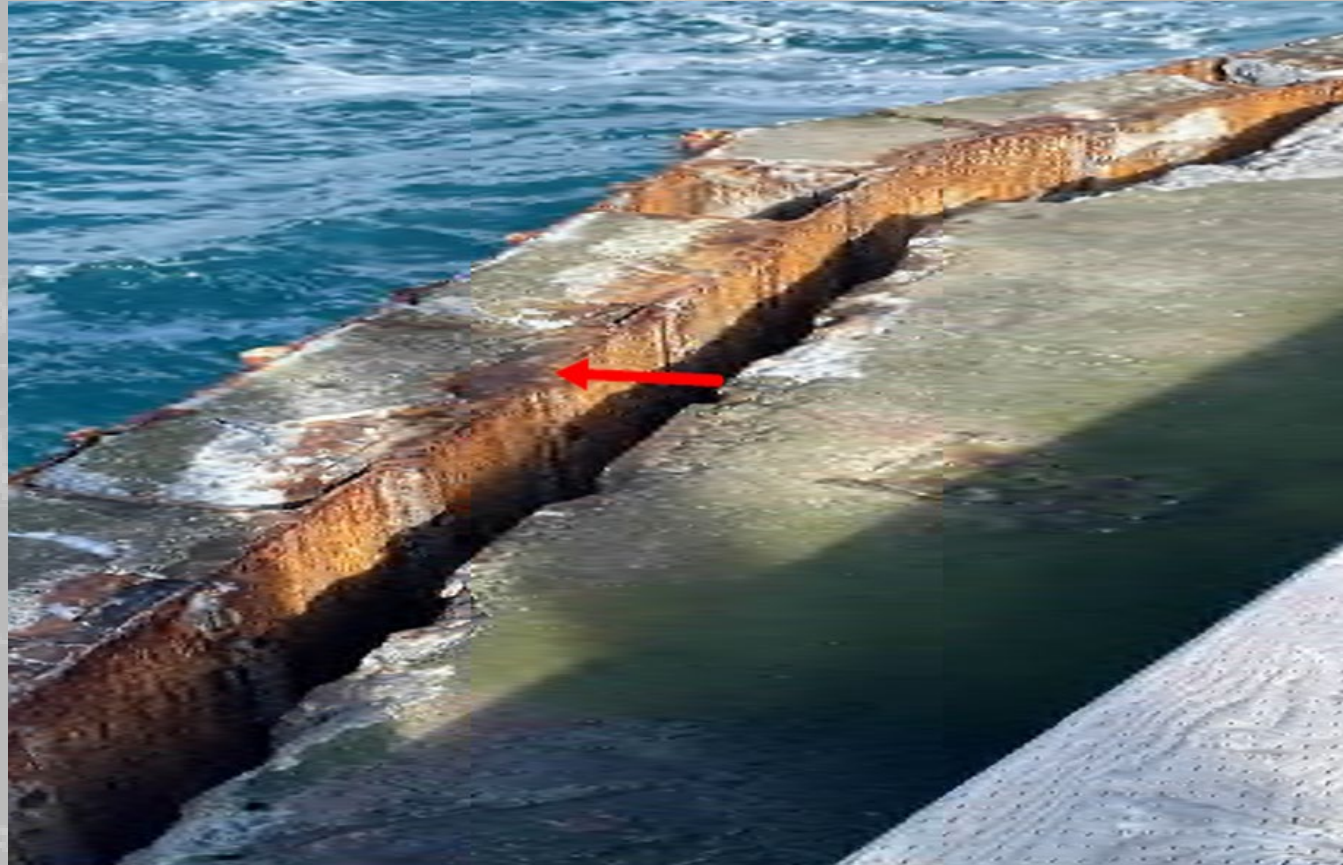
Pier face separation  
from concrete deck up  
to 12 inches.

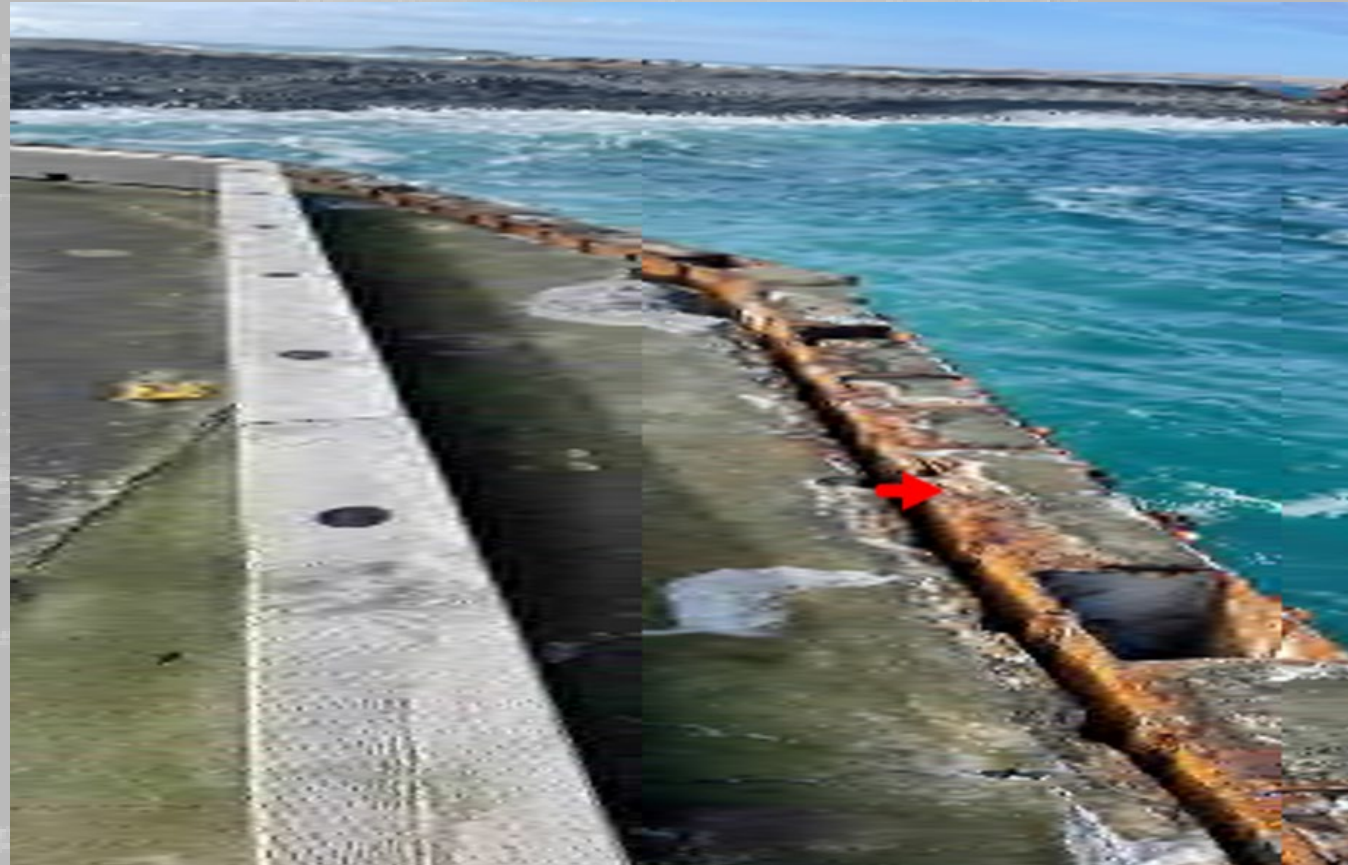
Pier face separation  
from concrete deck up  
to 12 inches.

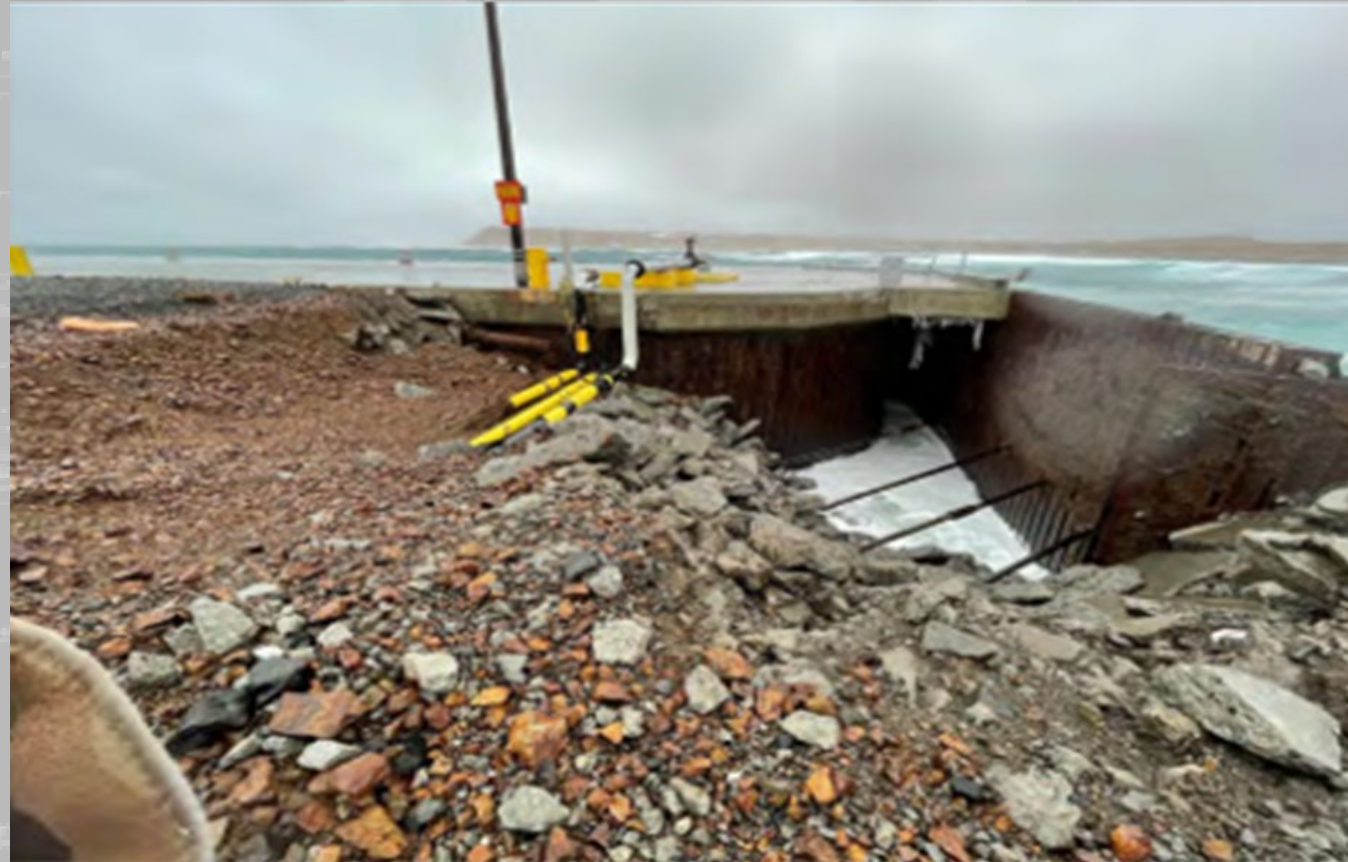
Wave action entering via  
sheet piles torn away  
from pier face.

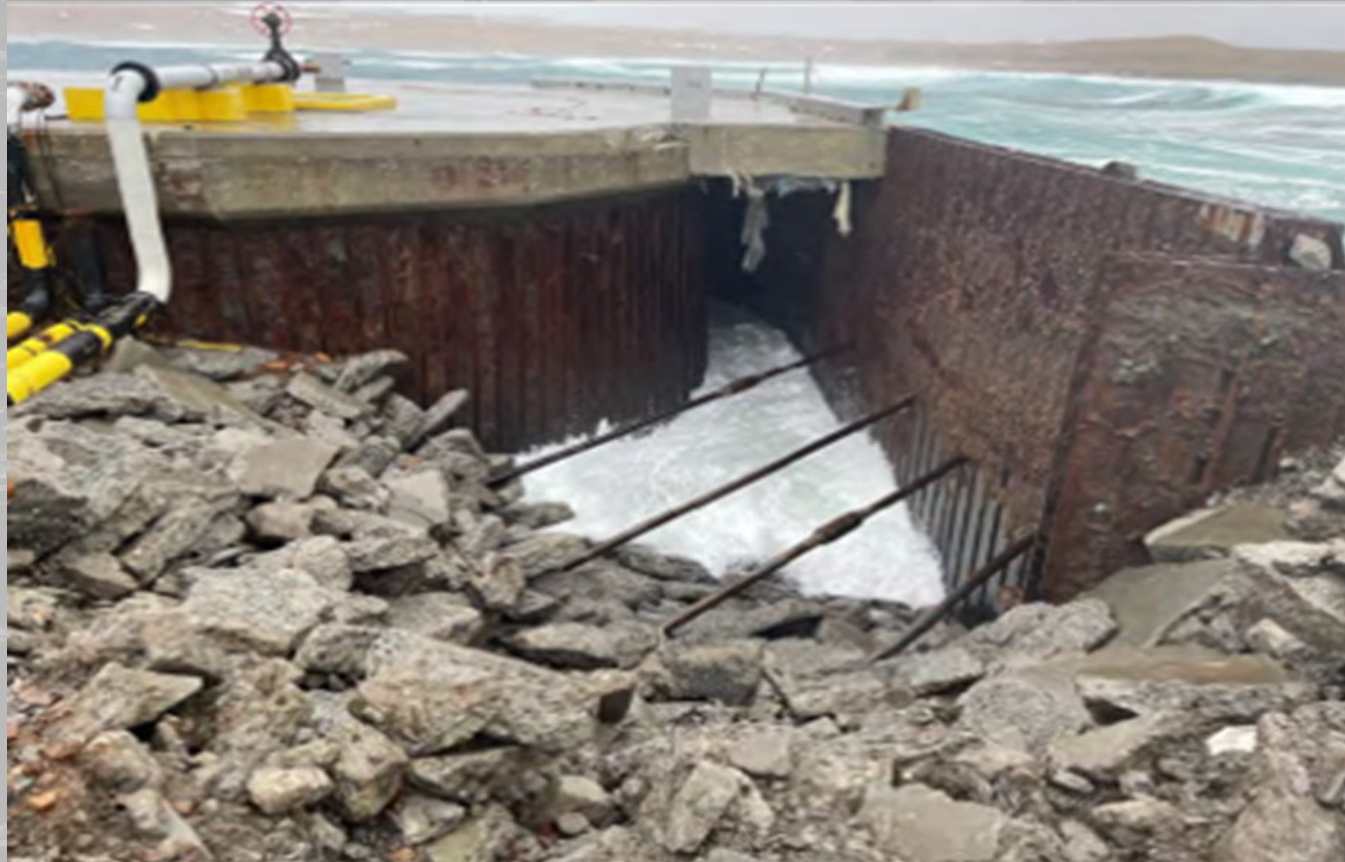
Wave action entering via  
sheet piles torn away  
from pier face.

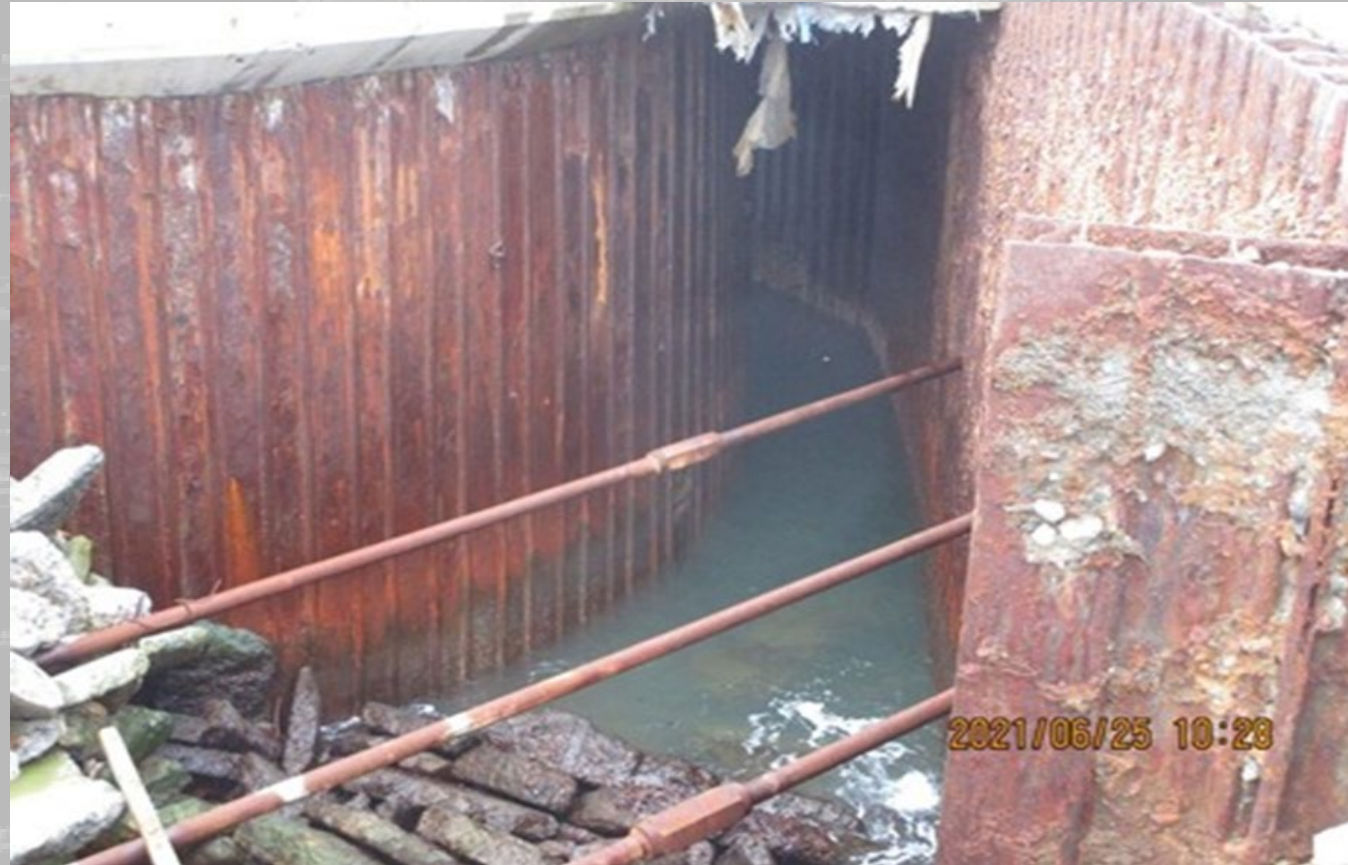
Reduced wave action  
observed after pier face  
repairs completed.

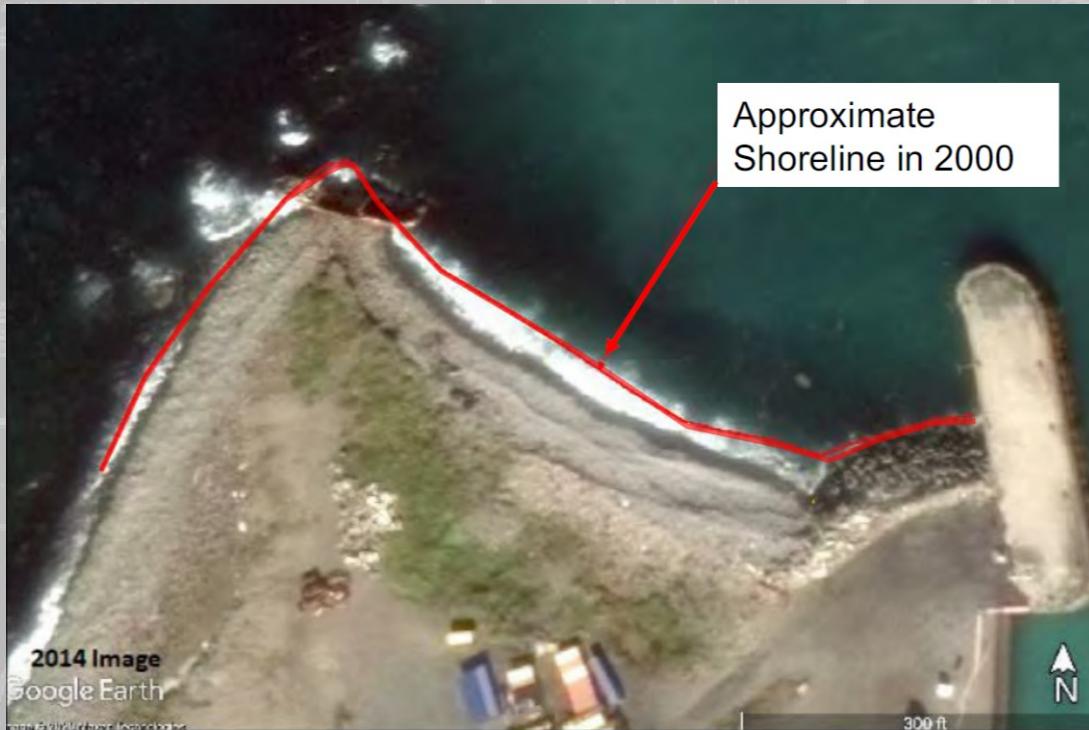
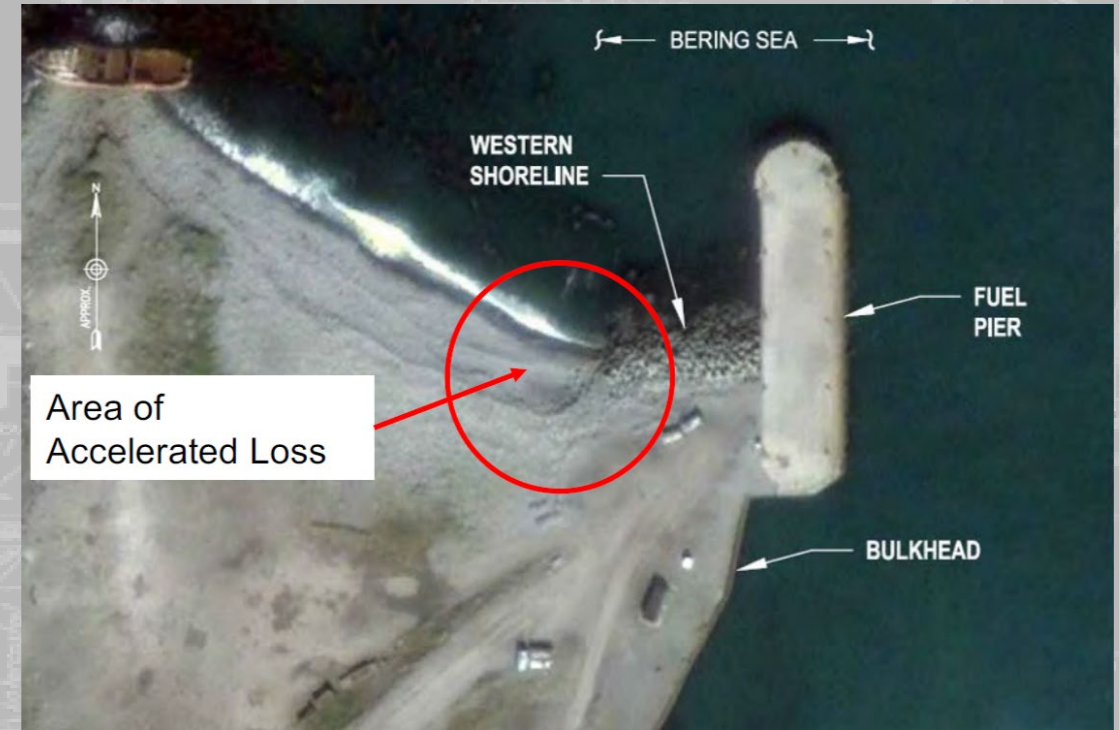
Significant loss of shoreline has occurred in the recent past. Shoreline retreat has been estimated at 4ft per year.
