U.S. Army Corps
of Engineers
Alaska District

ALASKA BASELINE EROSION ASSESSMENT

Erosion Information Paper - Akhiok, Alaska

Current as of December 12, 2007

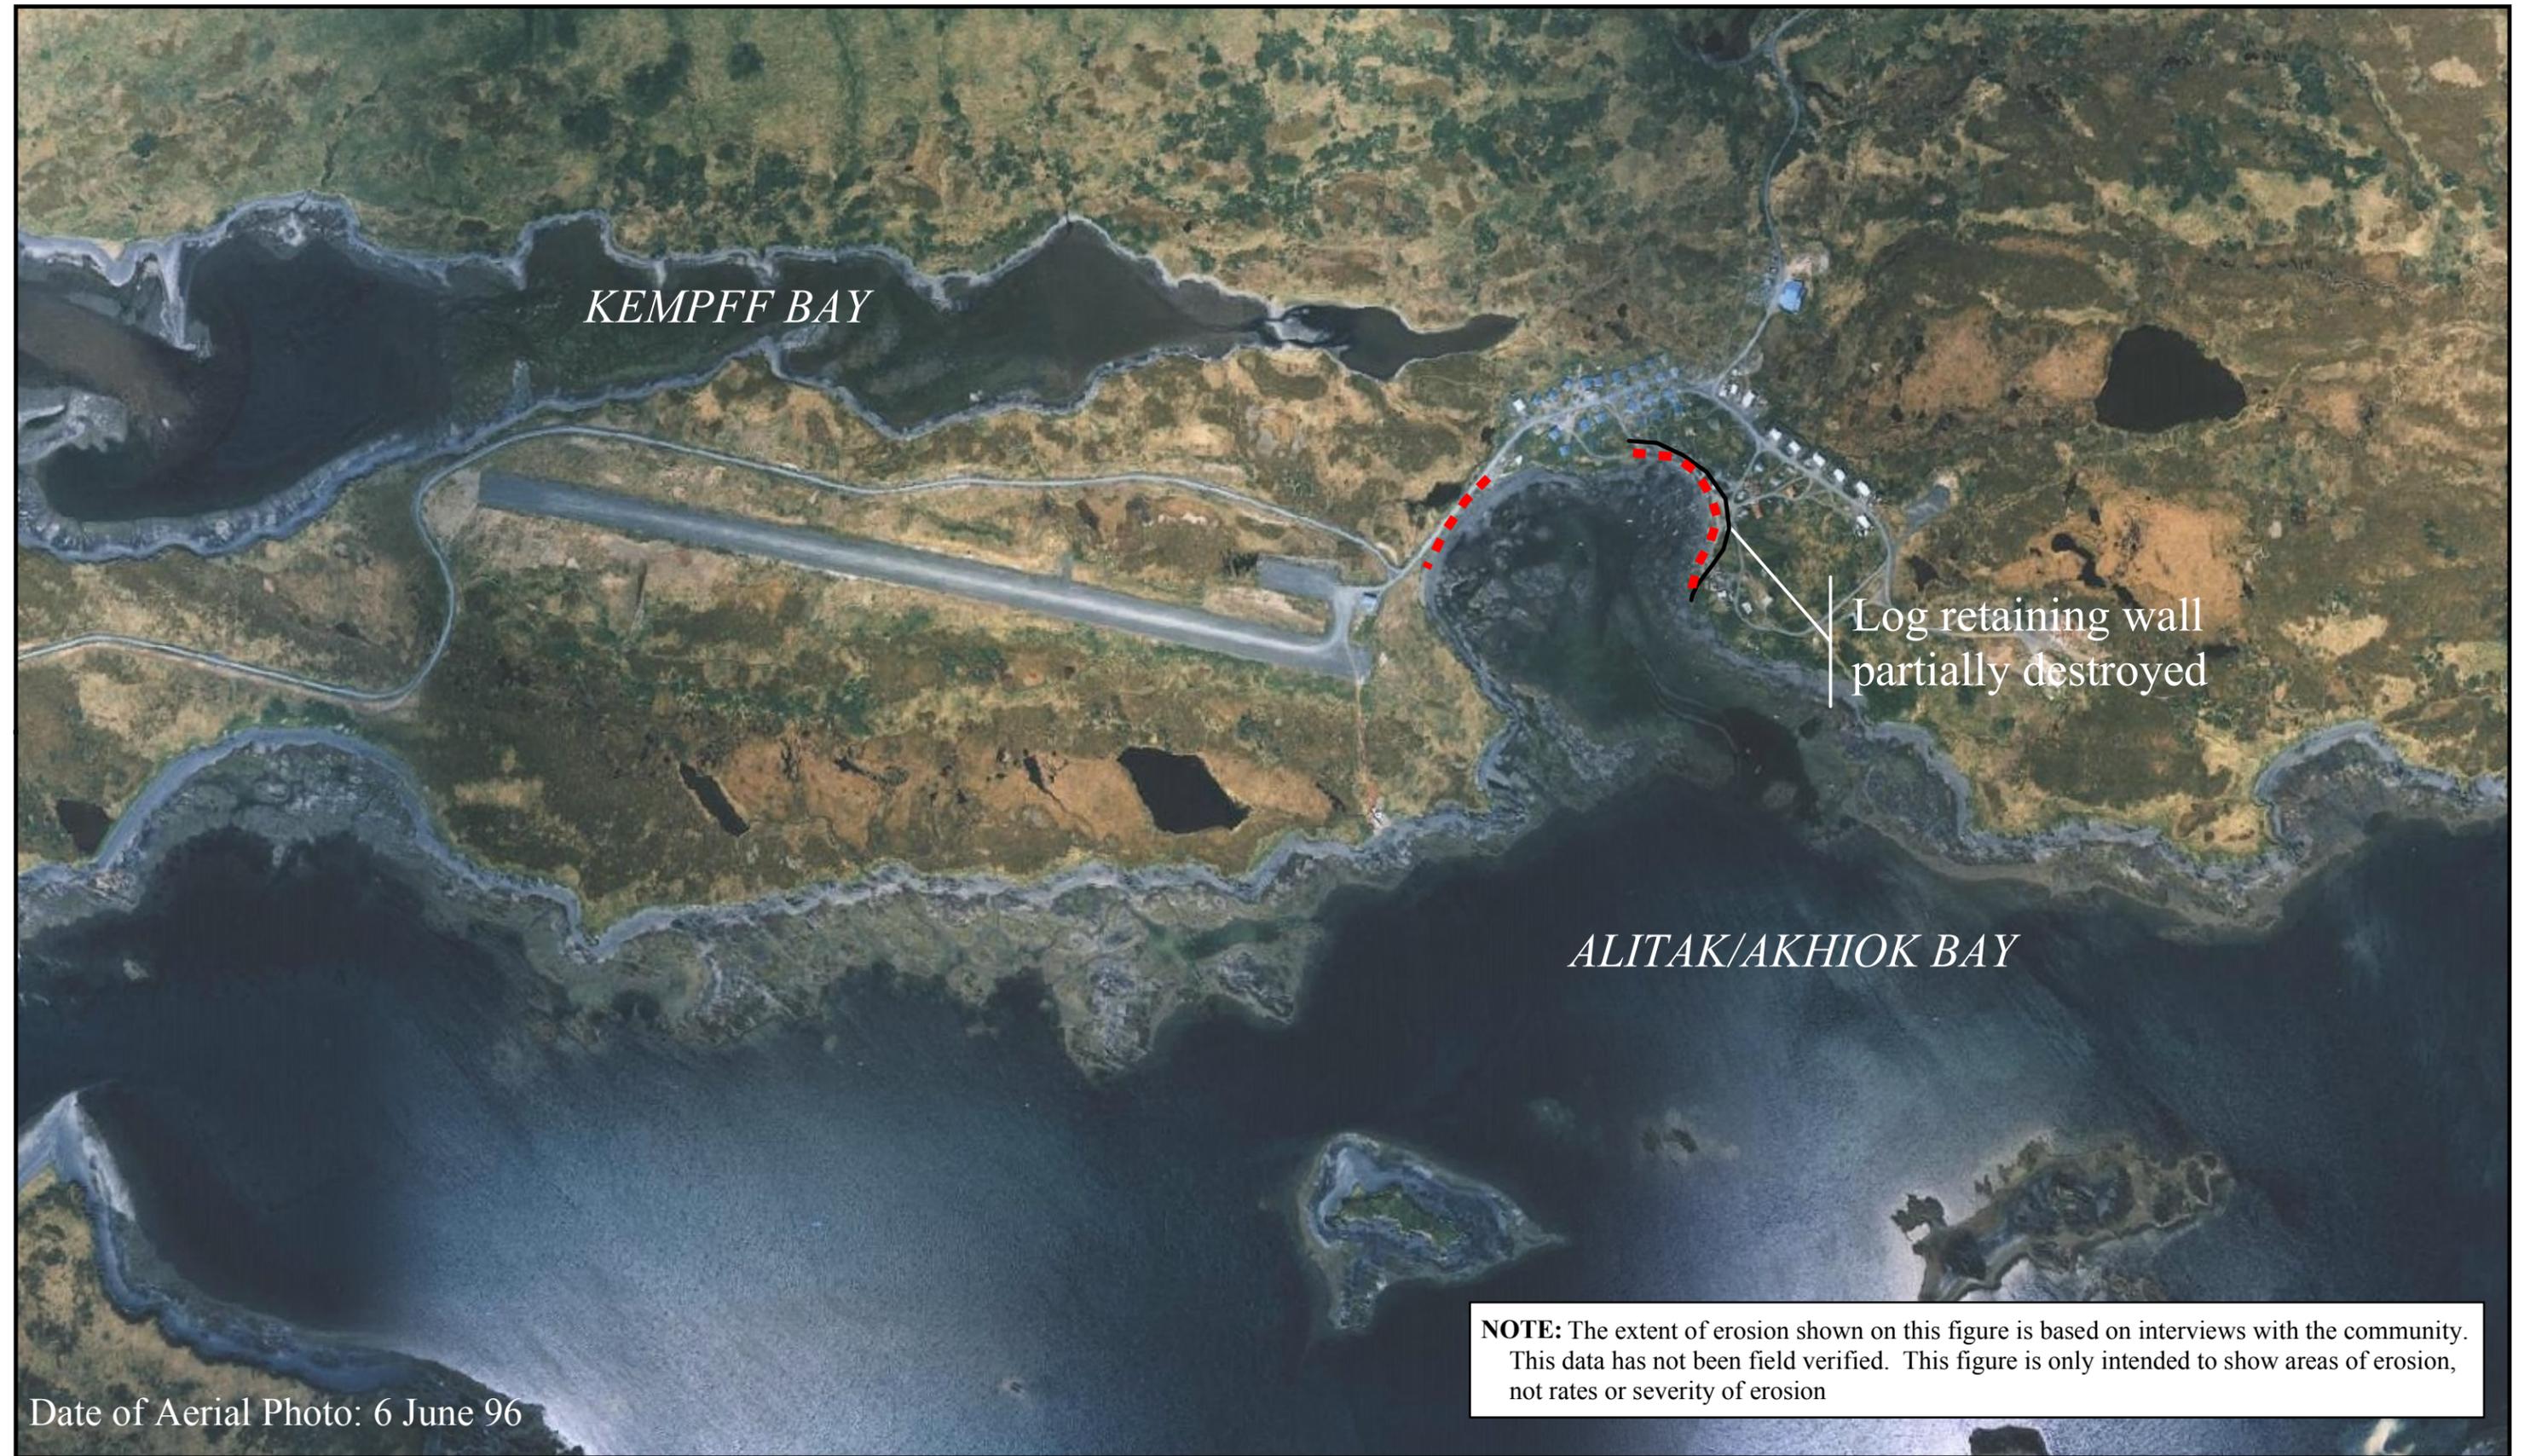
Alaska Baseline Erosion
Akhiok, Alaska

No photos of erosion were provided by community or other sources. A diagram is attached depicting the linear extent of erosion.

--- Linear Extent of Erosion
