U.S. Army Corps
of Engineers
Alaska District

ALASKA BASELINE EROSION ASSESSMENT

Erosion Information Paper – Aleknagik, Alaska

Current as of October 26, 2007

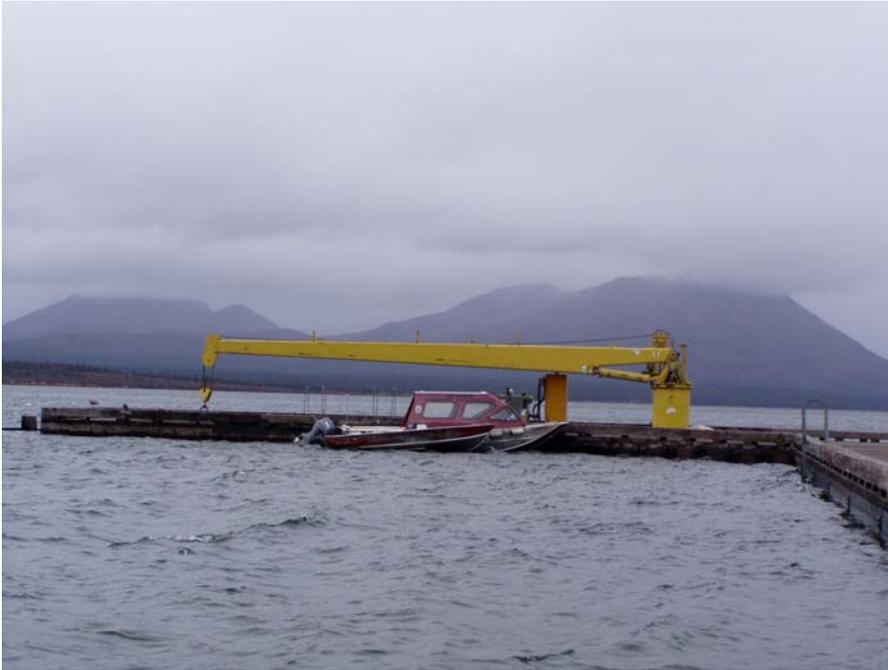
Aleknagik experiences periodic episodes of erosion, typically associated with spring flooding or fall storm events, which occur at least twice per decade. There was a damaging flood in the spring of 1996 and a severe fall storm in October 2006. Fall storms and spring breakup combined with increased waves from westerly winds on Aleknagik Lake can cause erosion. Erosion can also be caused by boat wakes, even though the Wood-Tikchik State Park has no-wake zones along the south and north shores. There is a boat ramp at the recreation site by the city dock that experiences erosion from boat traffic. That erosion area is approximately 200 feet long and 10 feet high. The boat storage area by the city dock had significant erosion during the October 2006 storm, which threatened the safety of the boats.

Photo 1: Aleknagik city dock, October 2006.

One hundred cubic yards of gravel were added to the city’s boat storage area to help repair erosion damage. Additional large rock has since been added to the staging area behind the dock to help stabilize the shore. Generally, bank protection and restoration measures have been used in areas where active bank erosion was occurring or where potential erosion may occur and jeopardize land and/or structures. No information on costs was provided.

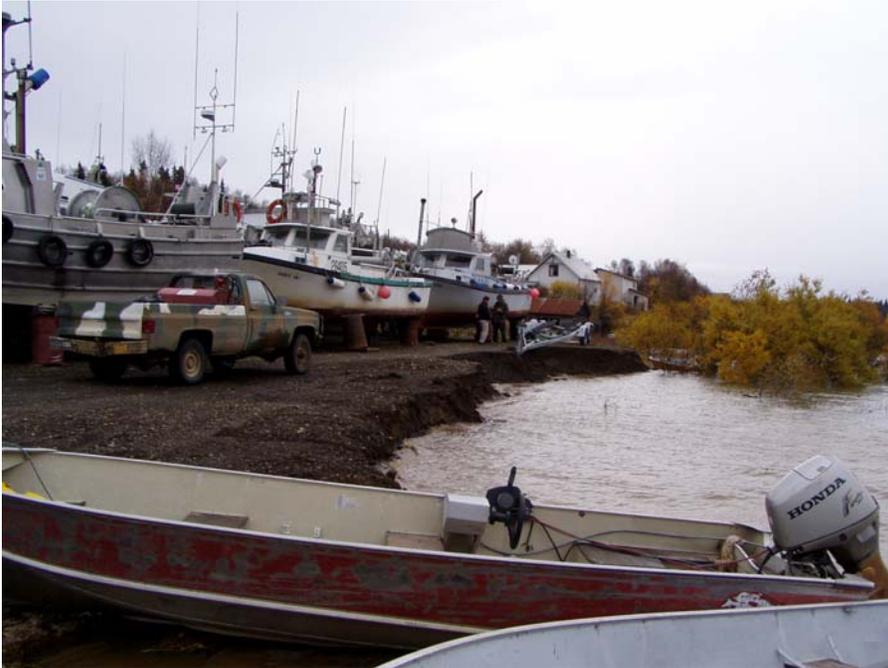
Photo 2: Aleknagik city dock after October storm but before city replaced fill, October 2006.

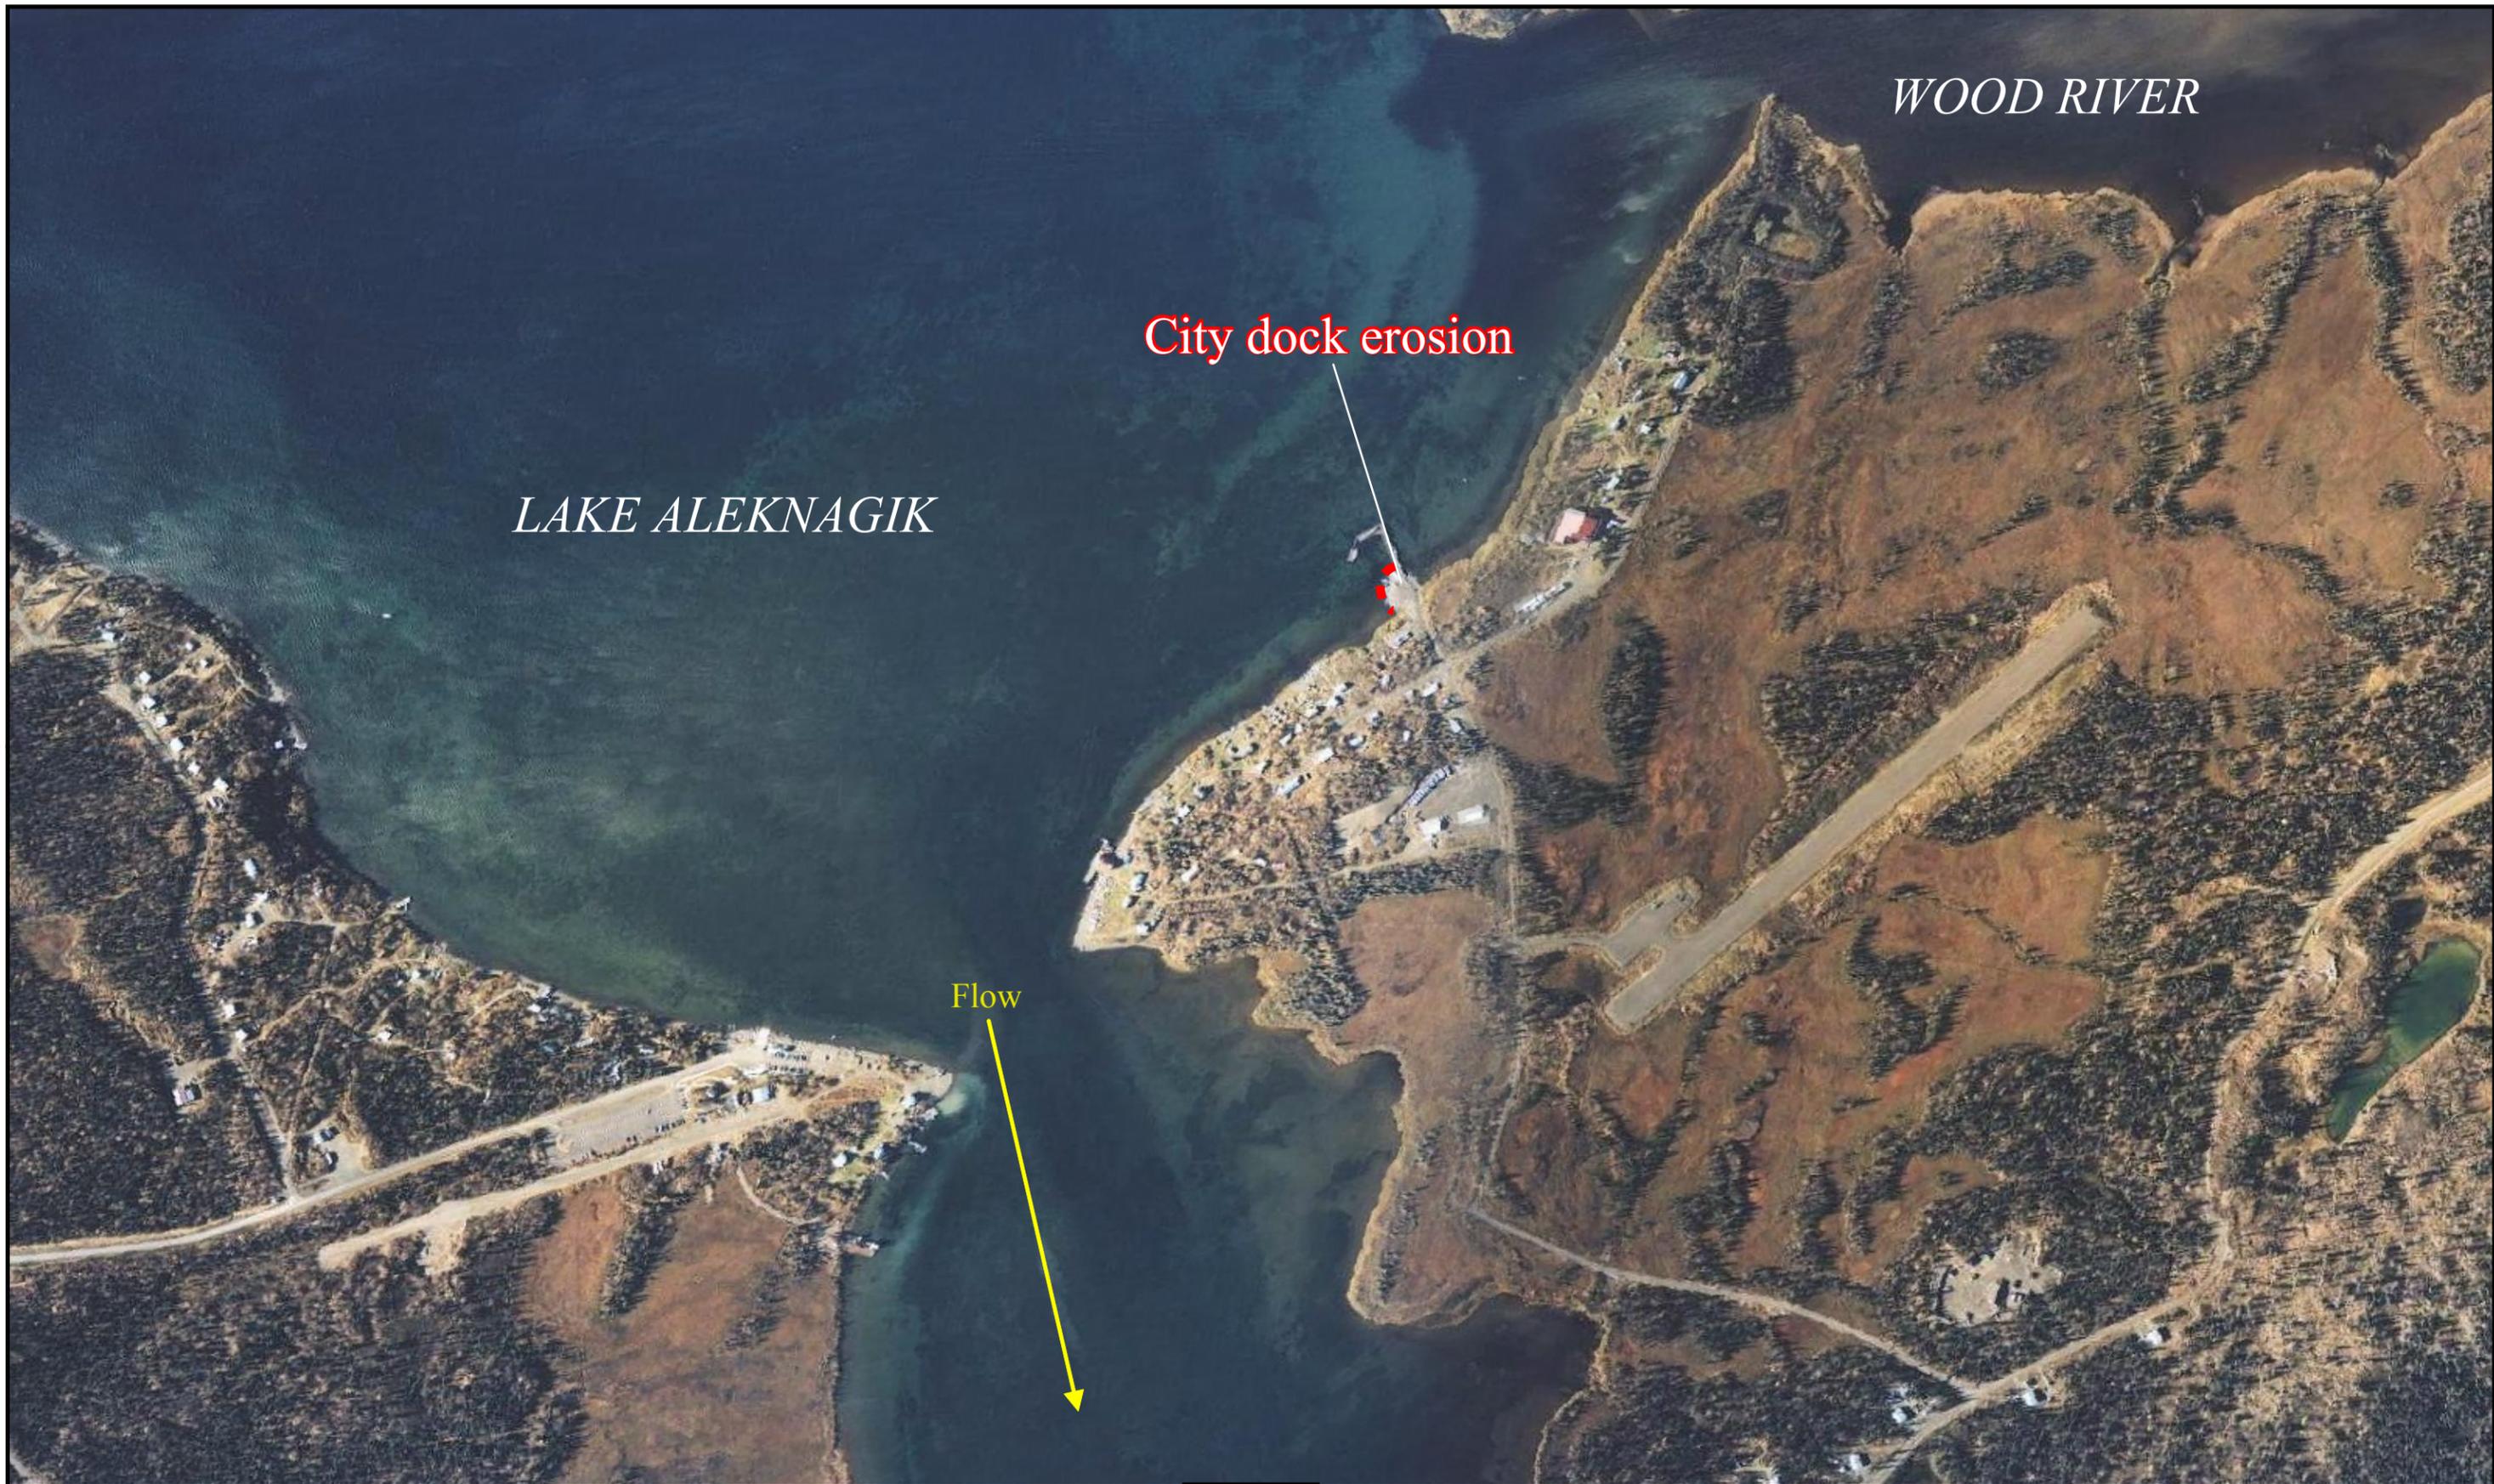
Photos of erosion provided by the Aleknagik city administrator are attached. Also, attached is a diagram depicting the linear extent of erosion near the city dock.

City dock erosion

--- Linear Extent of Erosion
