ALASKA BASELINE EROSION ASSESSMENT

Erosion Information Paper - Ambler, Alaska

Current as of March 10, 2008

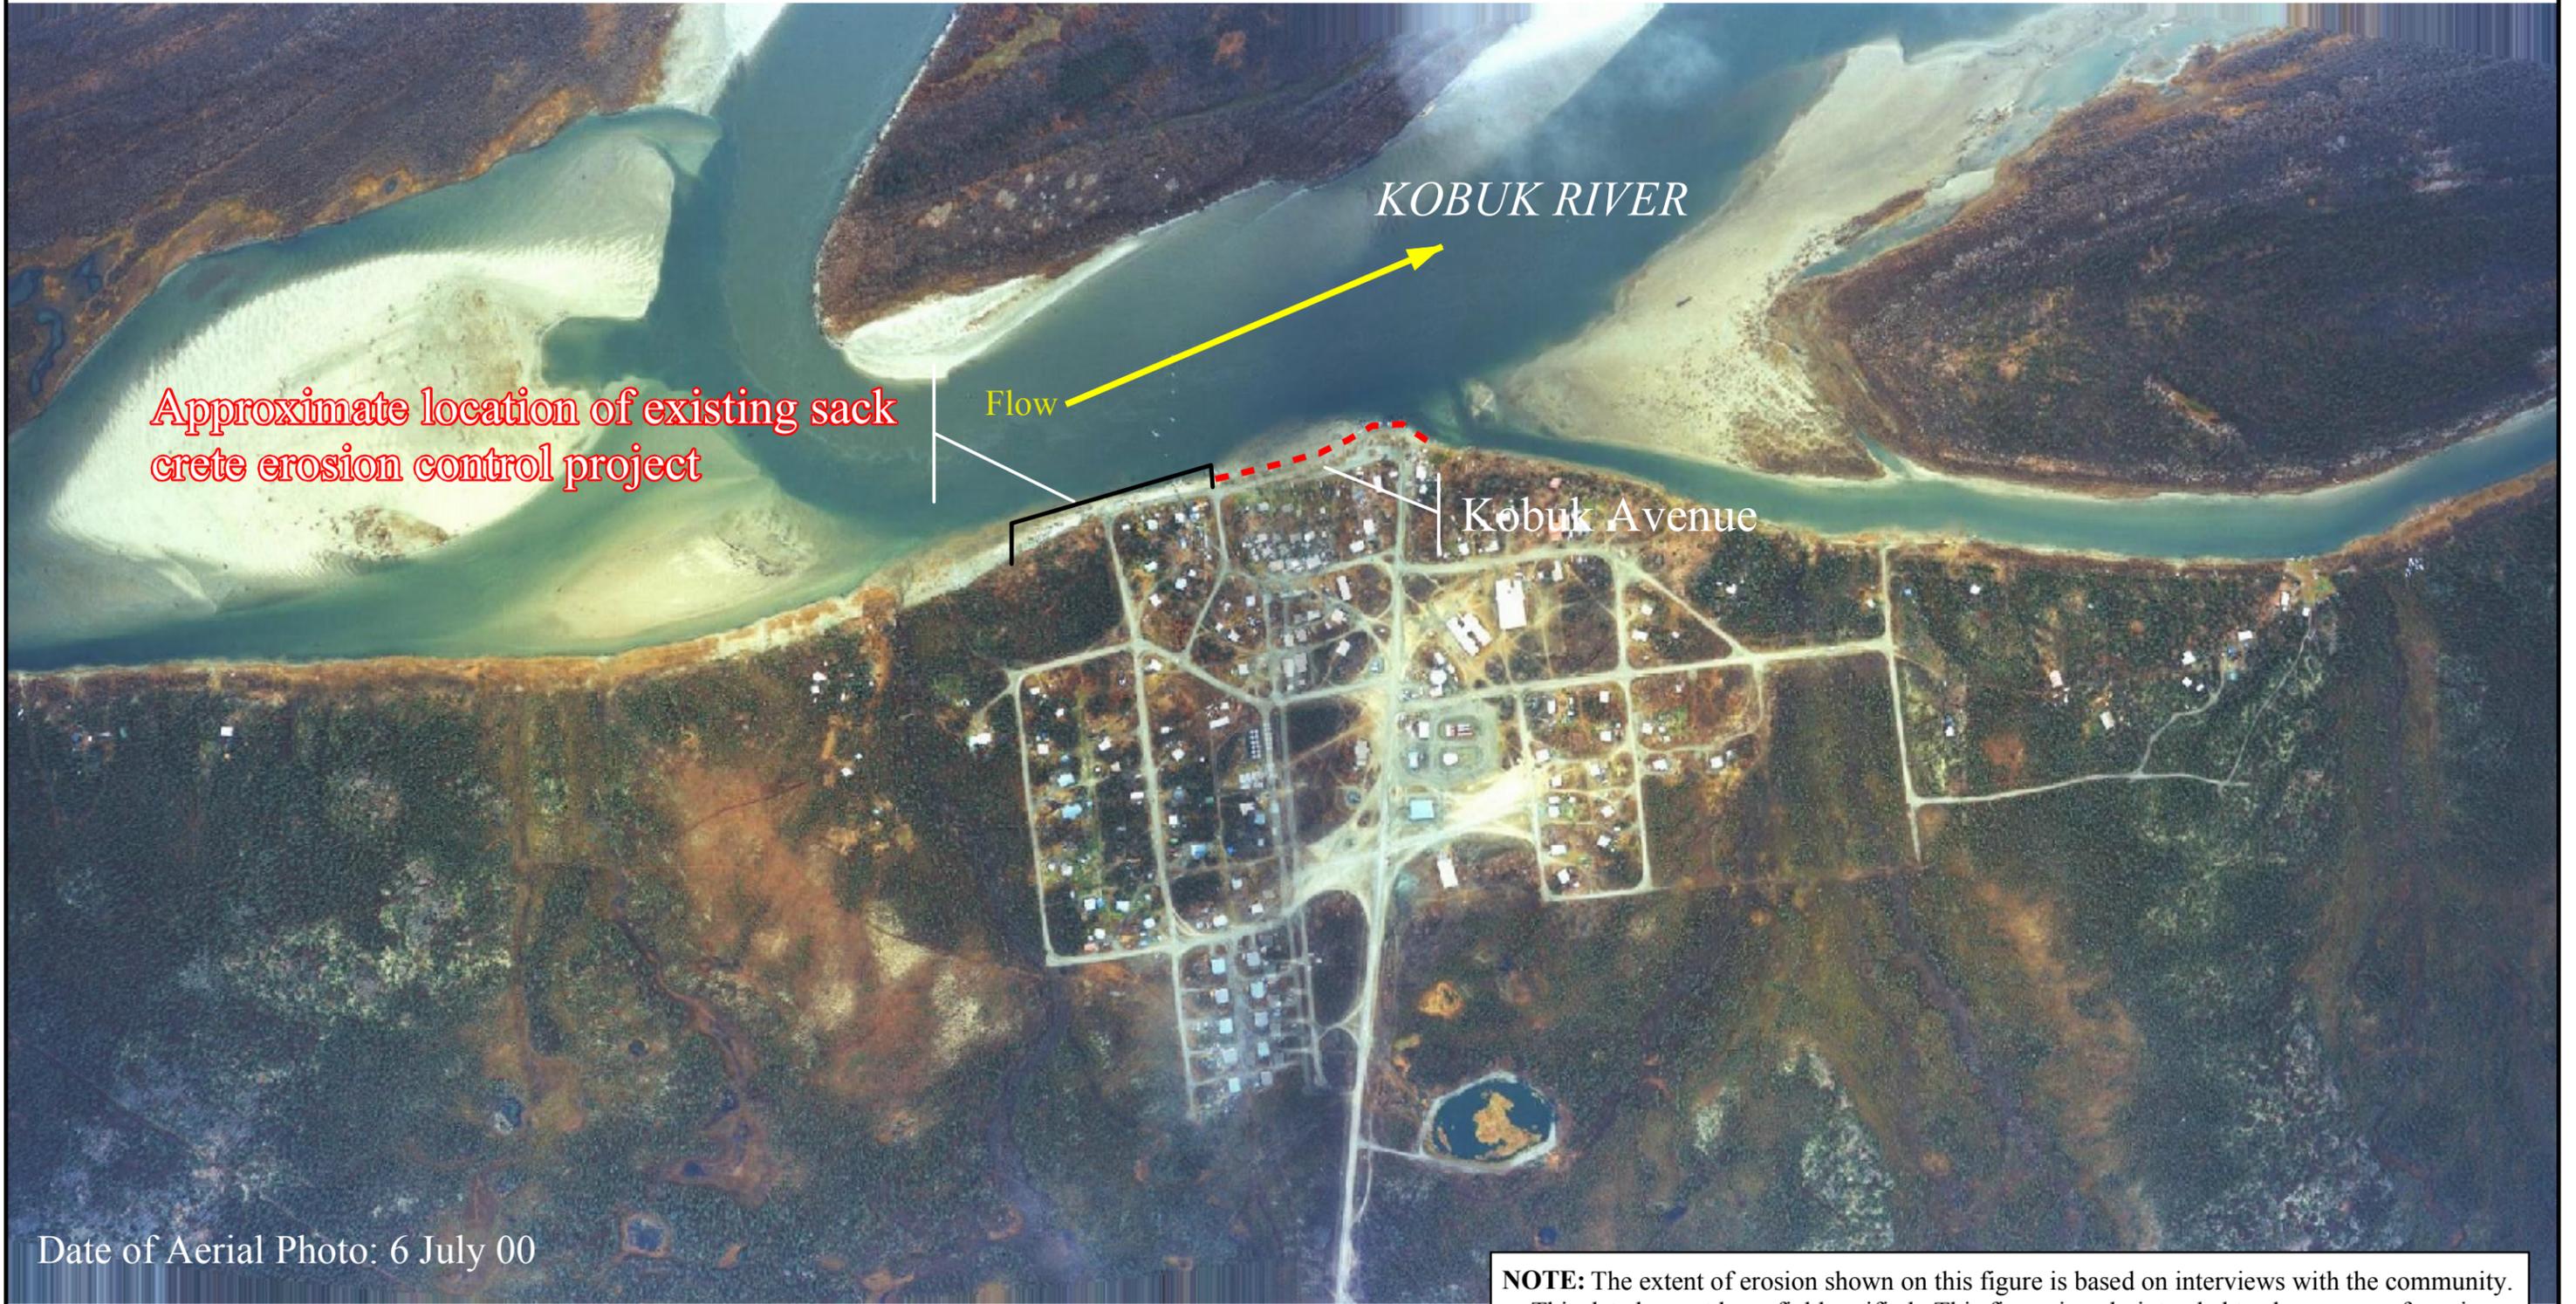
Alaska Baseline Erosion
Ambler, Alaska

In 1987-88, the city built an erosion control project of concrete-filled bags to protect part of the city's river front. The project was funded by state grants, however a shortfall in funding prevented the project from being completed. Erosion along this area has been mitigated to some extent by installing concrete bags, but these measures have been failing in recent years as bags sag and tear.

No photos were provided by the community or other sources. The attached diagram shows the approximate linear extent of erosion.

Approximate location of existing sack crete erosion control project
