ALASKA BASELINE EROSION ASSESSMENT

Erosion Information Paper – Anchor Point, Alaska

Current as of April 29, 2008

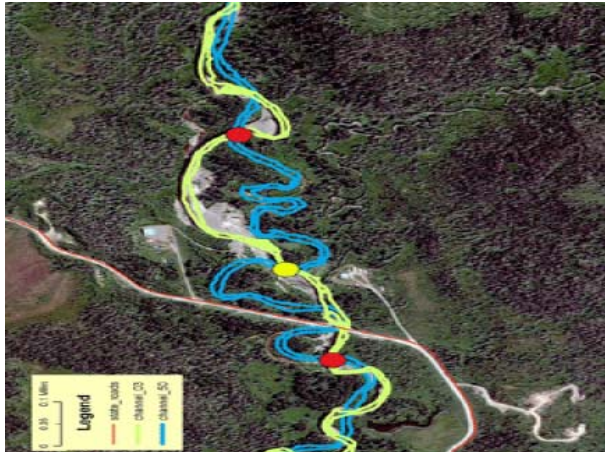
Photo 1: North Fork Anchor River stream channel movement 1950 (blue) and 2003 (green); aerial photo Courtesy of the Kenai Watershed Forum, Anchor Point Study.

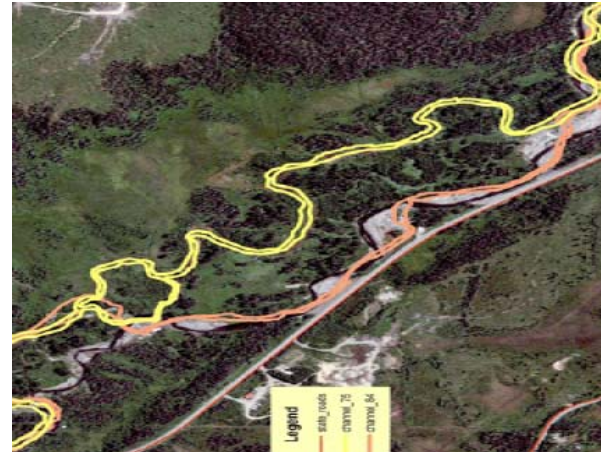
Access to cabins in the Clark Peterson Subdivision was cut off during a 2002 flood-erosion event. Flood waters reached 13 feet above the top of the four 8-foot culverts that pass under the Sterling Highway. Piping and seeping through the highway roadbed is monitored by the state Department of Transportation and Public Facilities (DOT/PF). Erosion in 2007 destroyed a recreational cabin near Black Water Bend Bridge and brought the river within about 45 feet of Mile 152 of the Sterling Highway.

Photo 2: This photo shows the channel movement from 1975 to 1984; the channel now is very close to the Sterling Highway; aerial photo graphic courtesy of the Kenai Watershed Forum, Anchor Point Study.

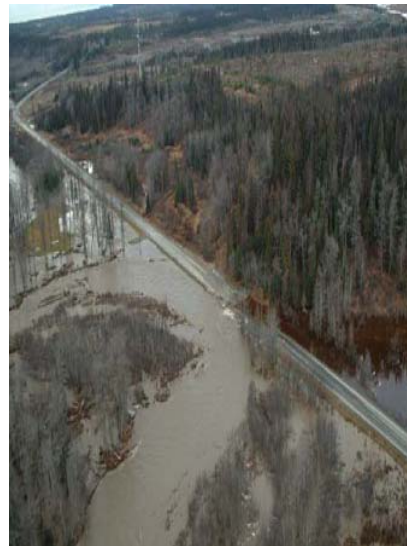
Photo 3: Anchor River by Black Water Bend, October 24, 2002. Photo courtesy KPB, OEM.

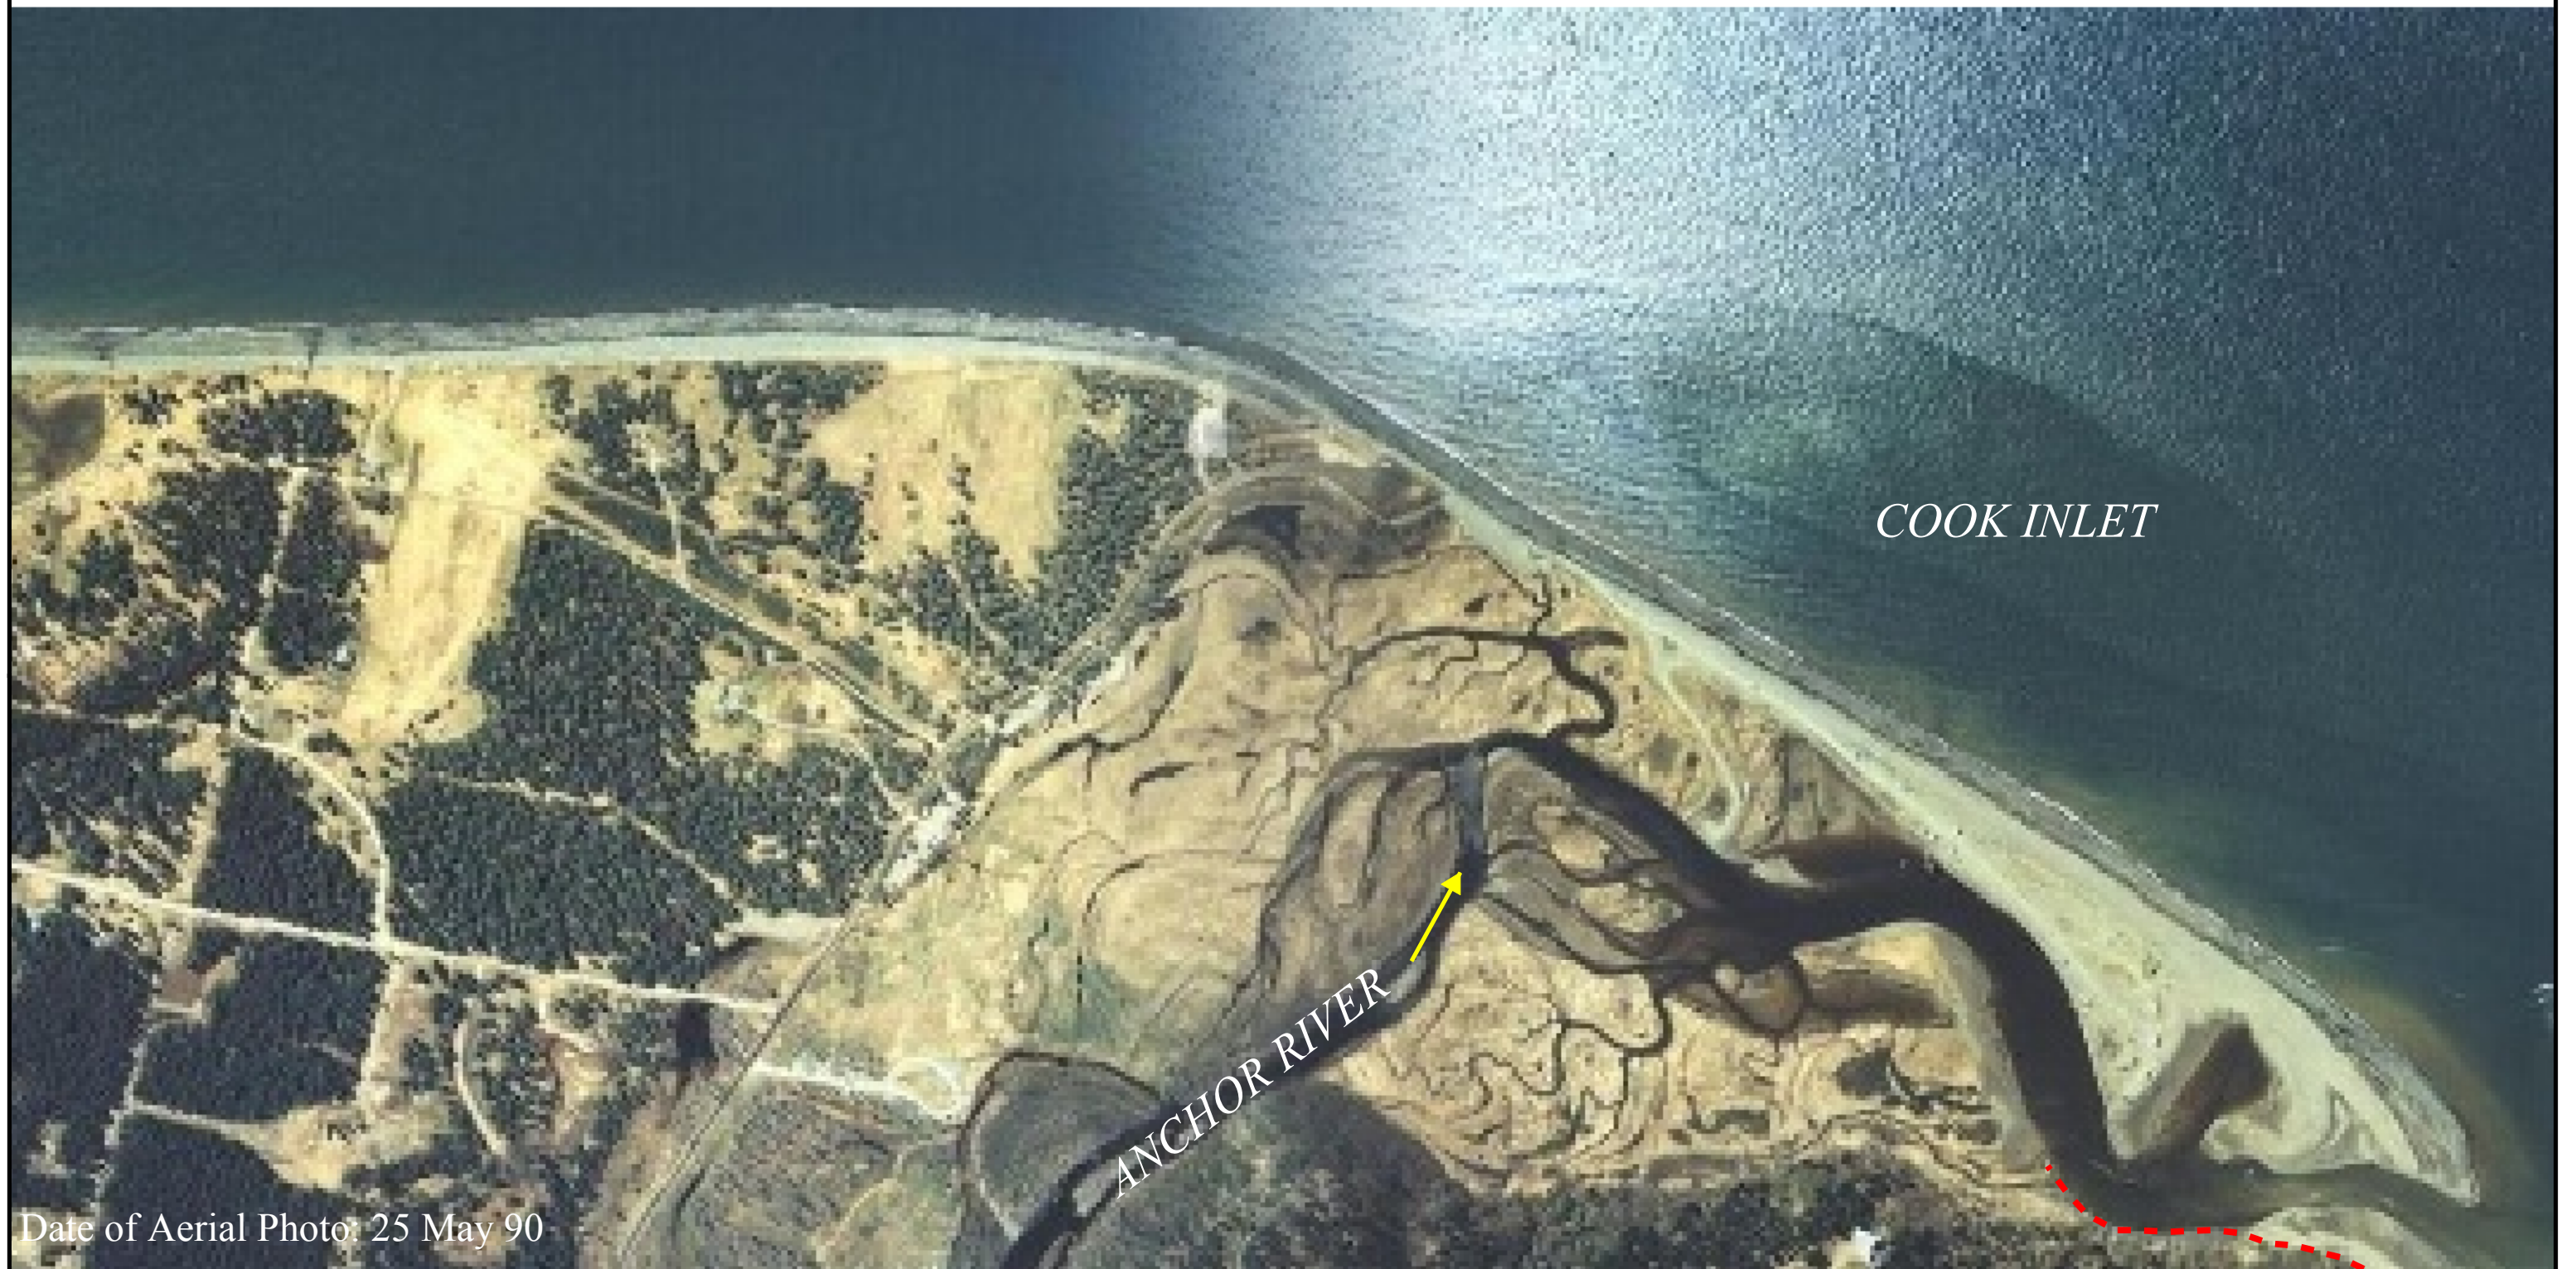
Alaska Baseline Erosion
Anchor Point, Alaska

--- Linear Extent of Erosion
