#### ALASKA BASELINE EROSION ASSESSMENT

# **Erosion Information Paper - Angoon, Alaska**

Current as of February 27, 2009

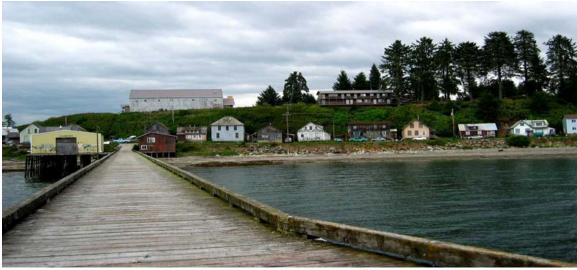
Photo 3: Angoon city dock; photo© courtesy of Nicole Grewe, DCRA, 2006.

The Angoon IRA President reported, the road in front of the community and the associated infrastructure is jeopardized due to fall/winter storms, to include power lines, water lines, and wastewater lines. The dock in front of town has some surface erosion and is not safe for vehicles or foot traffic in some places. Roads are eroding throughout the community due to lack of proper drainage. The ferry terminal is continually eroding and fine sediment is building up underwater. The graveyard resulting from community members hauling sand out of the area for burials and other uses, the community does not consider that this requires any protective measures.
