U.S. Army Corps
of Engineers
Alaska District

ALASKA BASELINE EROSION ASSESSMENT

Erosion Information Paper - Atmautluak, Alaska

Current as of August 27, 2007

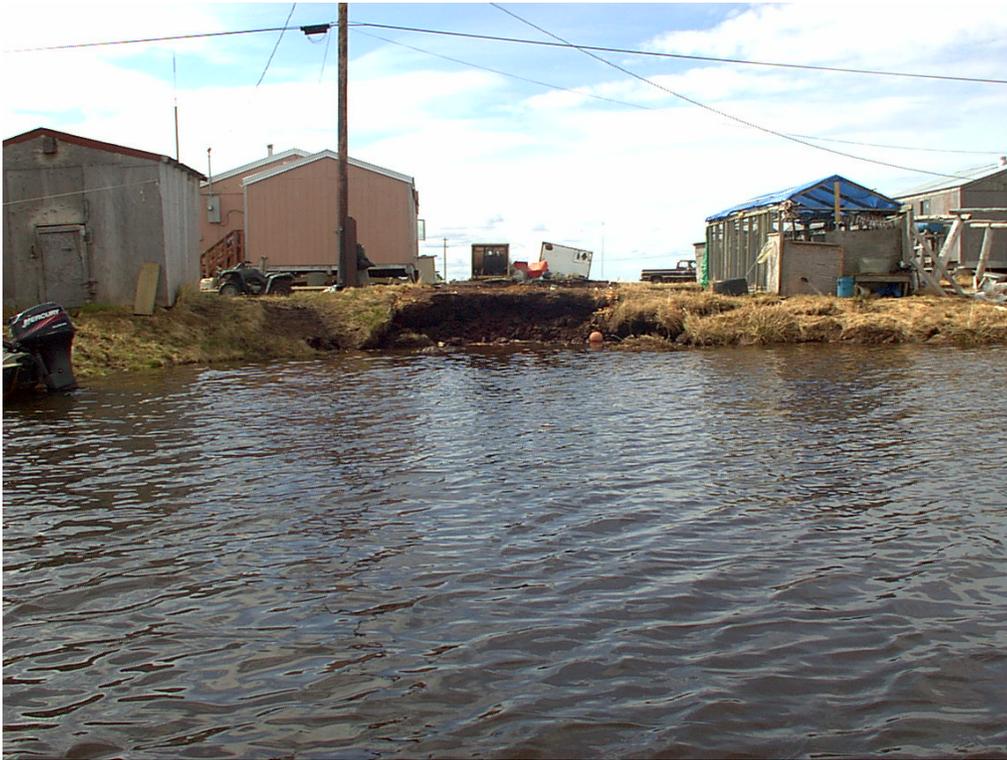
Photo 1: Erosion of the shoreline dated 16 June 2008

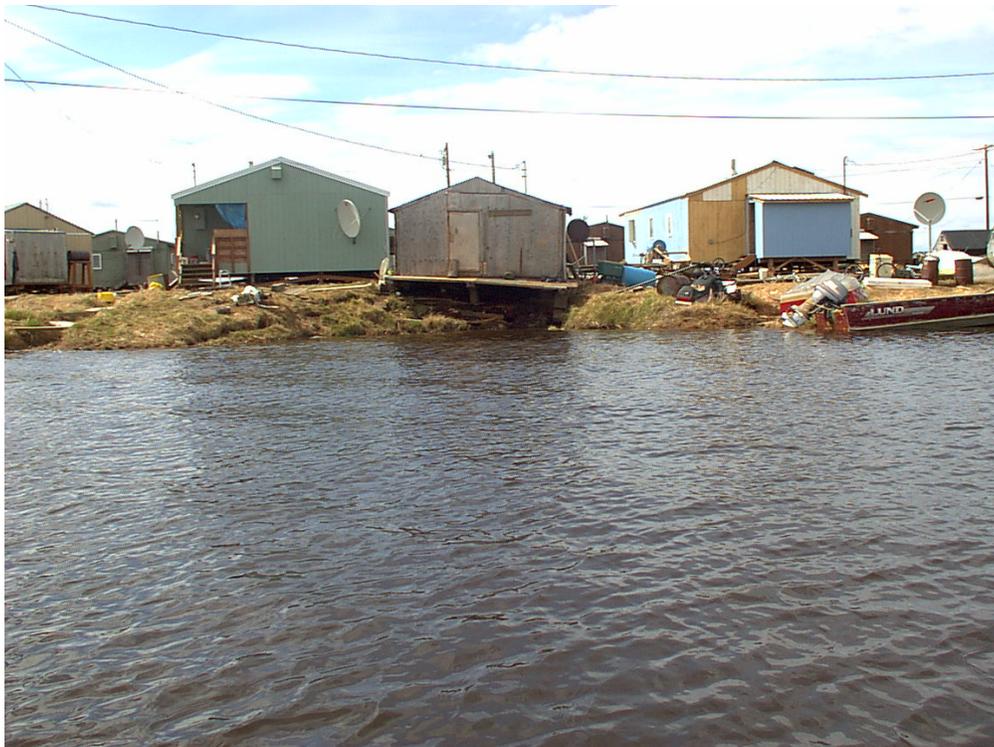
Photo 2: Land under house eroded out dated 16 June 2008

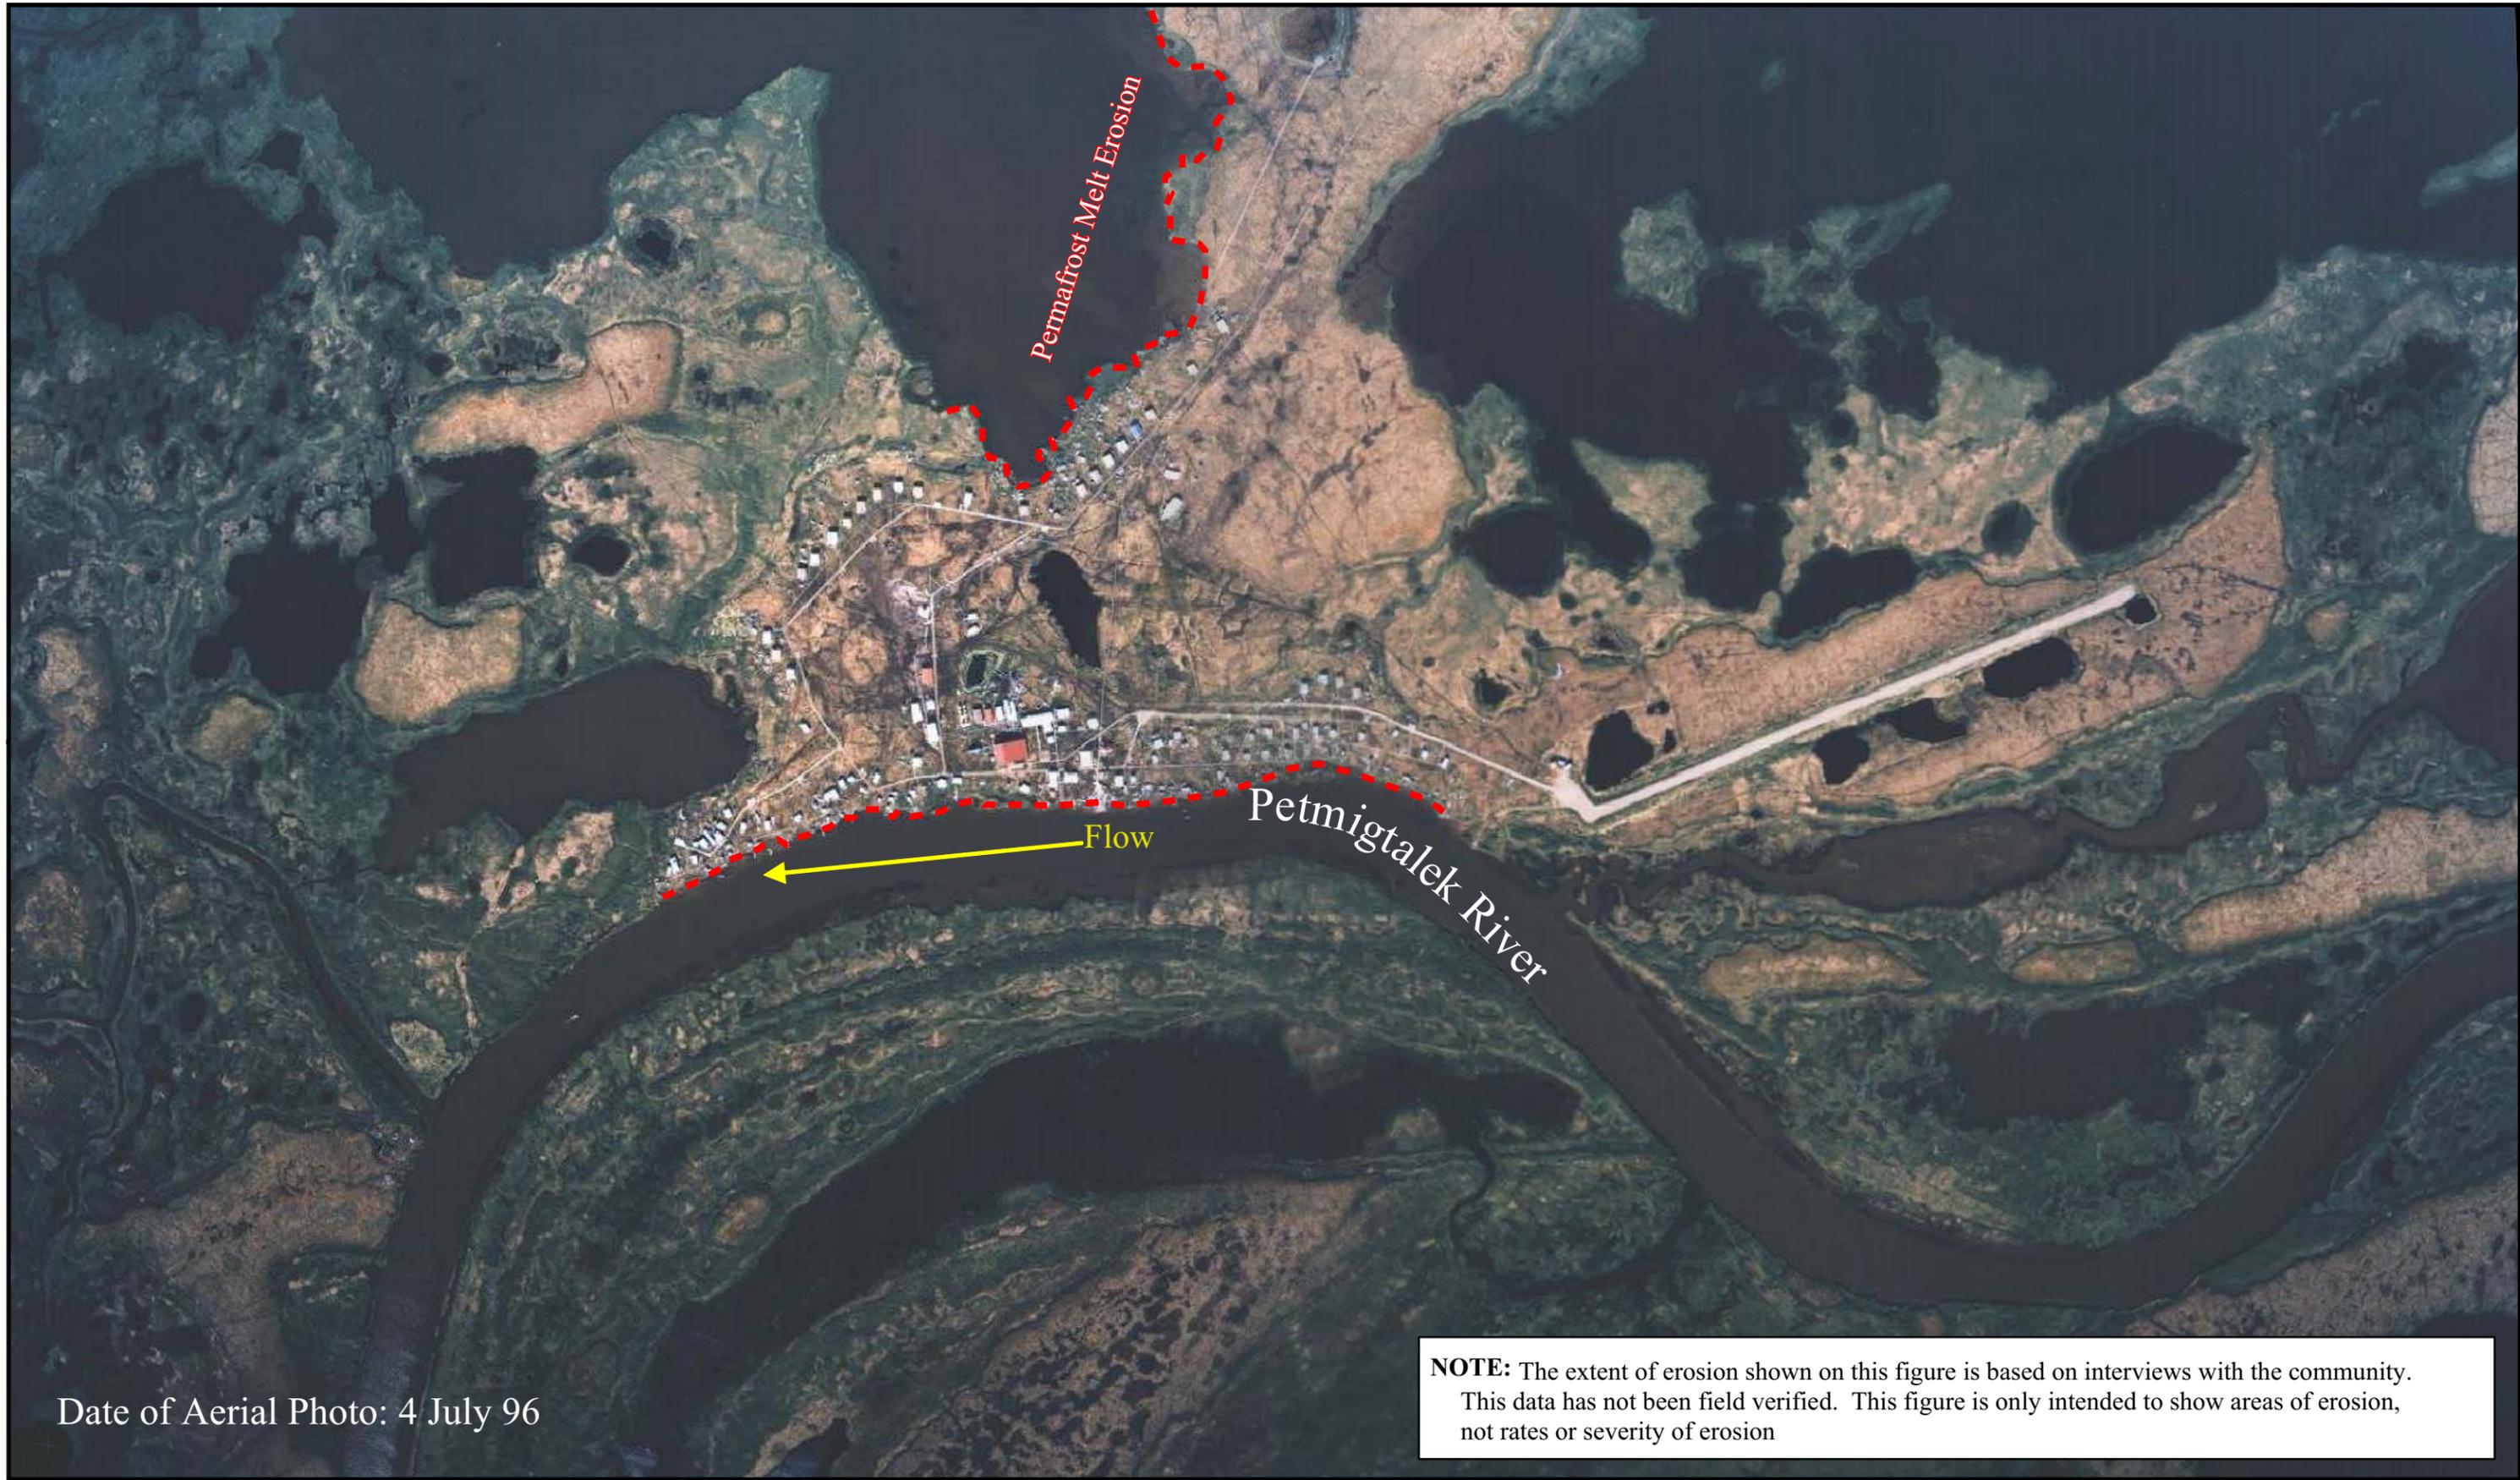
Alaska Baseline Erosion
Atmautluak, Alaska

--- Linear Extent of Erosion
