U.S. Army Corps
of Engineers
Alaska District

ALASKA BASELINE EROSION ASSESSMENT

Erosion Information Paper - Barrow, Alaska

Current as of September 14, 2007

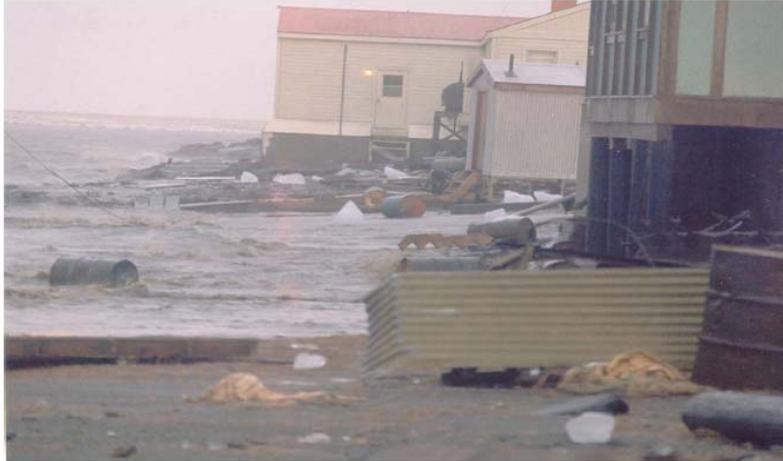
Photo 1: Coastal Flooding & Erosion. 2000.

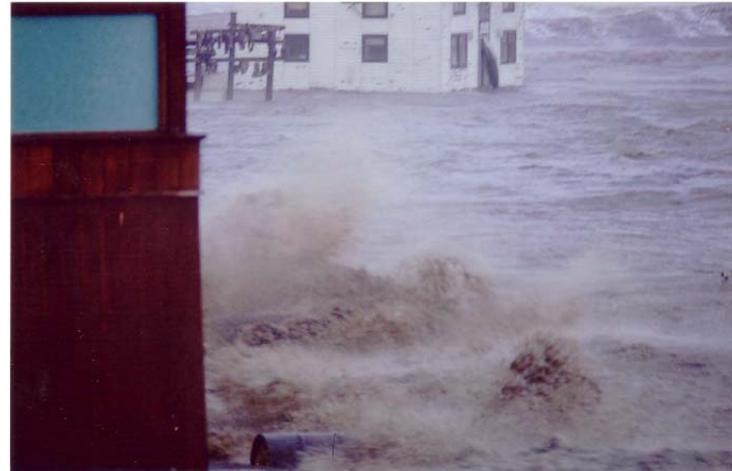
Photo 2: Coastal Flooding & Erosion. 2000.

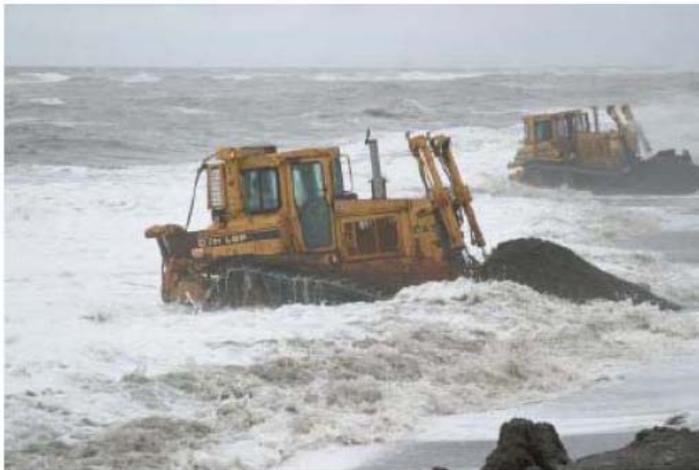
Photo 3: Rebuilding Beach Berm during Storm. 2000.

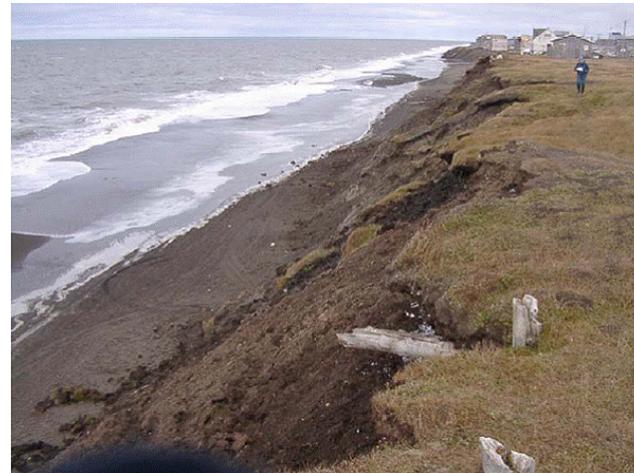
Photo 4: Barrow Bluff Erosion. 2000.

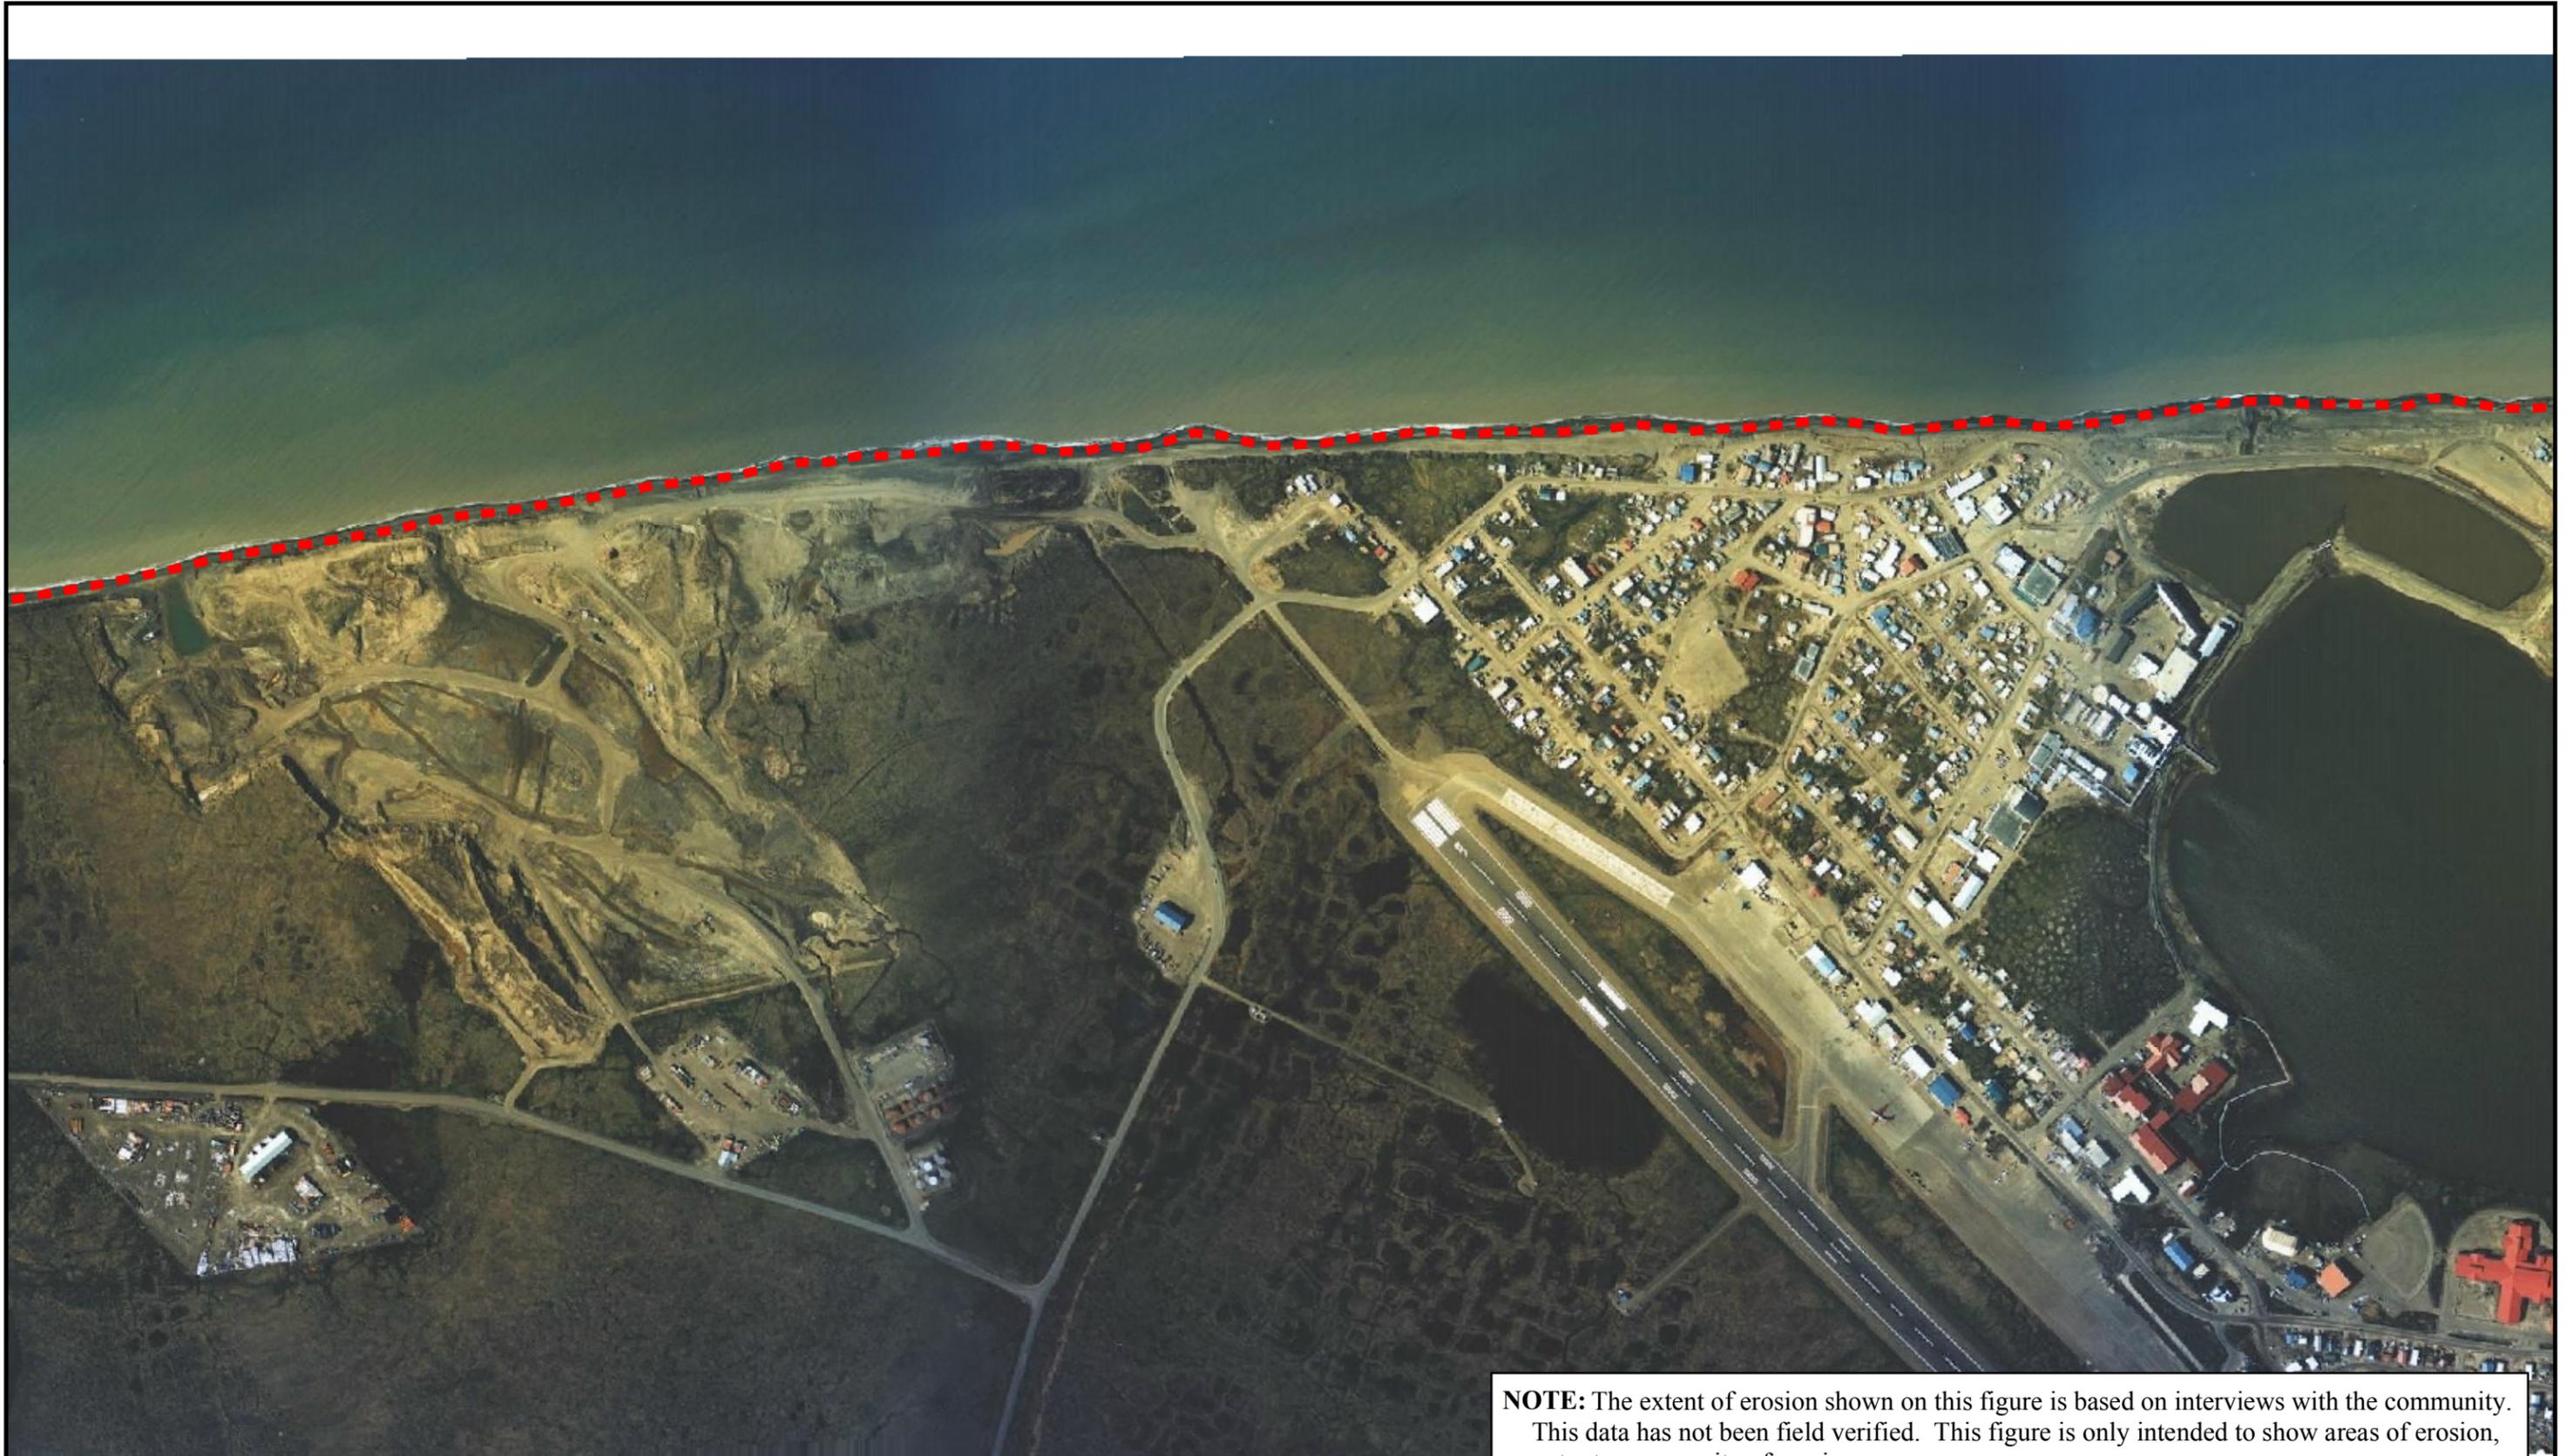
Linear Extent of Erosion
Part 1

NOTE: The extent of erosion shown on this figure is based on interviews with the community. This data has not been field verified. This figure is only intended to show areas of erosion, not rates or severity of erosion

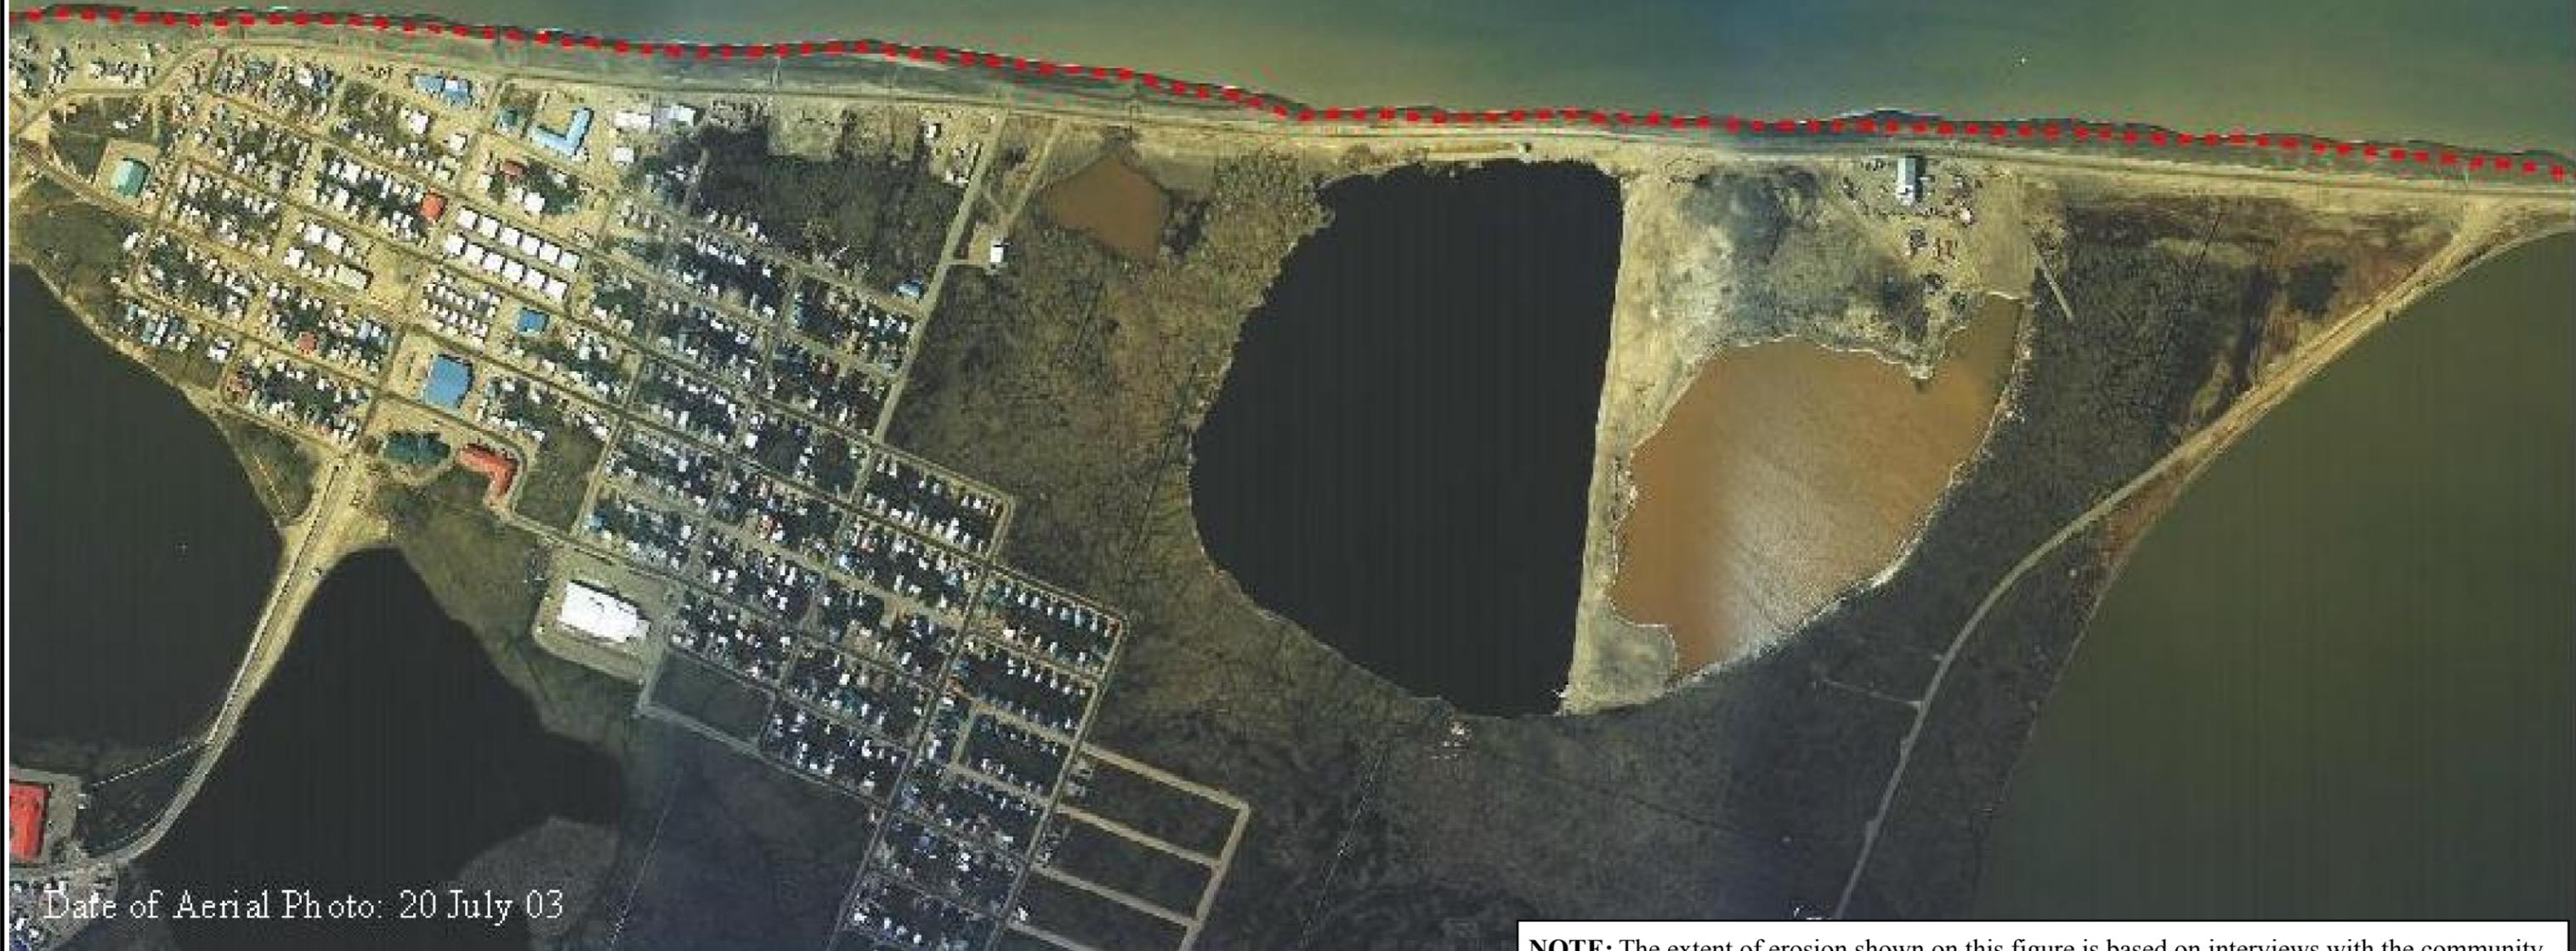
--- Linear Extent of Erosion

NOTE: The extent of erosion shown on this figure is based on interviews with the community. This data has not been field verified. This figure is only intended to show areas of erosion, not rates or severity of erosion
