ALASKA BASELINE EROSION ASSESSMENT

Erosion Information Paper - Bettles, Alaska

Current as of November 20, 2007

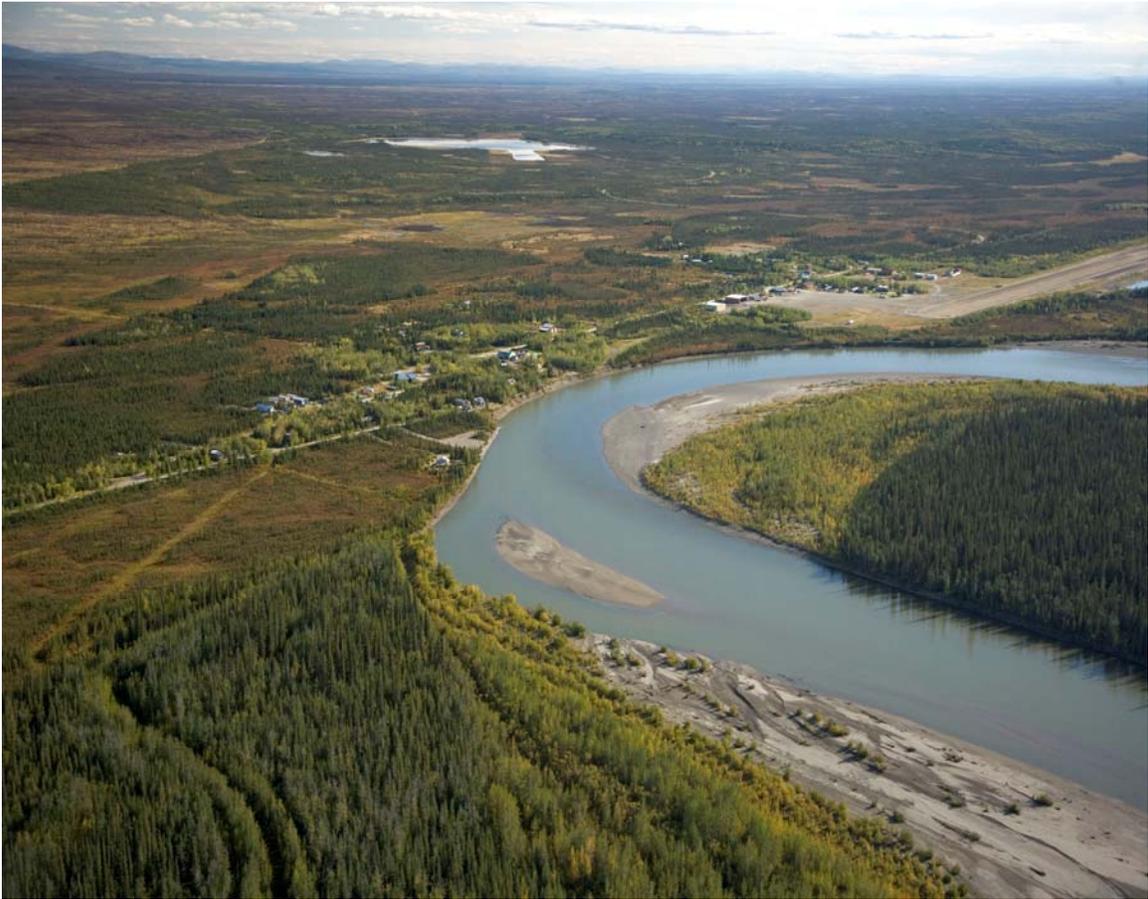
Photo 1: Evansville in foreground & Bettles in background near the airport; USFWS photo, September 2005.

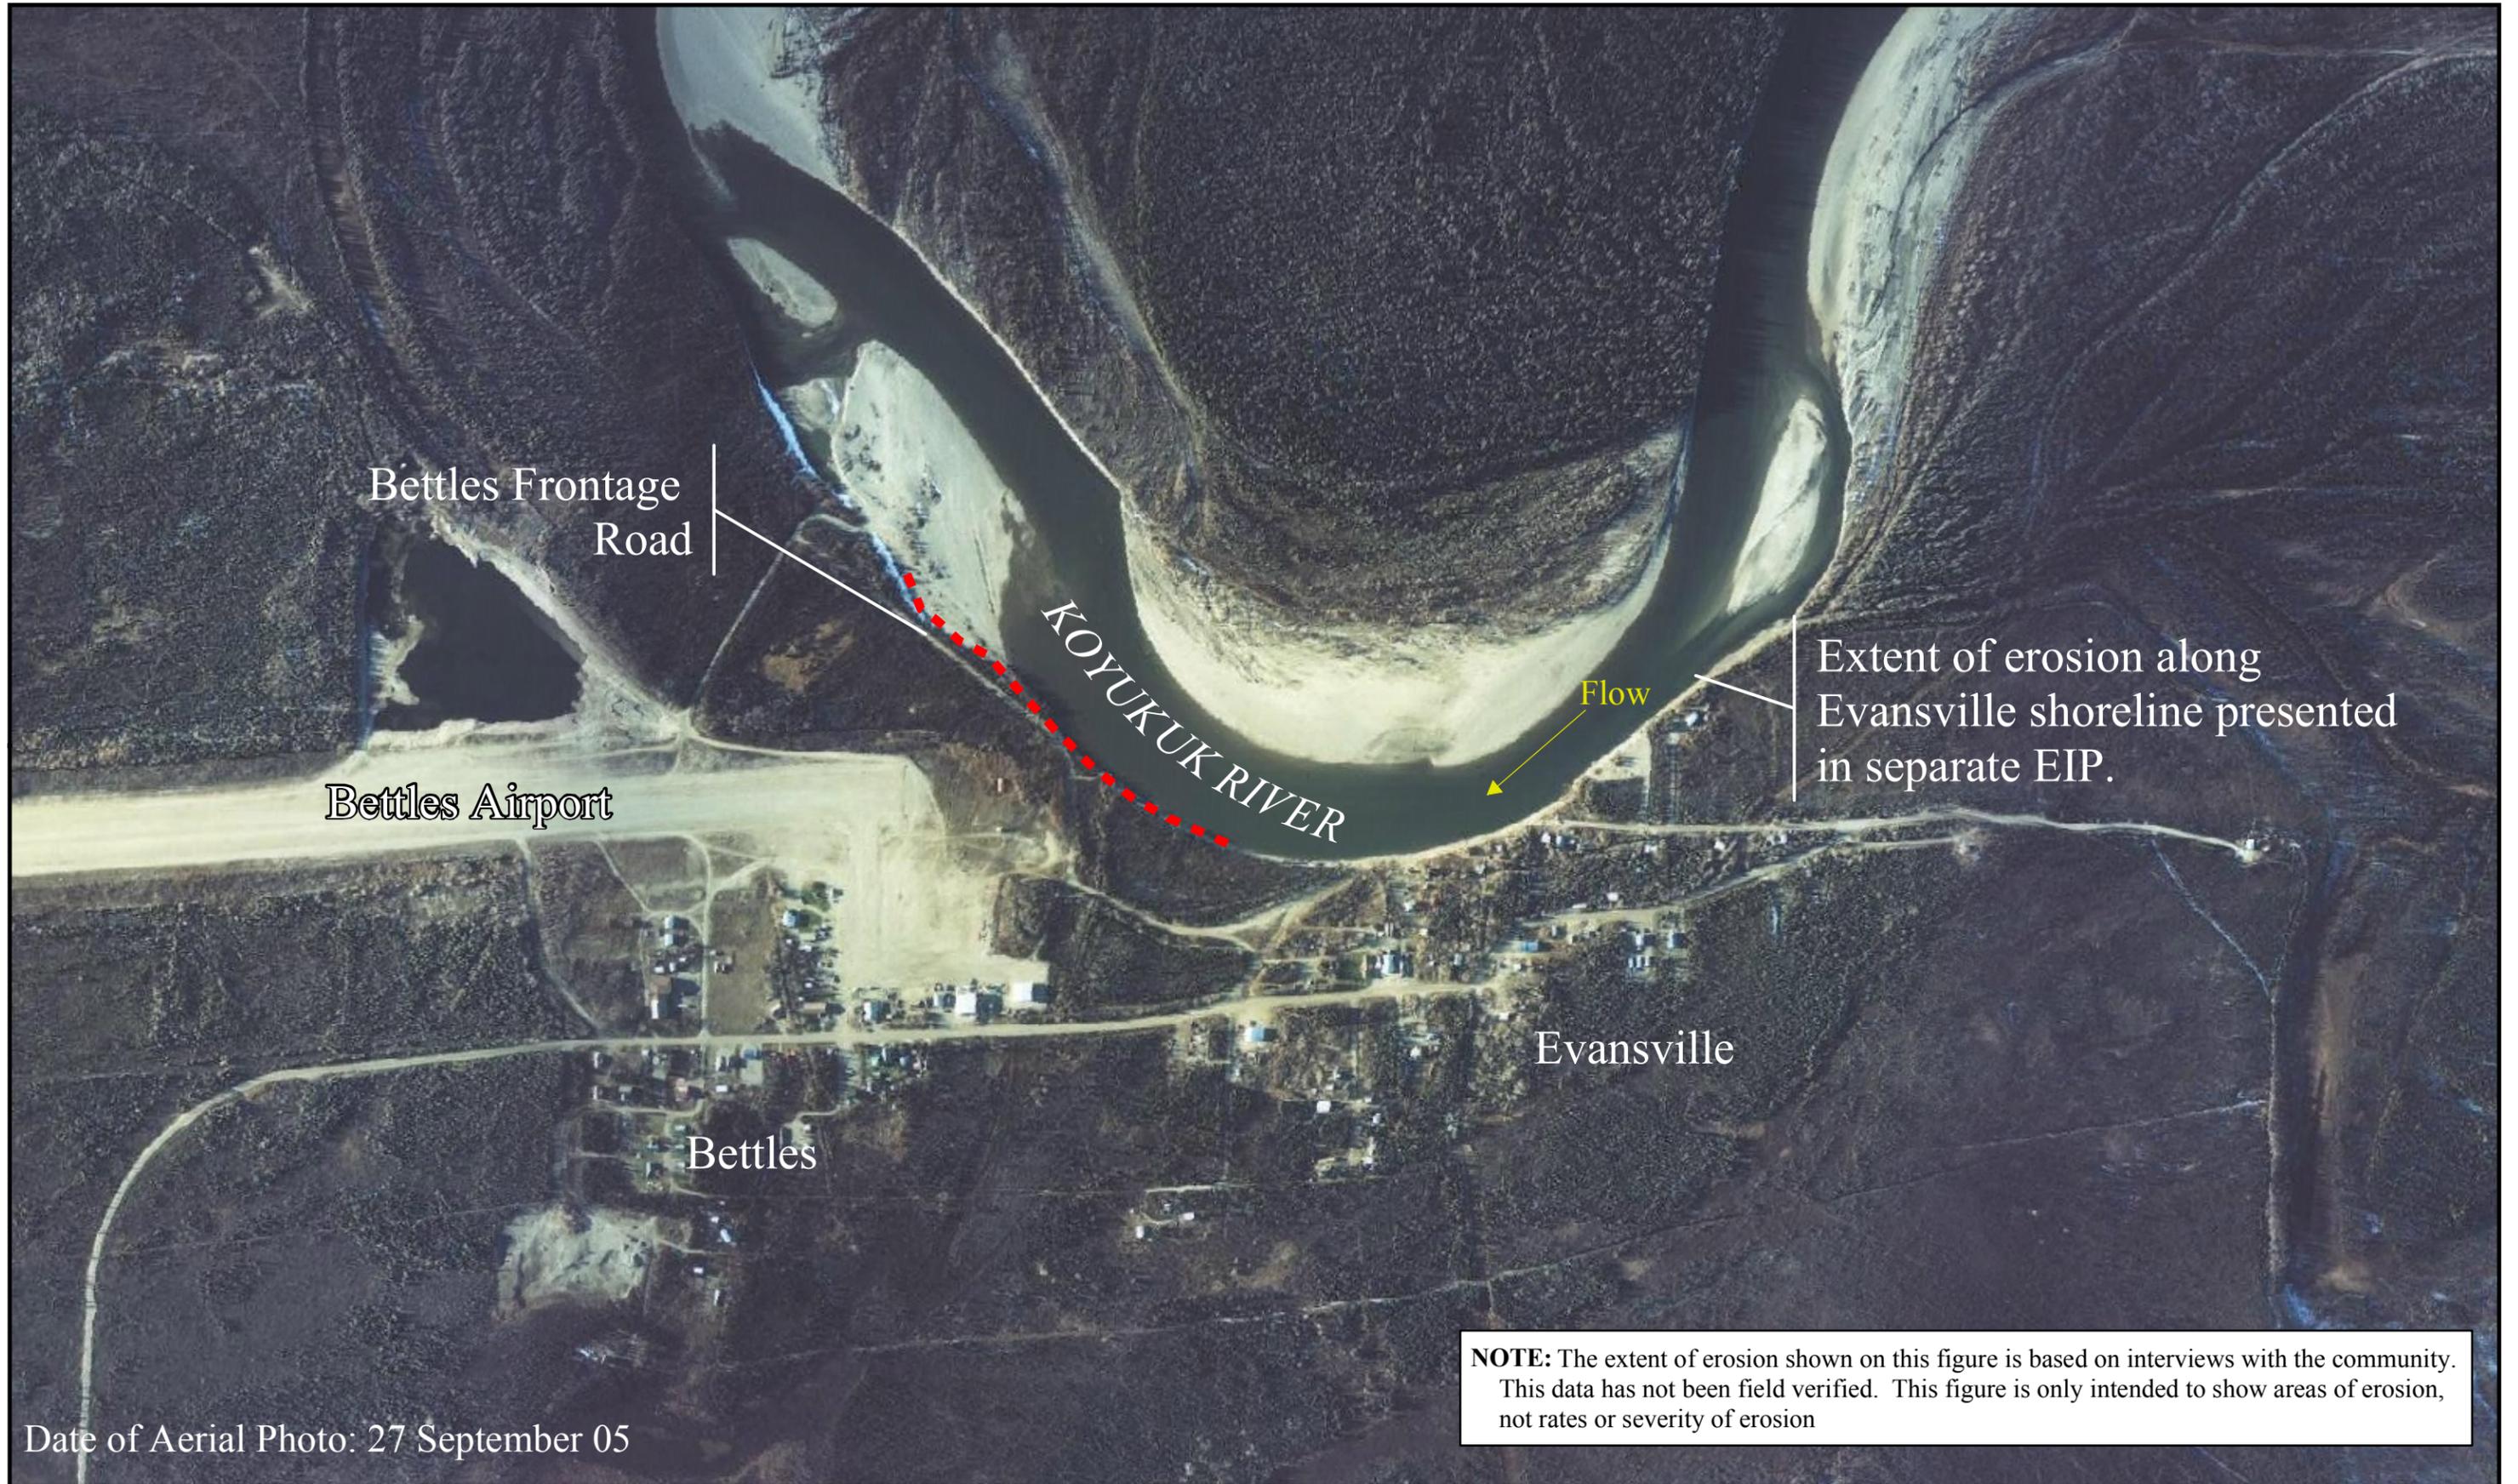
Alaska Baseline Erosion
Bettles, Alaska

Based on the community survey, Bettles experiences seasonal erosion associated with the Koyukuk River; a main tributary of the Yukon River. Natural river flow, heavy rains, flooding, ice jams, spring breakup, and melting permafrost are conditions causing and contributing to the riverine erosion. The community estimates the bank height in the erosion area to be 15 to 20 feet, with ongoing erosion occurring at about 10 feet per year.

According to the community survey, some sections of the frontage road less than 100 feet from the eroding riverbank are the only structures at risk in Bettles. The relative importance of this road to the livelihood or safety of the community was not stated in the survey. The portion of the state-owned Bettles airport closest to the river is about 2,000 feet away, according to the survey respondent.
