U.S. Army Corps
of Engineers
Alaska District

ALASKA BASELINE EROSION ASSESSMENT

Erosion Information Paper - Big Delta, Alaska

Current as of November 15, 2007

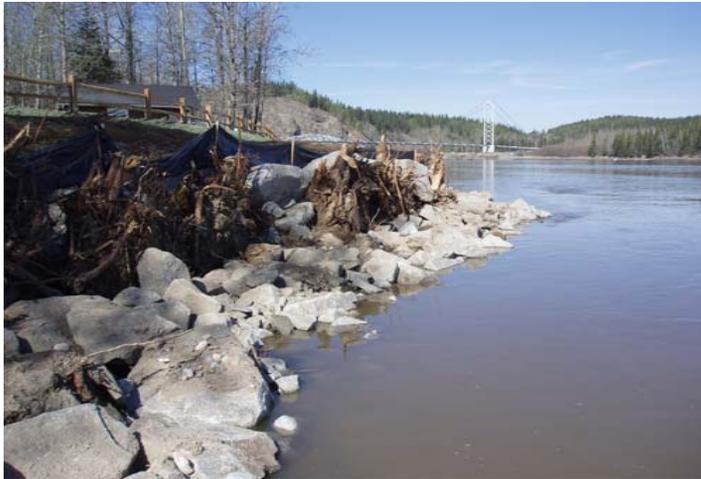
Photo 1: Toe rock & root wad erosion protection during installation along Tanana River at Rika's Roadhouse. Pipeline crossing is in background, USDA, NRCS photo, 2007.

Rika's Roadhouse is threatened by river bank erosion along the Tanana River. The U.S. Fish and Wildlife Service and Natural Resources Conservation Service (NRCS) completed an erosion protection project in this area during 2007. The project included treating (a) a 200-foot section with toe rock, rootwads, and burritos; (b) a 110-foot section with brush layering/burritos; and (c) an additional 110 feet of riverbank with live stakes. "Burritos" are willow cuttings, native soil,

and straw mulch rolled up in a high-strength erosion control blanket. The NRCS state conservation engineer said the total NRCS project cost was \$300,000.

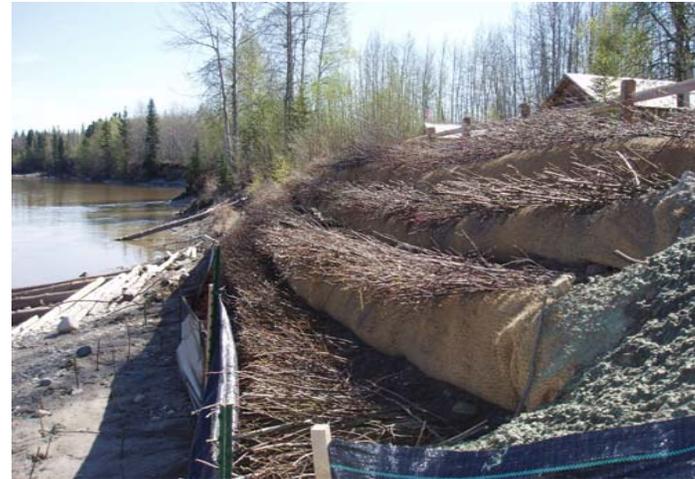
Photo 2: Willow burritos along Tanana River, looking upstream adjacent to Rika's Roadhouse, USDA, NRCS photo, 2007.

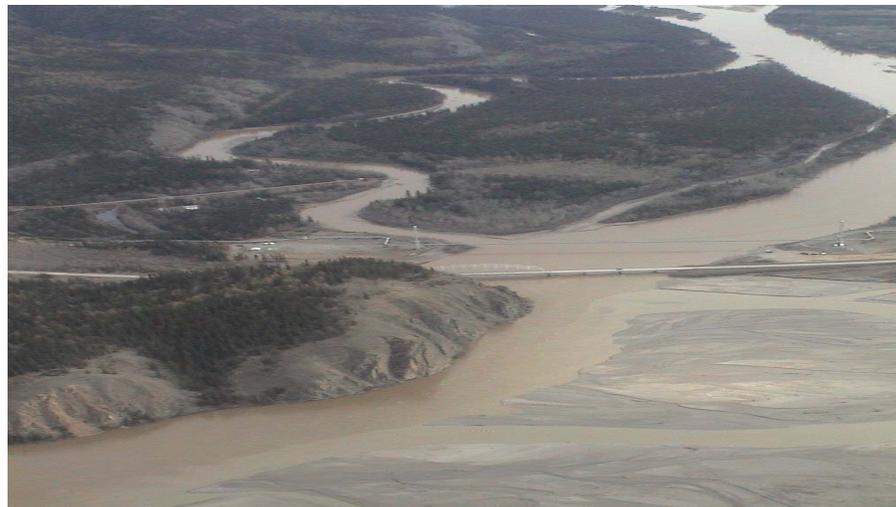
Photo 3: Big Delta area during the May 10, 2004 flood.

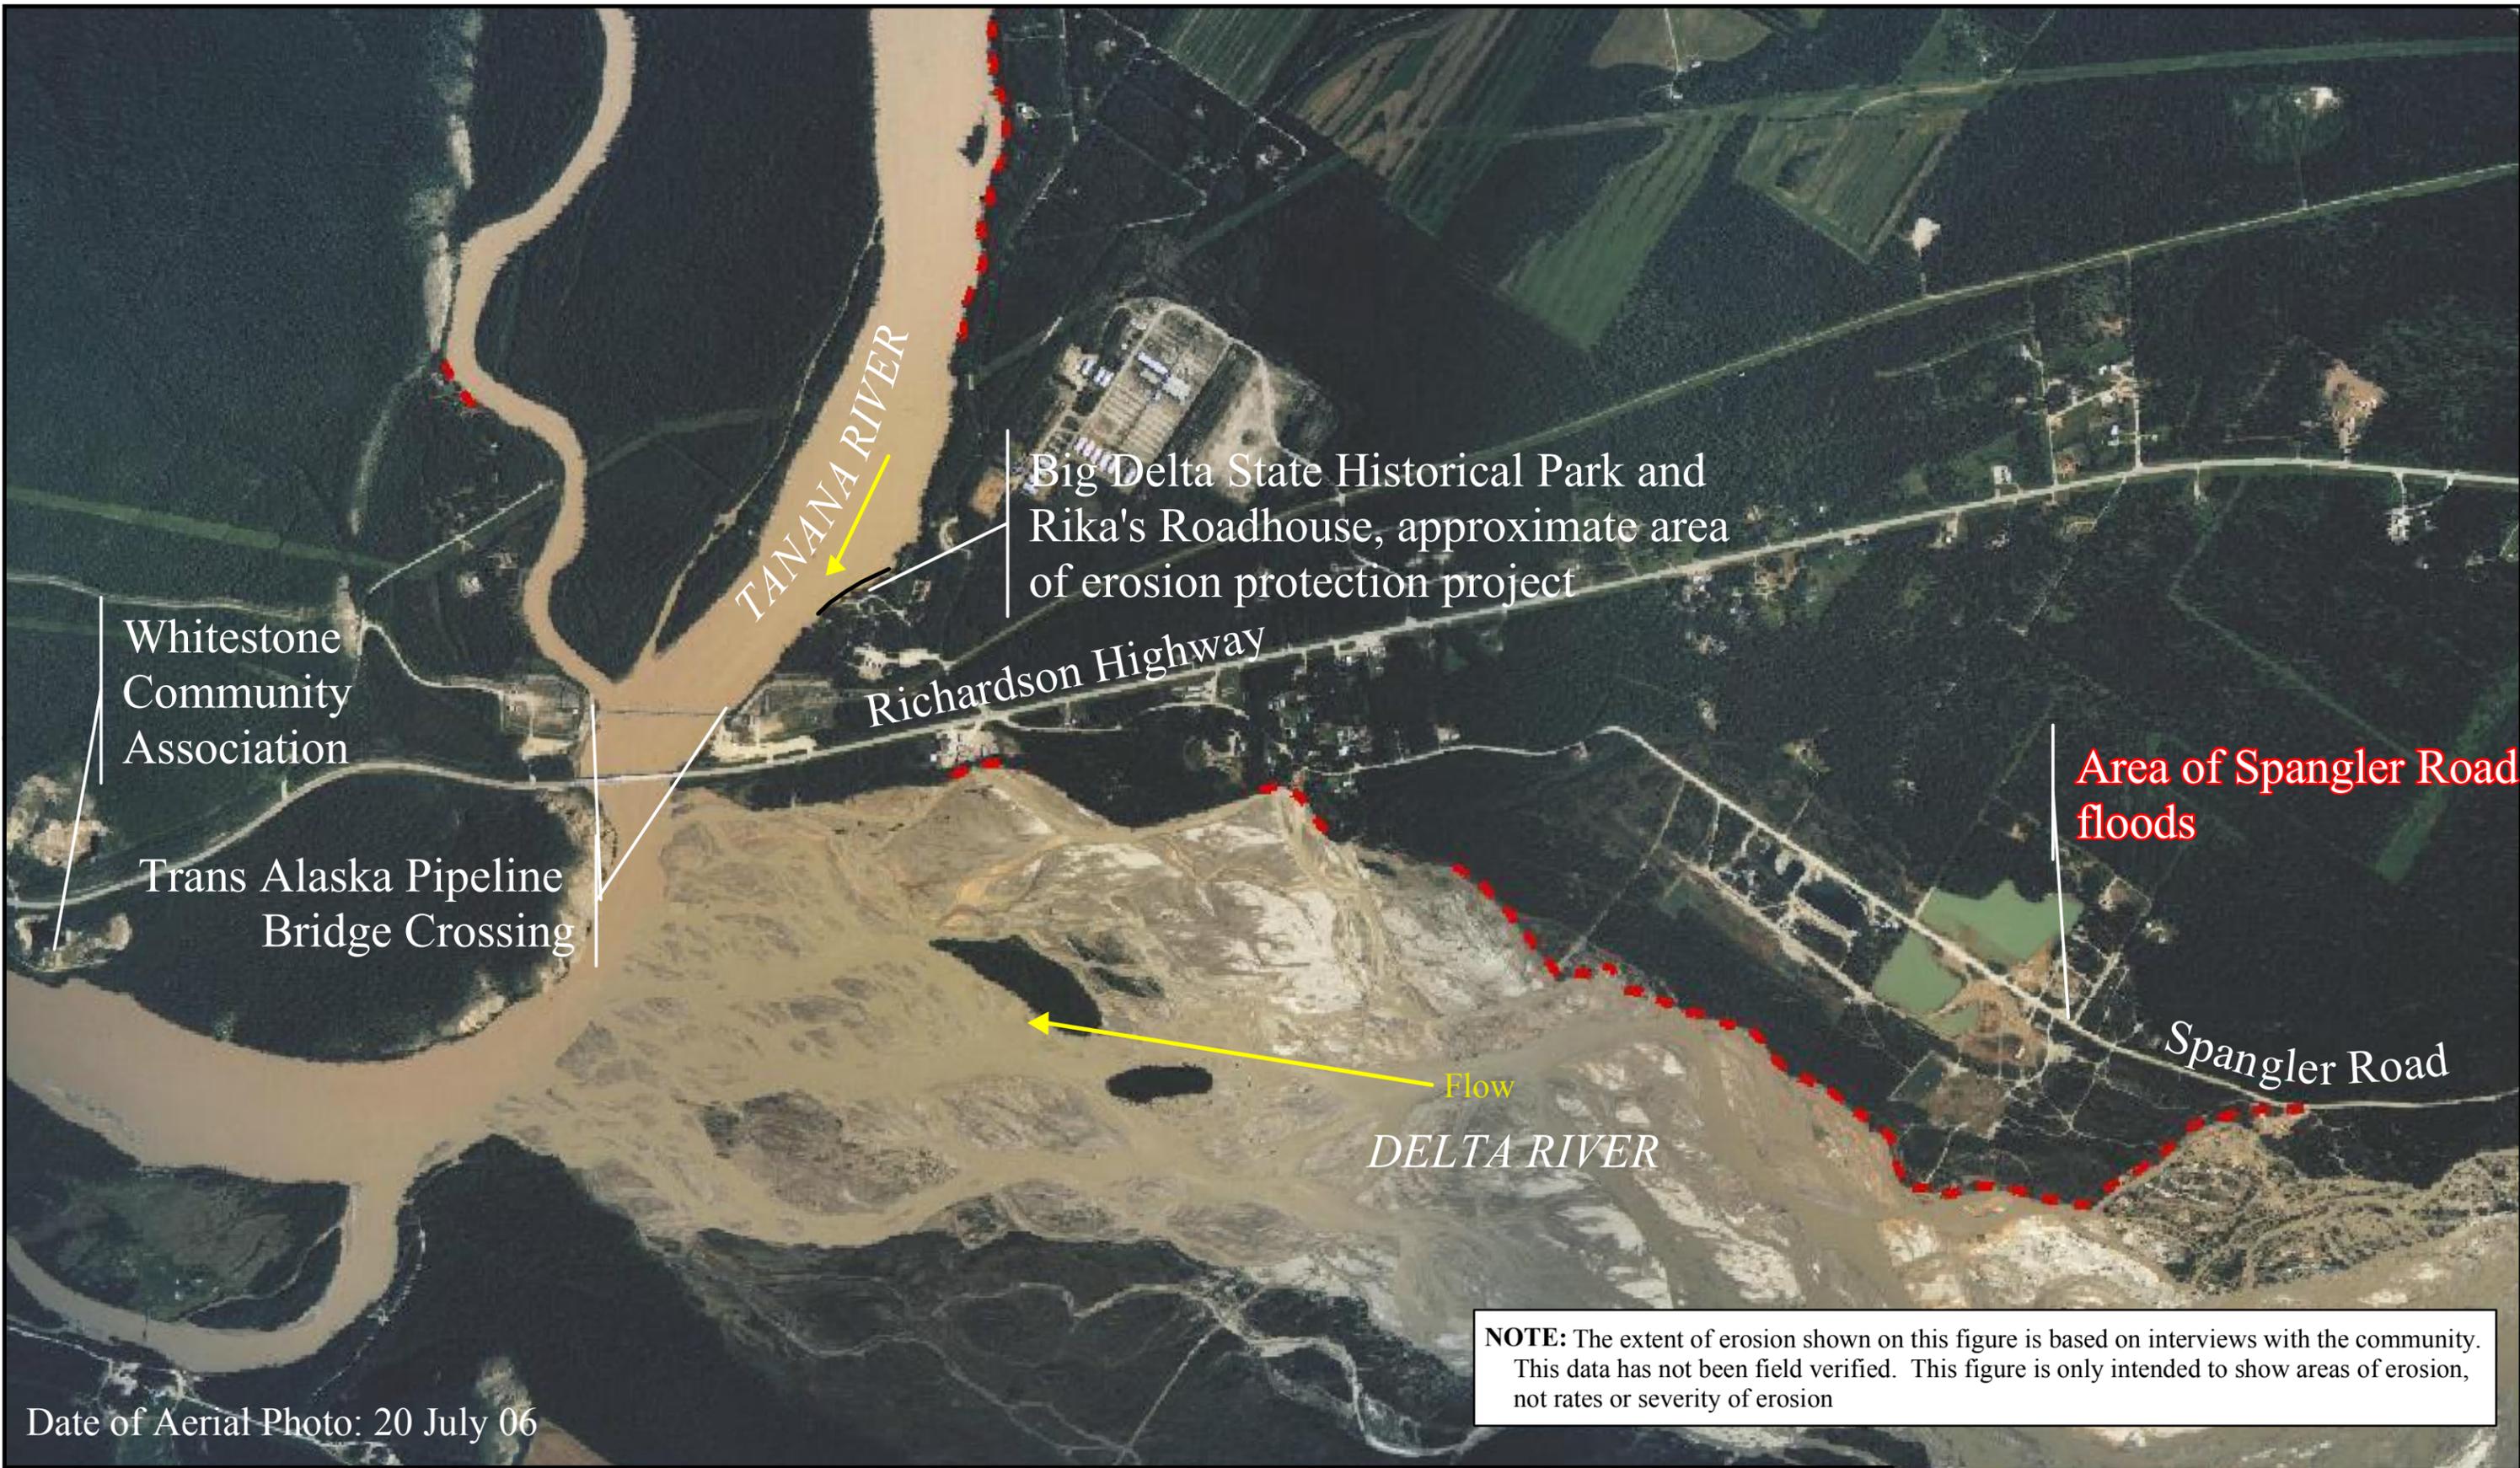
--- Linear Extent of Erosion
Part 1

The Deltana Community Corporation president estimates that the main bank is eroding along a 1 to 1.5-mile stretch of the Tanana River upstream from Rika's Roadhouse. The 2005 *Big Delta State Historical Park Riverbank Restoration Feasibility Study* reports that bank erosion in the area of the roadhouse is influenced by periodic vegetation clearing associated with ongoing vegetation maintenance practices and by pedestrian (visitor) traffic along the bank.

According to the community survey, approximately 6 homes upstream from the State Park are threatened by erosion. The majority of these homes are estimated to be between 100 and 500 feet from the river bank. In 2003, homeowners along the Tanana River and Deltana Community Corporation discussed applying for U.S. Department of Agriculture (USDA), NRCS Wildlife Habitat Improvement Program (WHIP) funds for a possible erosion protection project. It is not known if they applied. The community survey reported that in 2004 one of the property owners installed logs along the riverbank on their property.
