U.S. Army Corps
of Engineers
Alaska District

ALASKA BASELINE EROSION ASSESSMENT

Erosion Information Paper - Buckland, Alaska

Current as of September 20, 2007

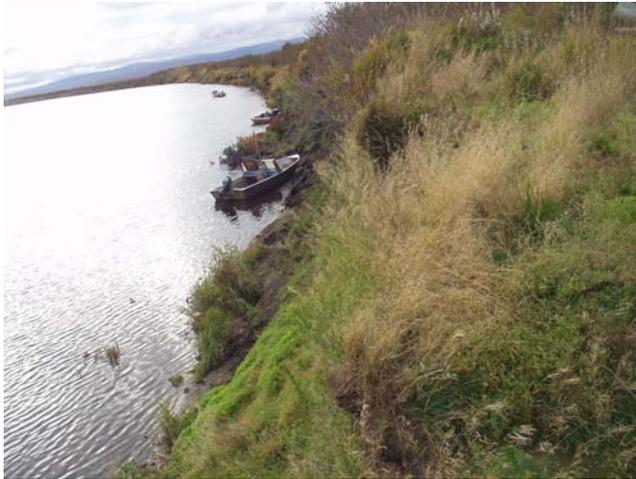
Photo 1: Buckland River bank, September 2007.

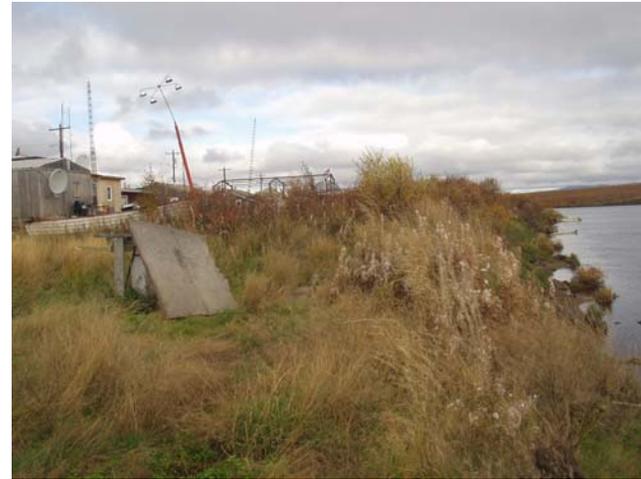
Photo 2: Erosion along Buckland River, September 2007.

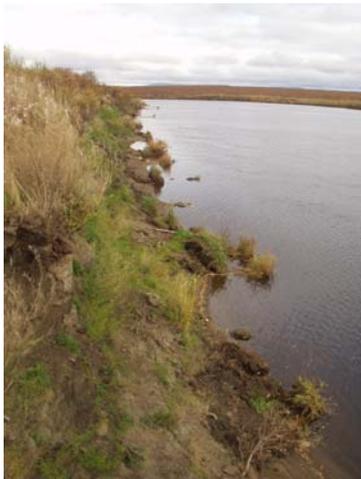
Photo 3: Buckland Riverbank, September 2007.

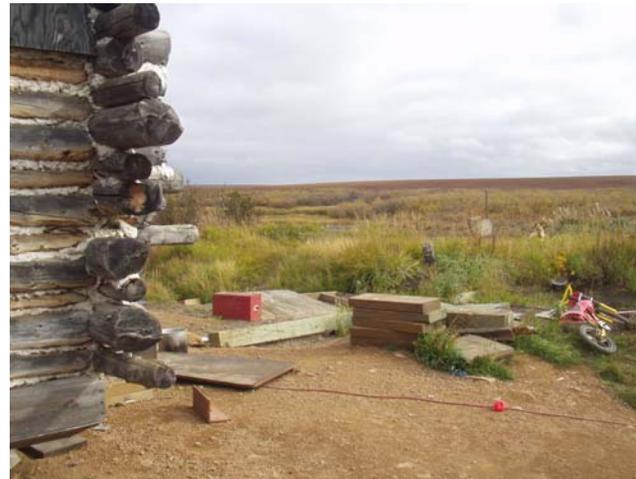
Photo 4: House threatened by Buckland River erosion, September 2007.

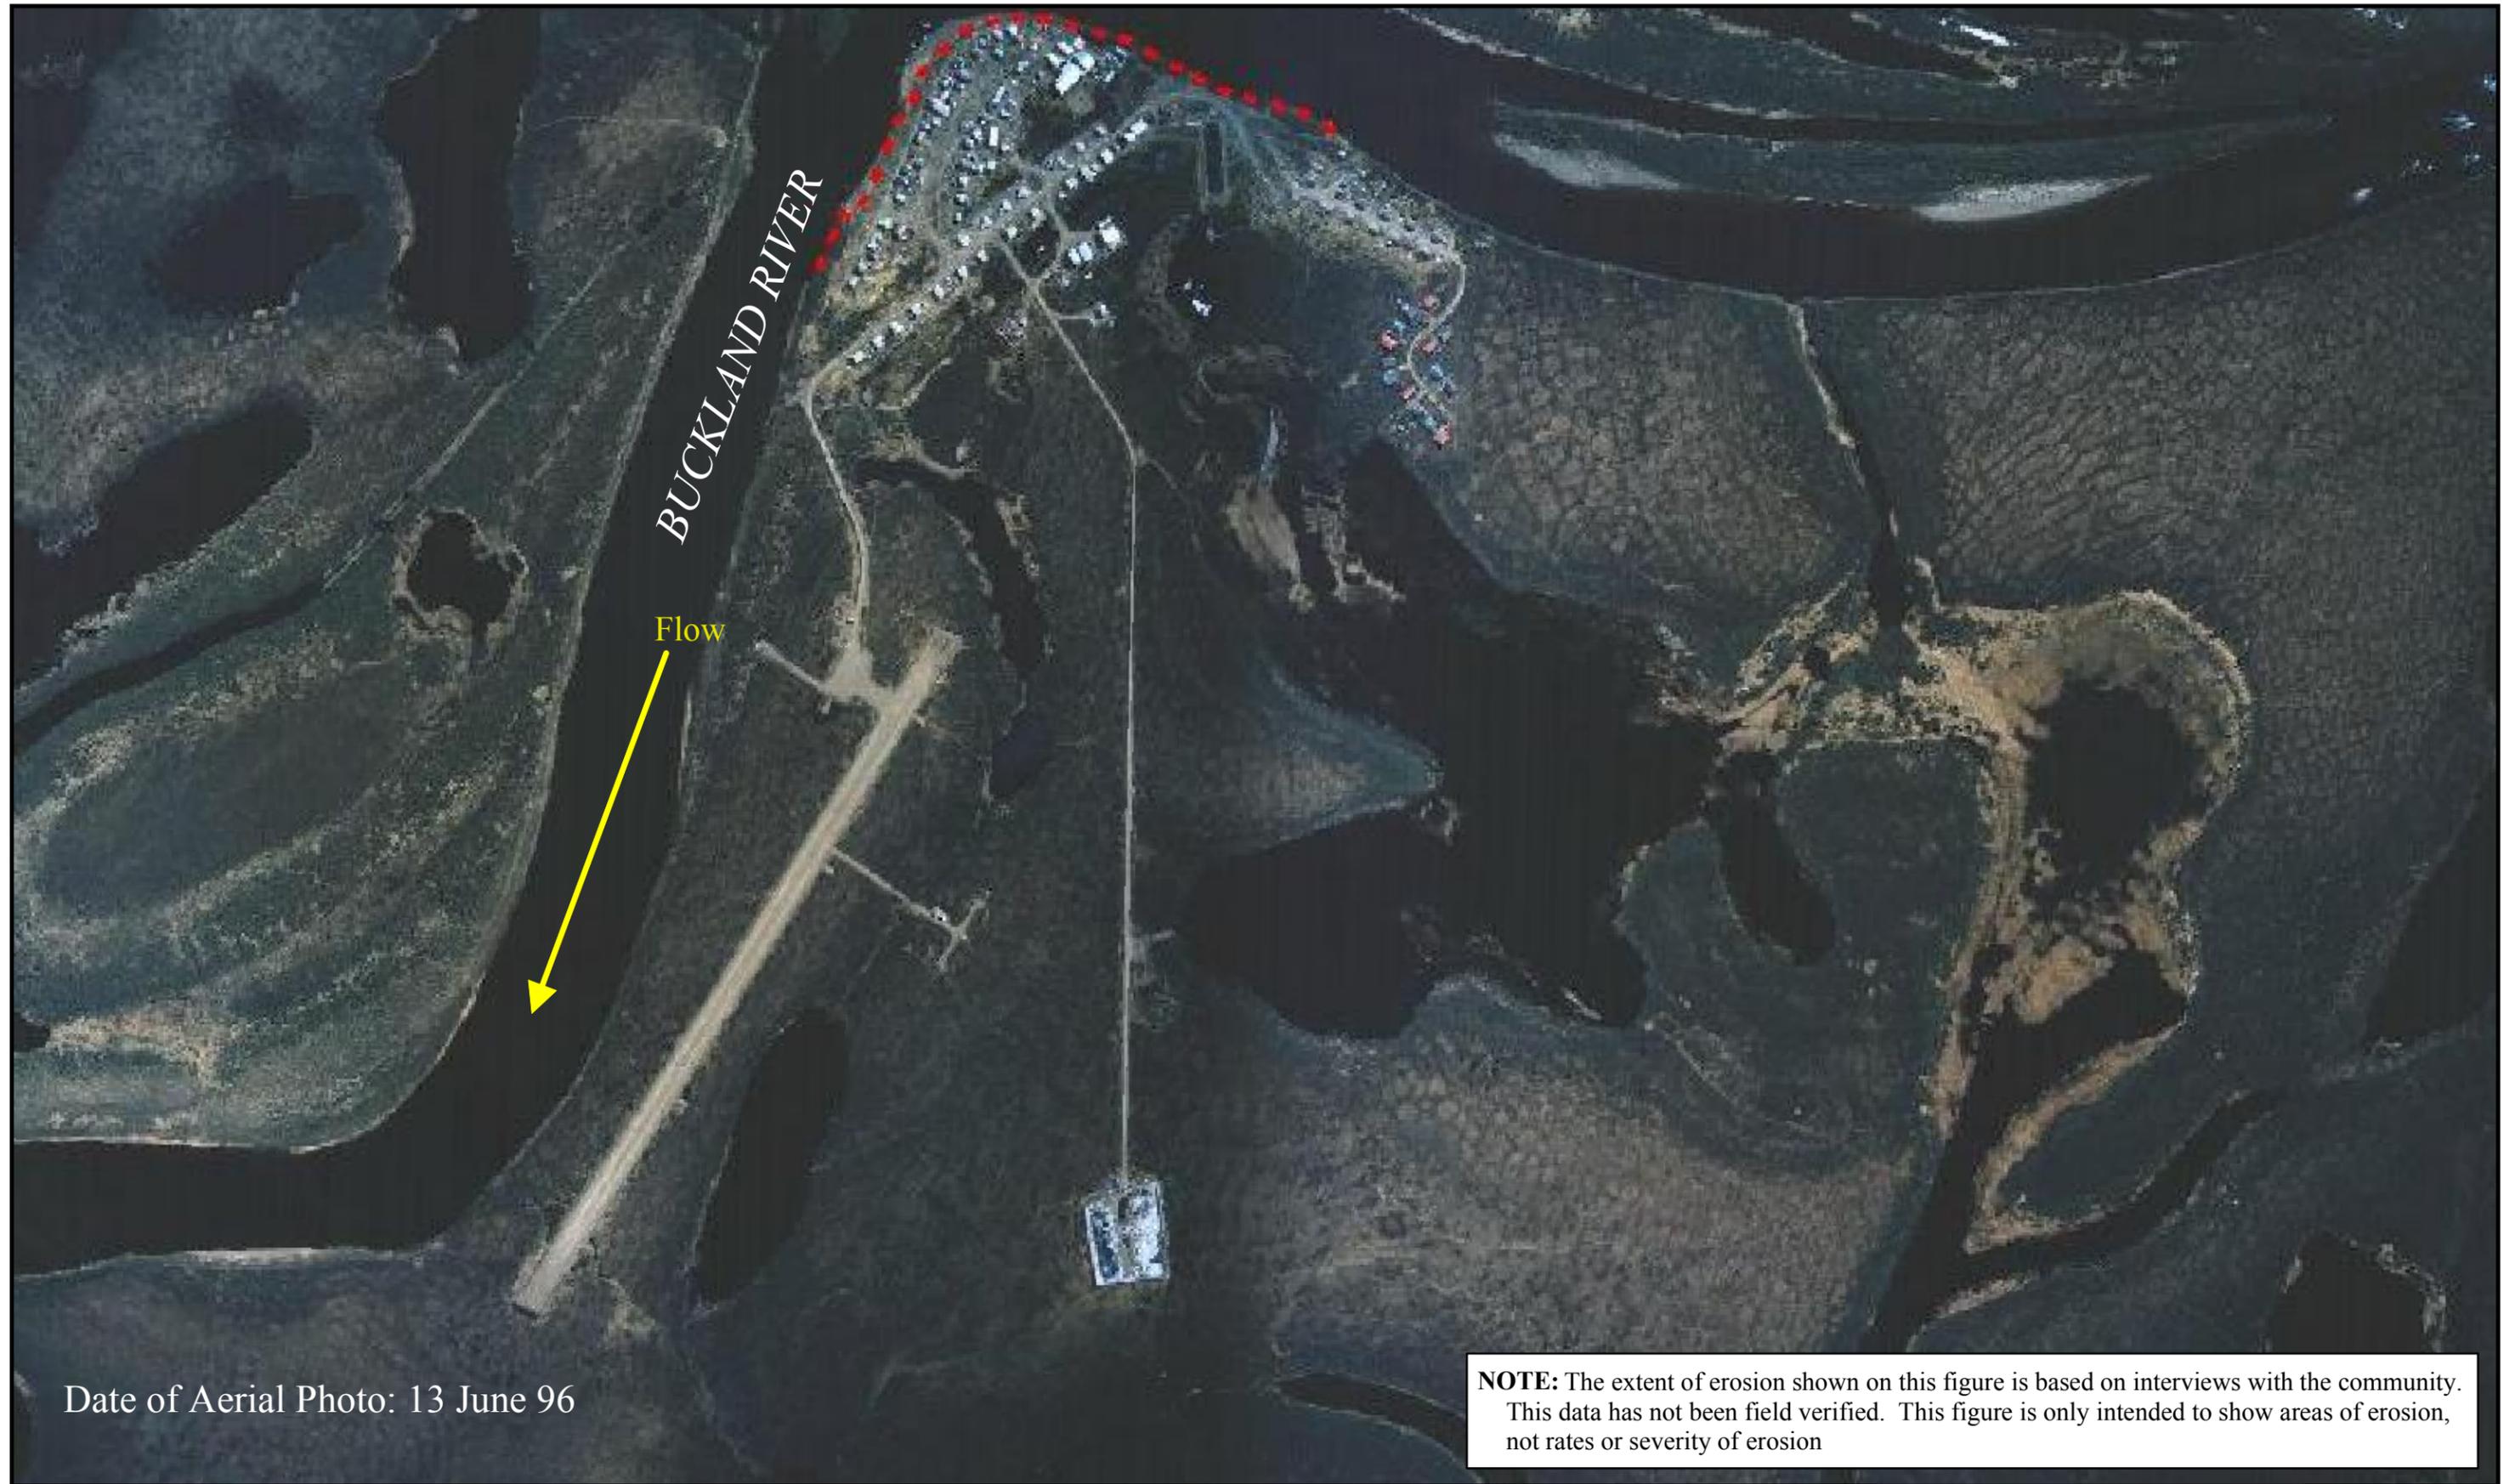
Alaska Baseline Erosion
Buckland, Alaska

--- Linear Extent of Erosion
