ALASKA BASELINE EROSION ASSESSMENT

Erosion Information Paper - Butte, Alaska

Current as of October 16, 2007

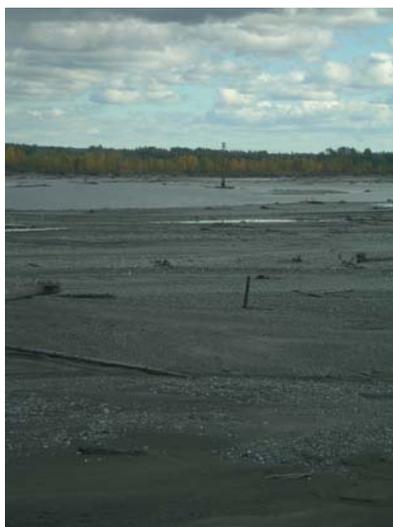
Photo 1: Matanuska River; well head remaining of home lost to river erosion, September 2007.

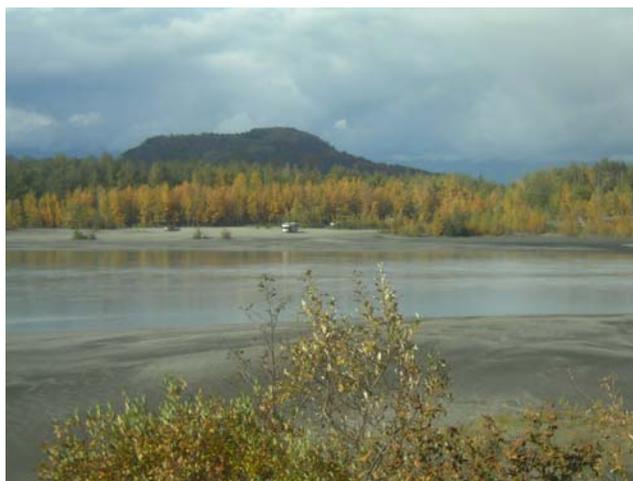
Photo 2: View north across Knik River to Bodenburg Butte in background, September 2007.

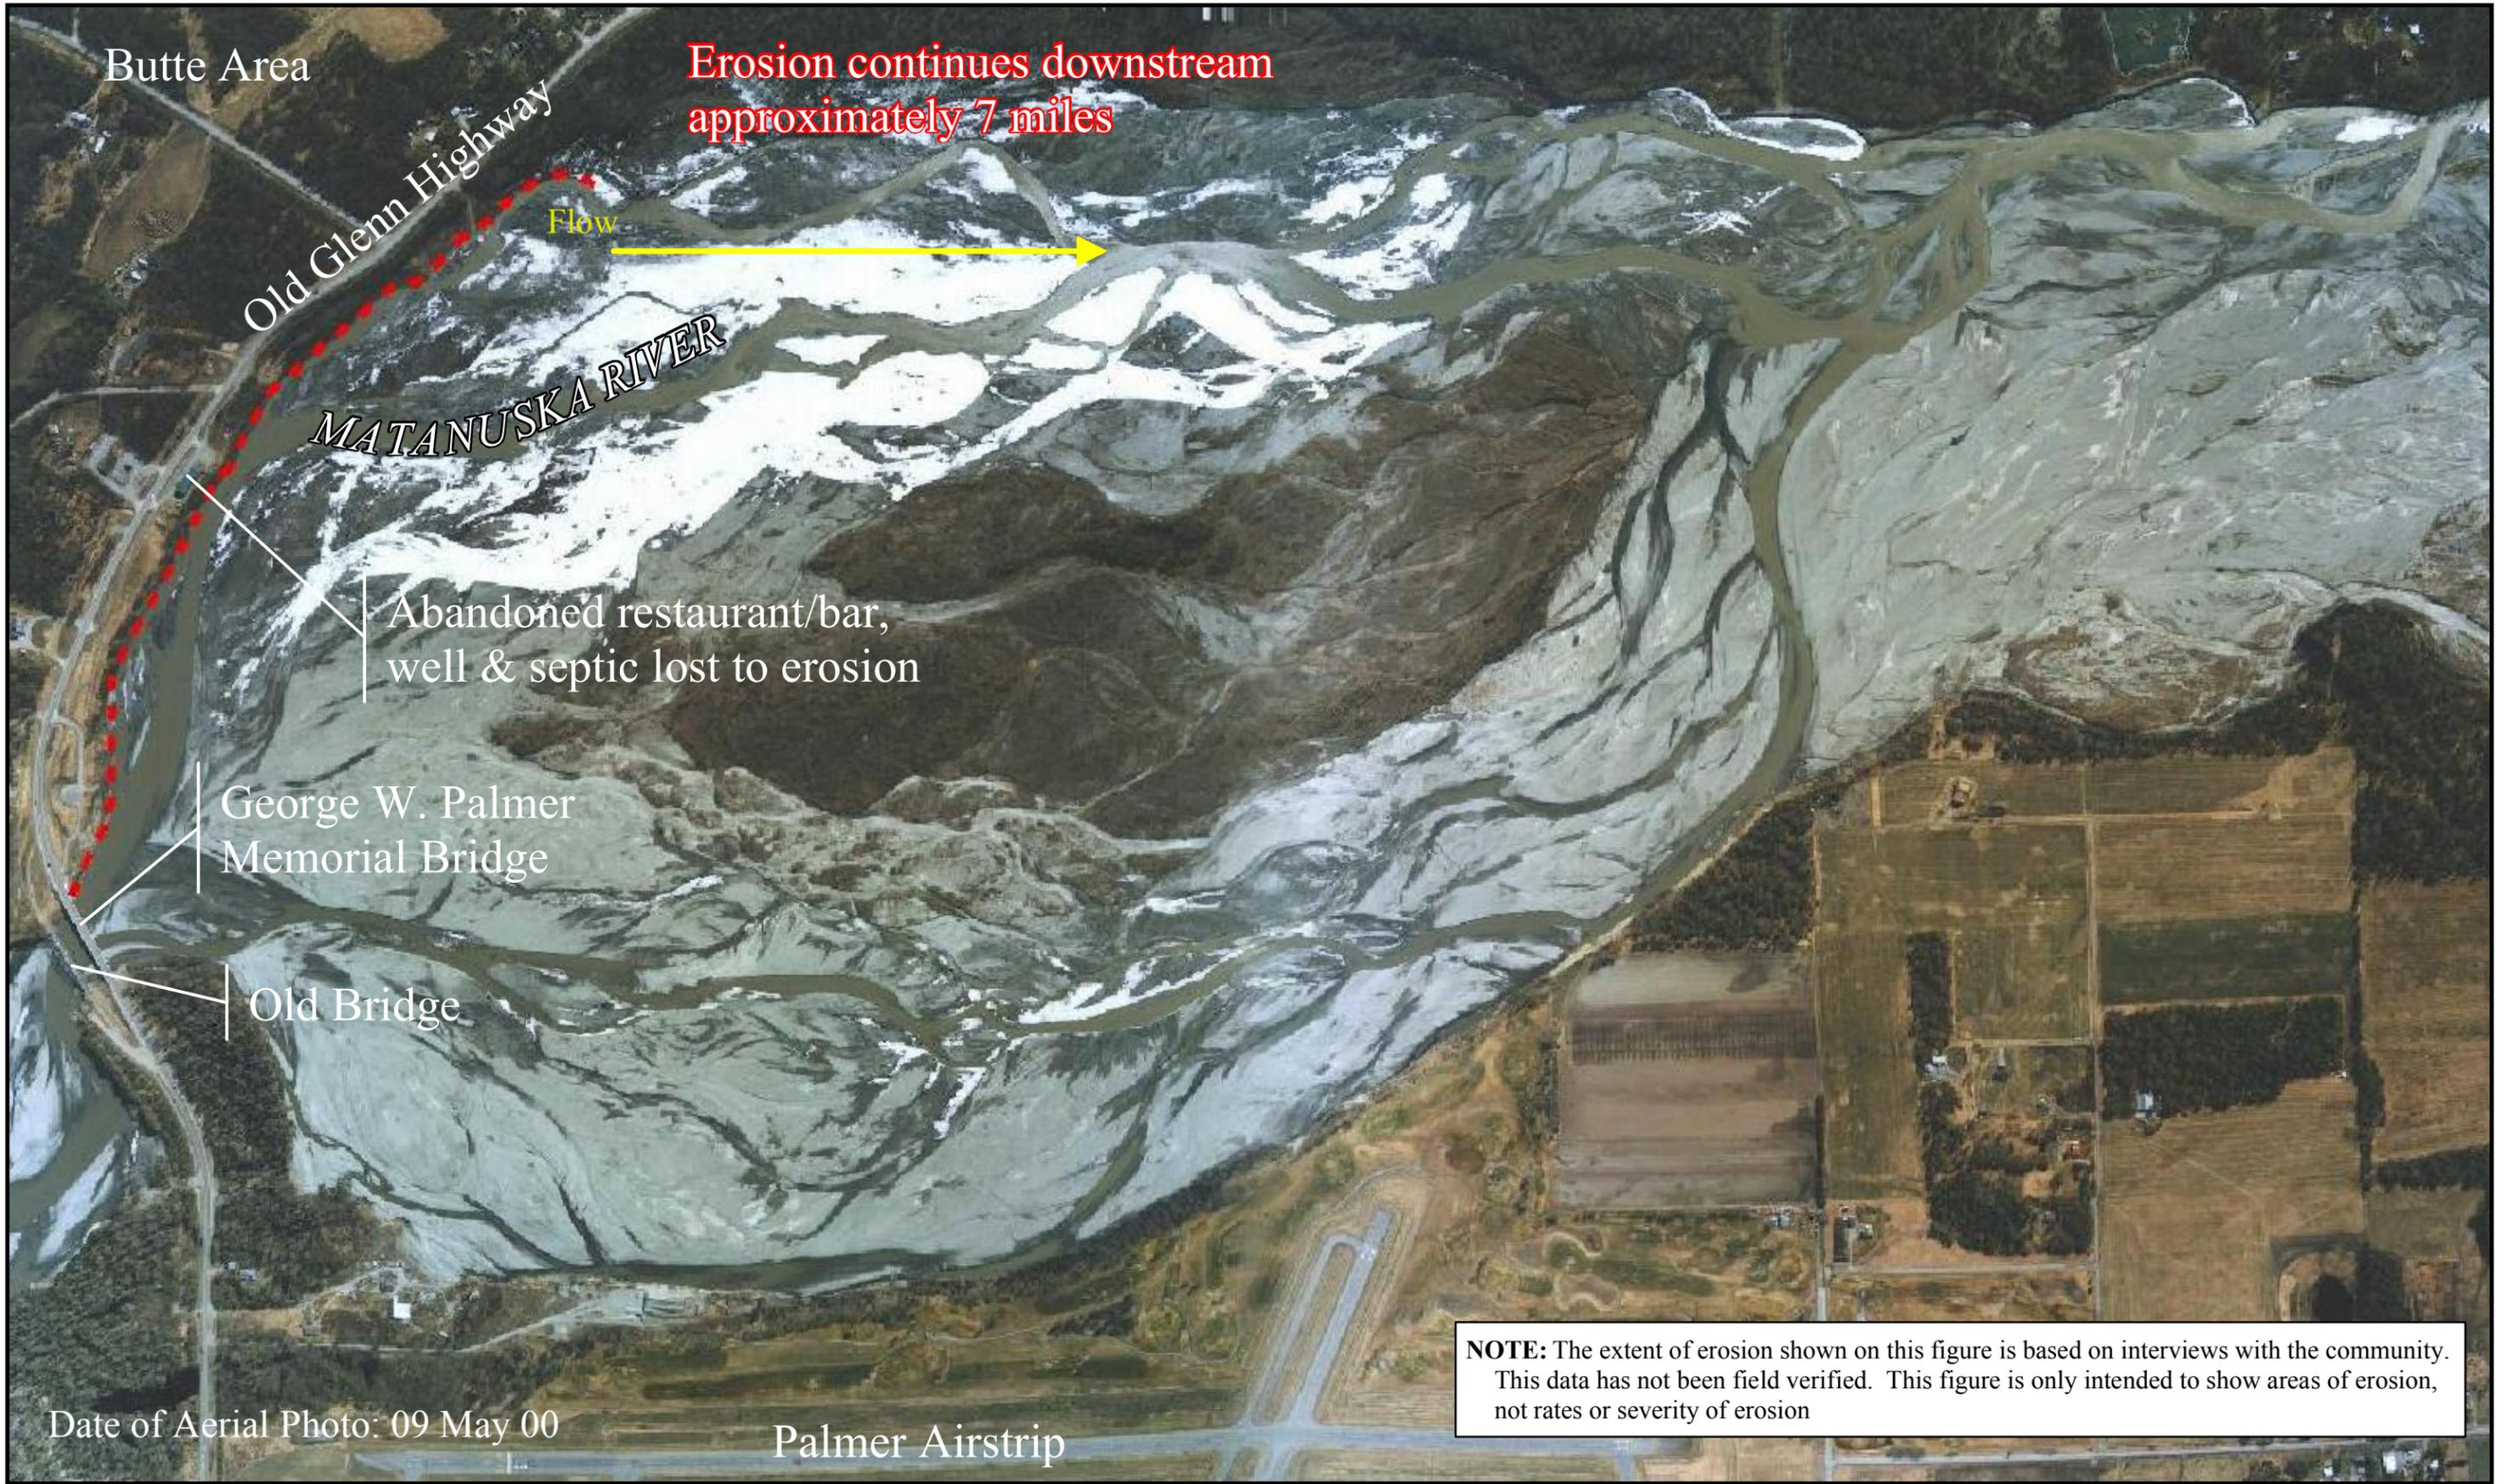
--- Linear Extent of Erosion
Part 1

Erosion continues downstream
approximately 7 miles

Abandoned restaurant/bar,
well & septic lost to erosion
