U.S. Army Corps
of Engineers
Alaska District

ALASKA BASELINE EROSION ASSESSMENT

Erosion Information Paper - Cantwell, Alaska

Current as of September 24, 2007

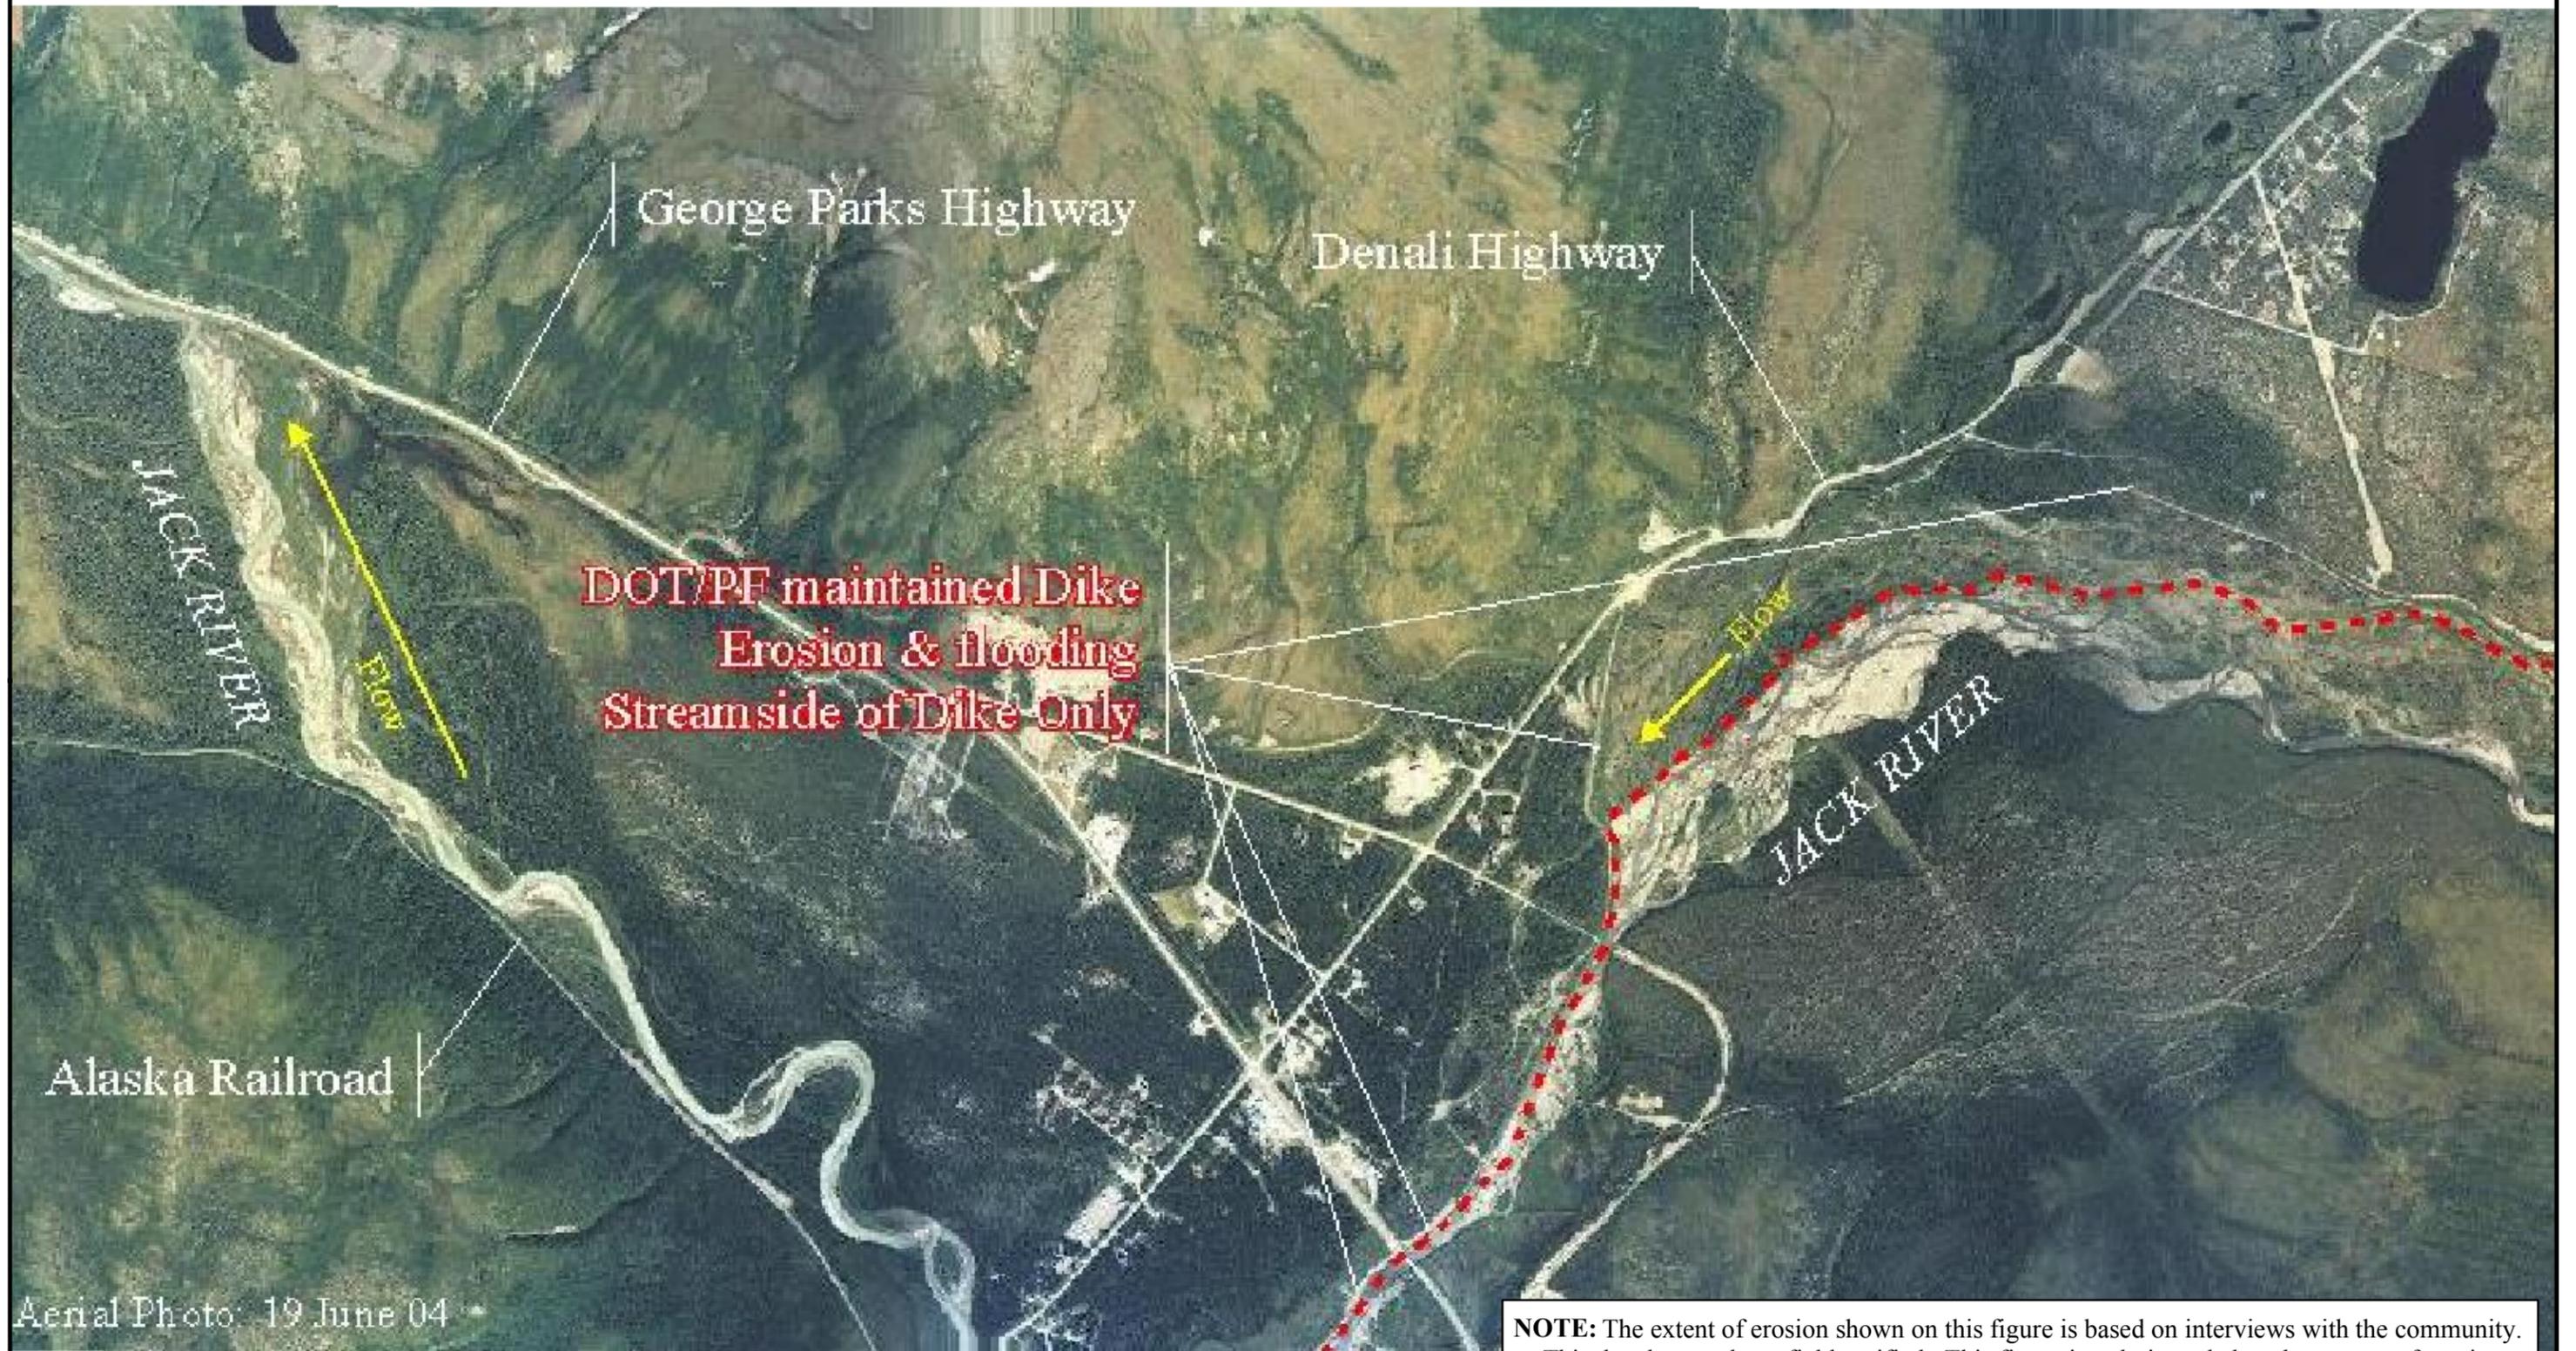
Aerial Photo: 19 June 04

No photos were provided by community or other sources. See attached diagram showing linear extent of erosion.
