U.S. Army Corps
of Engineers
Alaska District

ALASKA BASELINE EROSION ASSESSMENT

Erosion Information Paper – Chalkyitsik, Alaska

Current as of November 3, 2007

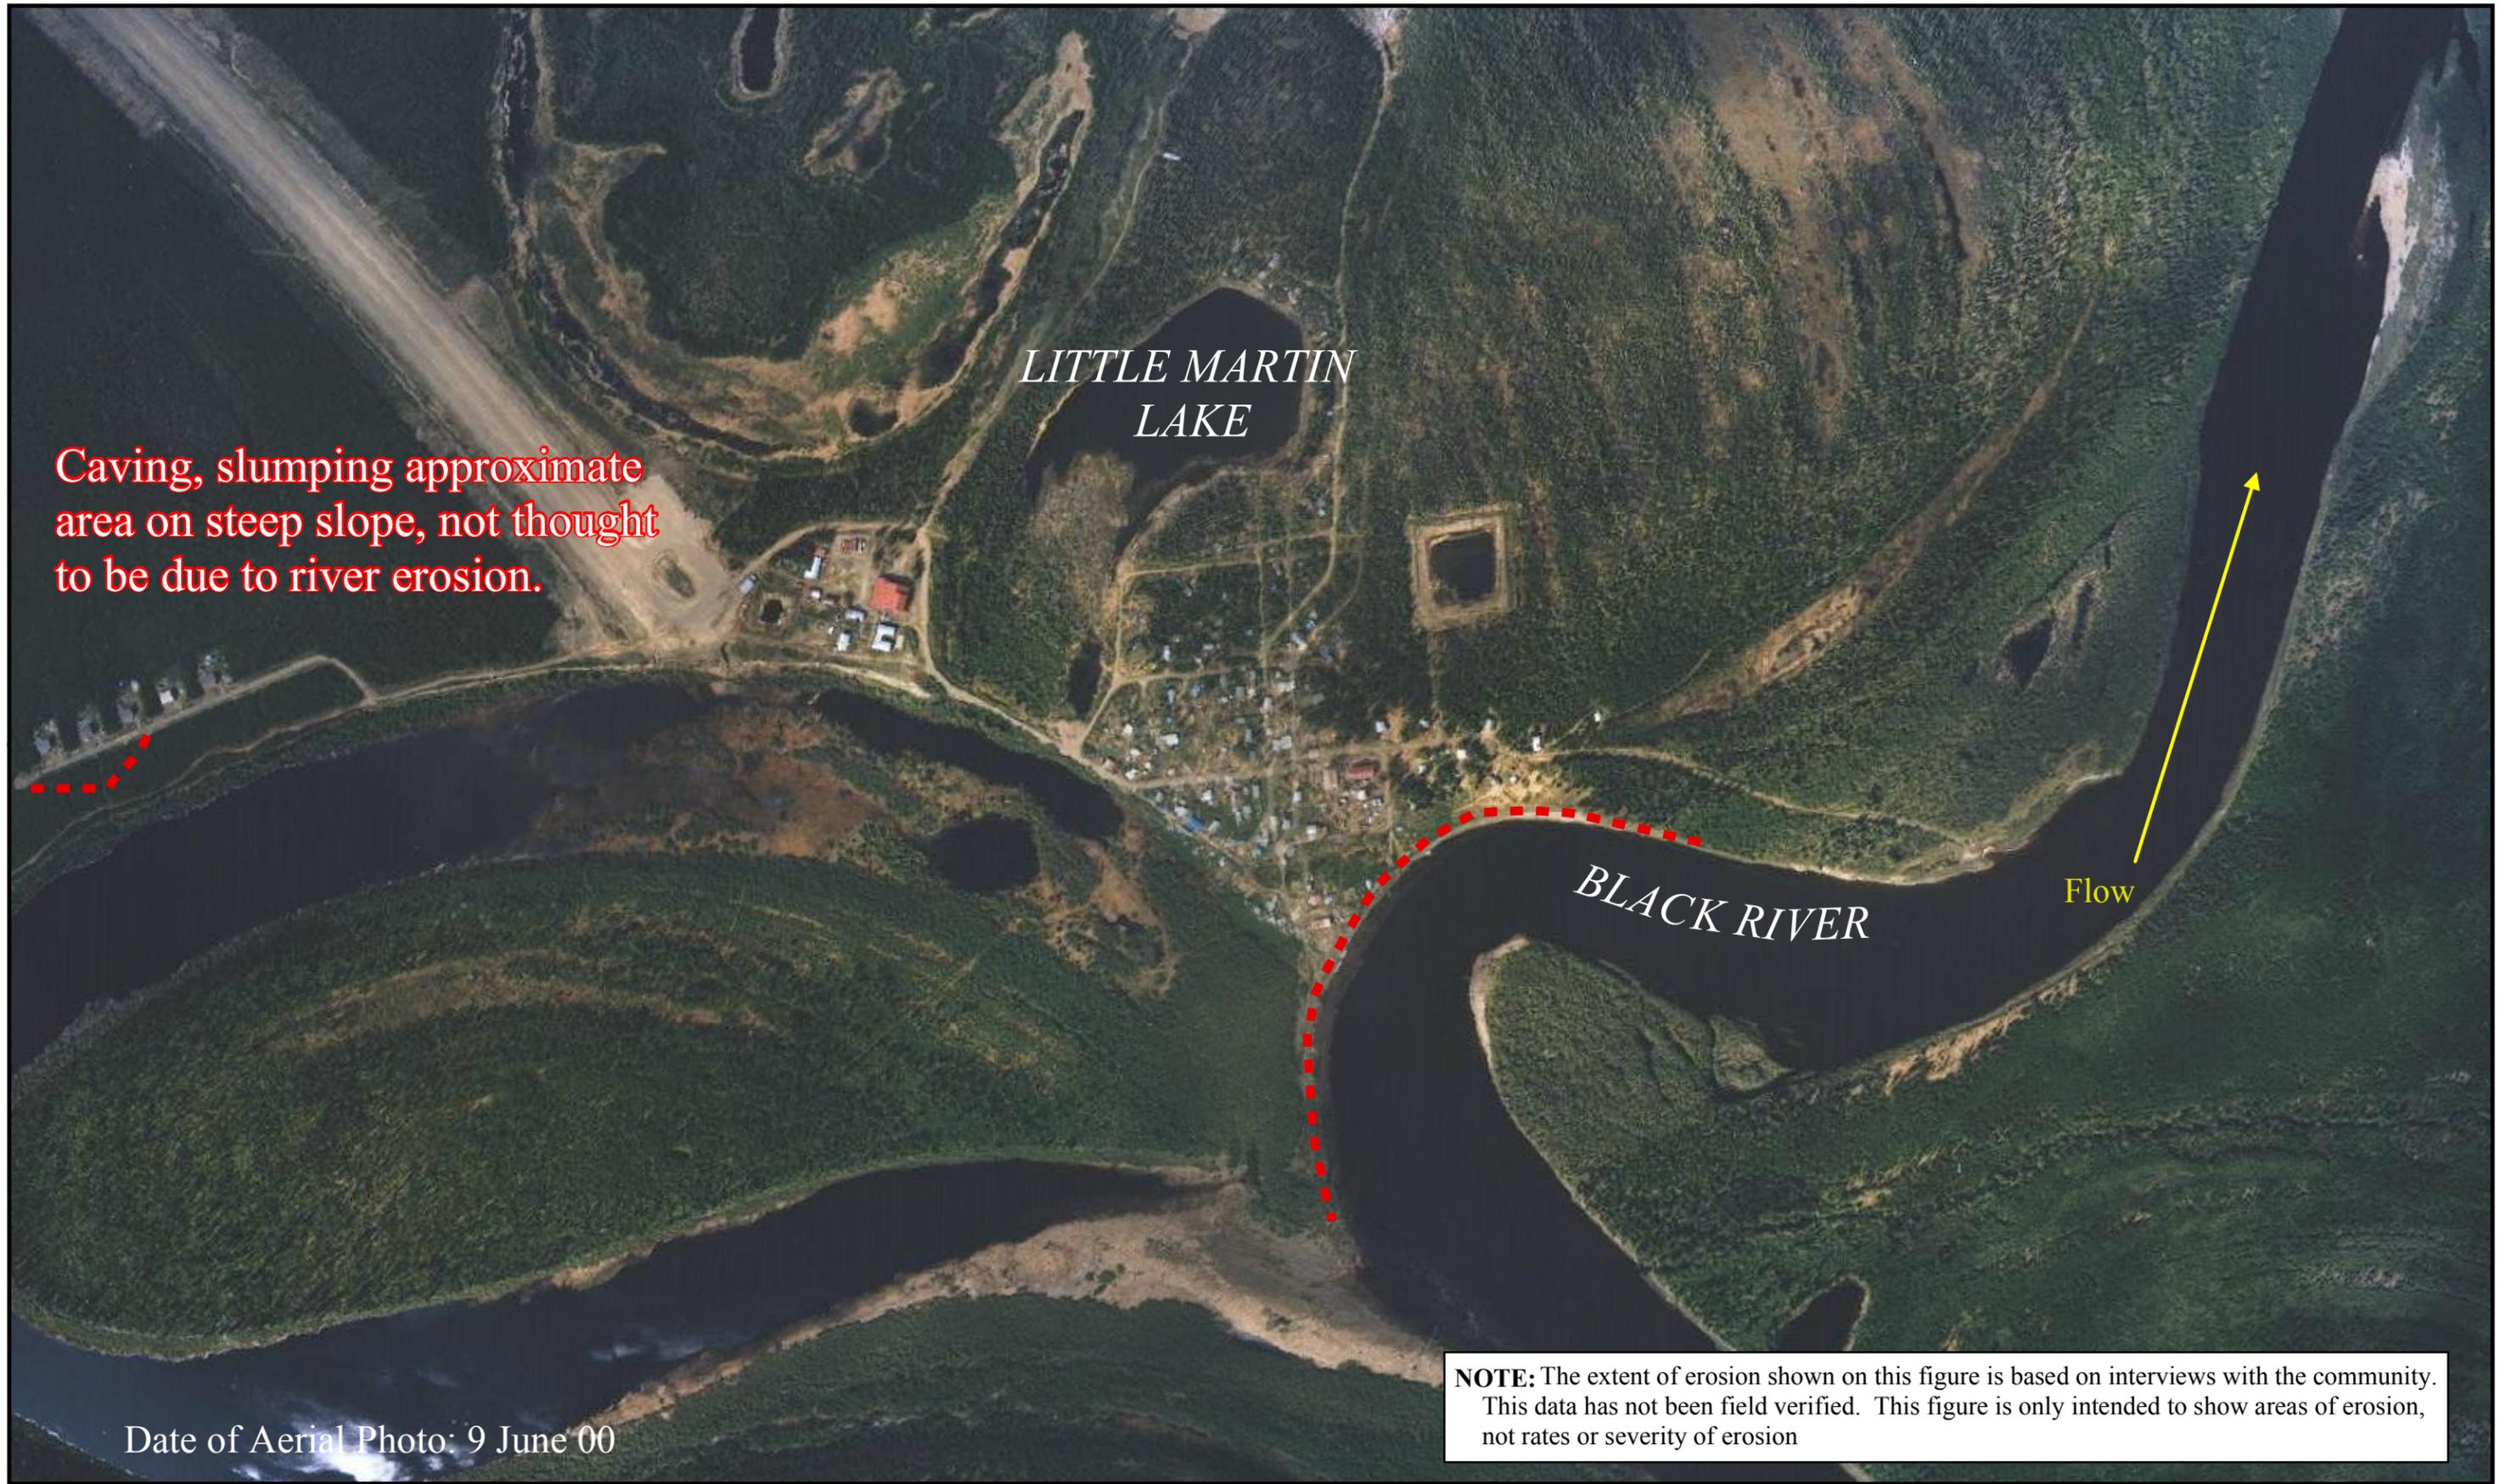
Alaska Baseline Erosion
Chalkyitsik, Alaska

The village of Chalkyitsik experiences gradual erosion along the entire bank of the Black River (about 2 linear miles). The river moves, abandoning old channels and cutting new ones. The river shore ranges from gradual beach to vertical bluffs about 12 feet above normal water level. A “river oxbow” next to the village is intermittently dry and then flowing as the river shifts. Riverine erosion is mainly caused by natural river flow. Ice jams, spring breakup, and seasonal flooding are factors contributing to severity. According to the community survey, melting permafrost and the activity of people and ATVs along the shore can also increase localized erosion. In 1987, about 3 feet of inland erosion occurred and a 2-story house was moved to prevent it being damaged. In 1997, about 300-feet of the Black River next to the community eroded inland about 10 feet. In 2000, the erosion rate was reported to be about 1 foot per year. According to the Corps *Online Flood Hazard Data*, flooding (with some erosion likely) is a common occurrence. Significant flooding occurred in 1937, 1947 or 1948 and 1967. The 1967 flood was the highest measurable flood.

Based on the community erosion survey, the river is less than 100 feet from 4 houses, 2 out-buildings, 2 roads, and the water treatment plant/washeteria/clinic building. A hillside area near 5 homes is caving in or slumping. The homes are on high ground and the river does not rise this high, so the cause of the slumping is unknown.
