ALASKA BASELINE EROSION ASSESSMENT

Erosion Information Paper - Chevak, Alaska

Current as of December 5, 2008

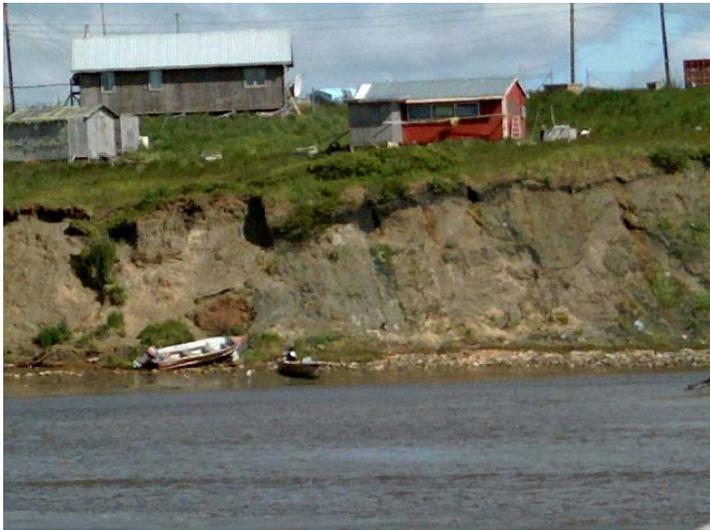
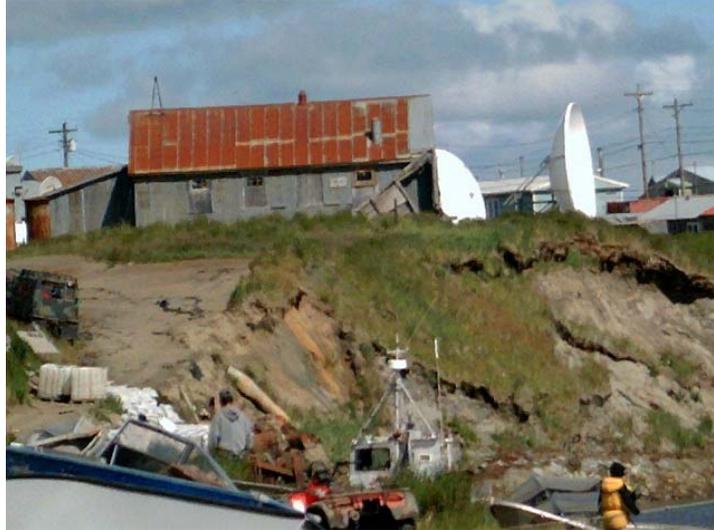
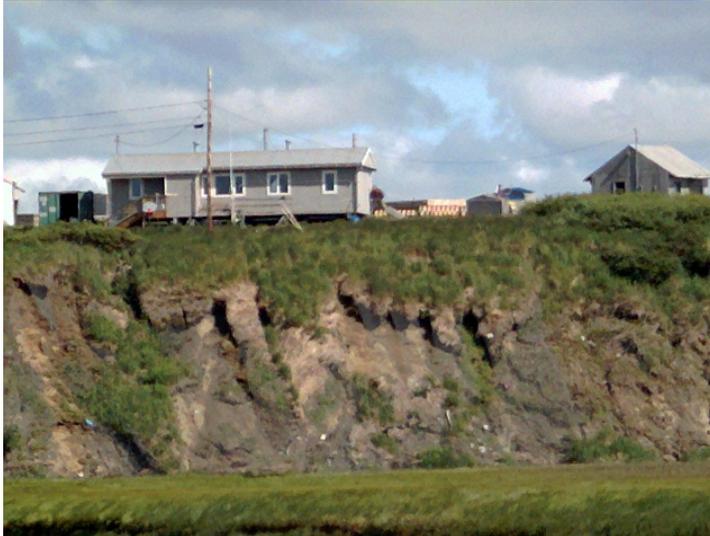
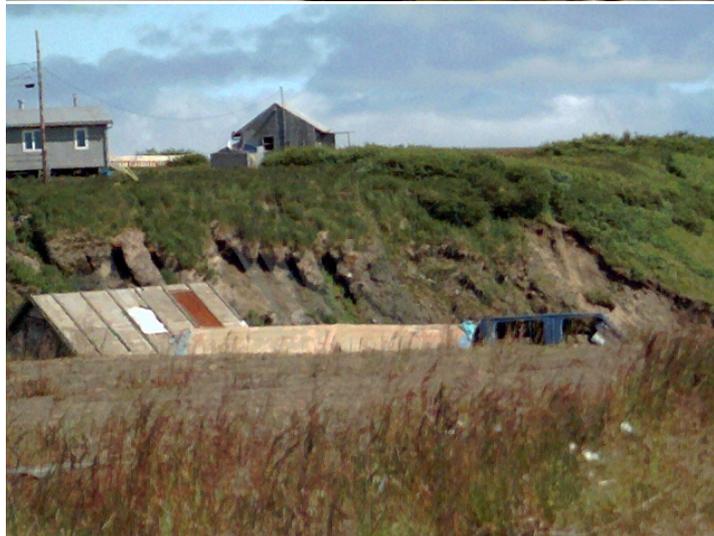
Photos of erosion have been provided by the Chevak Native Village. A diagram depicting the linear extent of erosion in the community is attached.

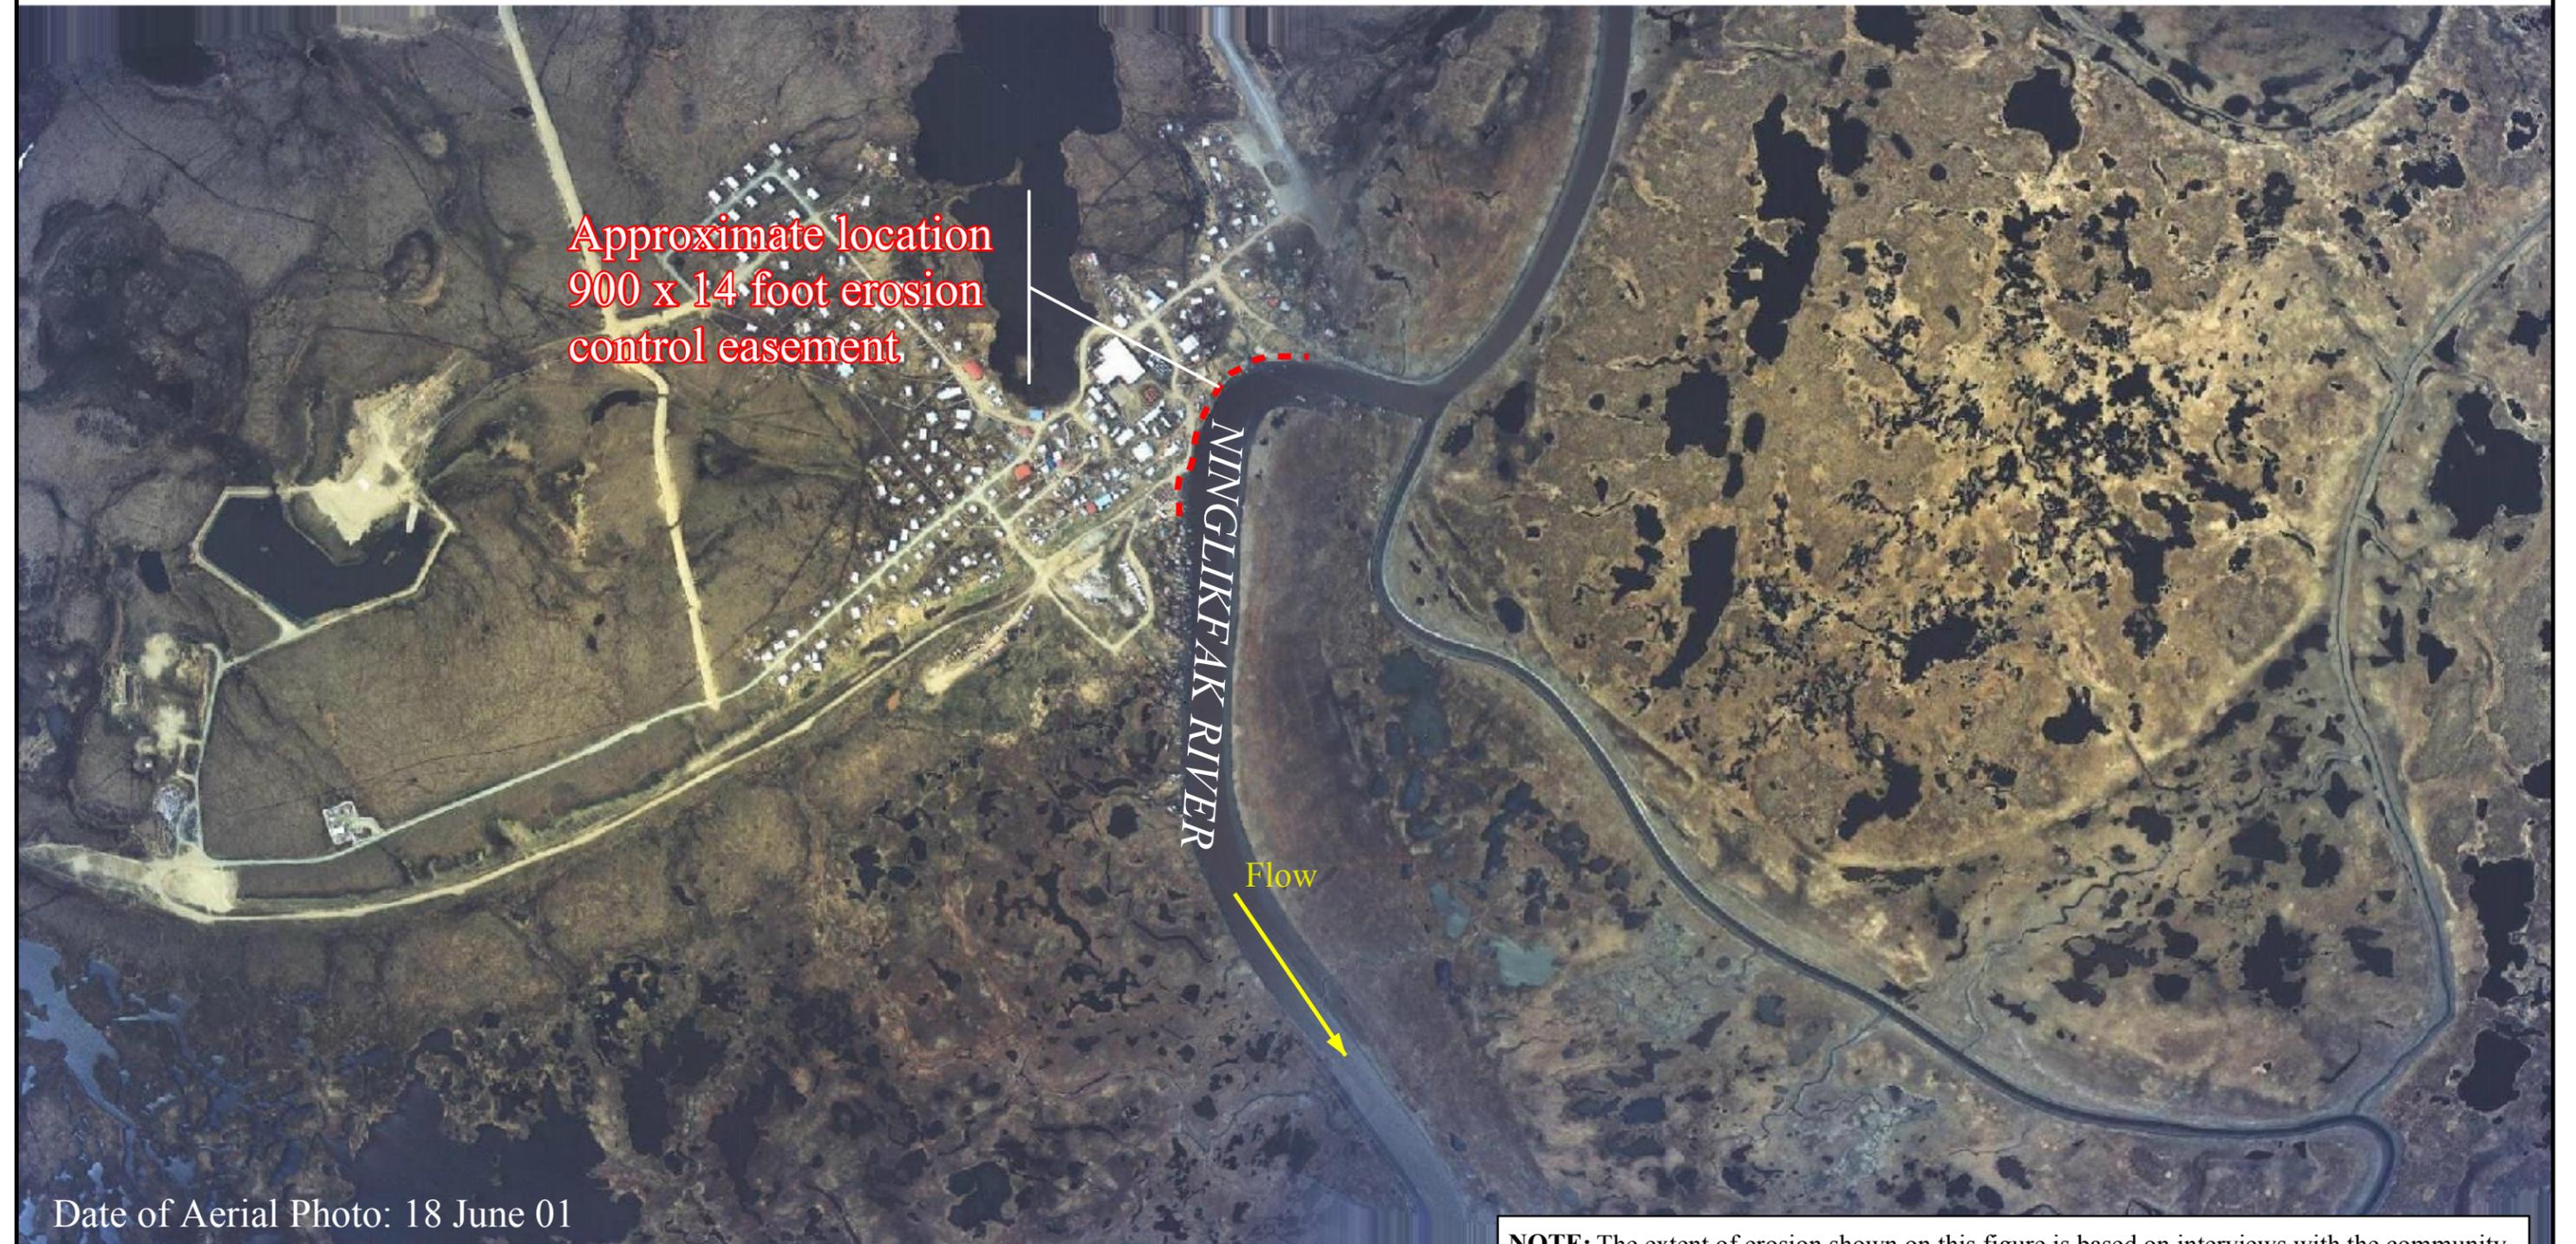
Alaska Baseline Erosion
Chevak, Alaska

NOTE: The extent of erosion shown on this figure is based on interviews with the community. This data has not been field verified. This figure is only intended to show areas of erosion, not rates or severity of erosion

--- Linear Extent of Erosion
